Quebec Bridge Failure #2, 1916

By Frank Griggs, Jr., Dist. M.ASCE, D.Eng, P.E., P.L.S.

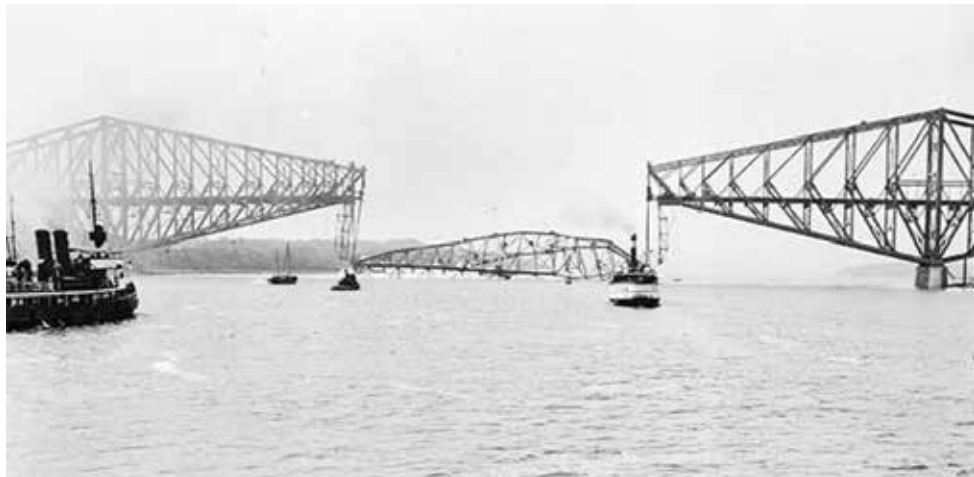
Suspended span collapsing into the St. Lawrence River.

The suspended span was finished in July of 1916. The span weighed over 5,000 tons and was floated into place and connected to the lifting jacks on September 11. After a short lift, the span slipped off its supports and collapsed into the river. The official report of the Board of Engineers described, in part, the series of events on that fateful day as follows,

and they were being lowered for another lift when, at 10:50 am, a sharp report was heard, and the span was seen to slide off its end supports into the river.

Thirteen men were killed this time, with fourteen injured. Once again, an intensive investigation into the cause of the accident was launched. It was clear to all that the truss had fallen off of the southwest supporting girder, where the designers used cruciform steel castings at each corner to provide for rotation about two perpendicular axes.

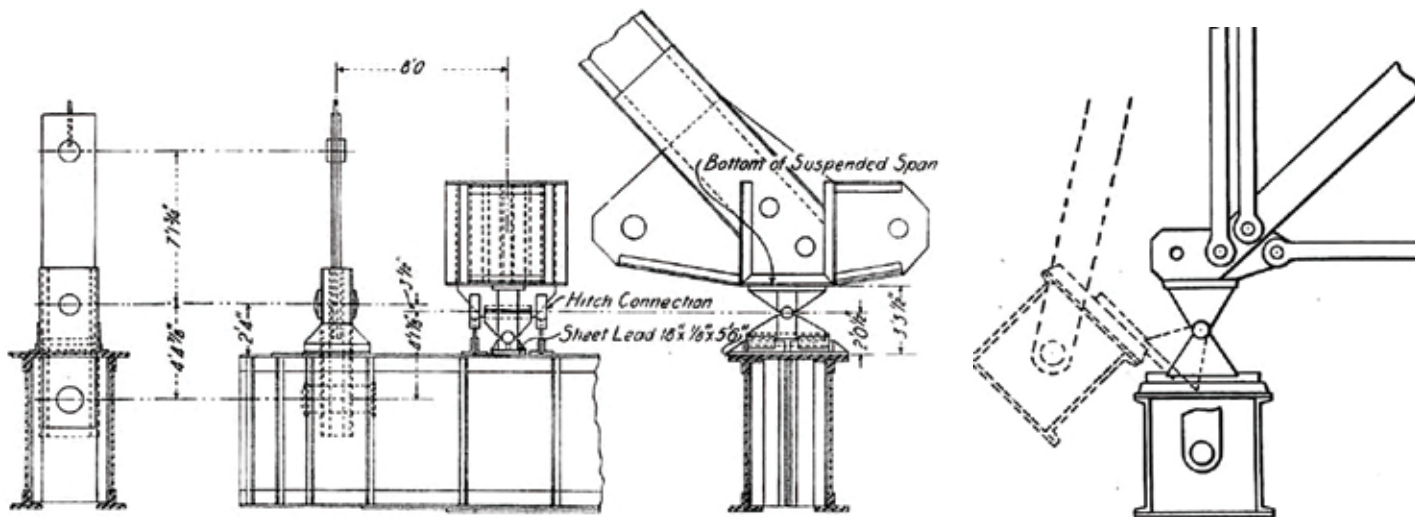
Lifting details.

Tipping of lifting beam.

“A steel casting, by which the weight of the south upstream corner of the suspended span was transferred to the lifting girder, broke in such a manner that the girder kicked back from under it. This corner of the span dropped into the water, starting transversal rotation of the whole south end of the span... But experience teaches again that disaster may come, even to the most careful. In the light of what has happened at Quebec, engineers in every rank of the profession must realize anew that there is a lurking

The Railroad Gazette wrote, “From examinations of the hangers since the accident, it is evident that the intermediate or roller casting under the southwest hanger gave way. The fracture of the front lower pin bracket of this rocker threw the lower pin out of service, and the concentration of the 1,200-ton load on the remaining pieces

crushed and tipped the remainder of the rocker at the same time kicking out the swinging girder and allowing the corner to fall. With the supports at this corner gone, the long, heavy span could not maintain its equilibrium, and it dropped into the river... The
