Adaptive Reuse OF THE HISTORIC WITHERSPOON BUILDING

Part 4: Structural Investigations

By D. Matthew Stuart, P.E., S.E., P.Eng, F.ASCE, F.SEI, A.NAFE, SECB

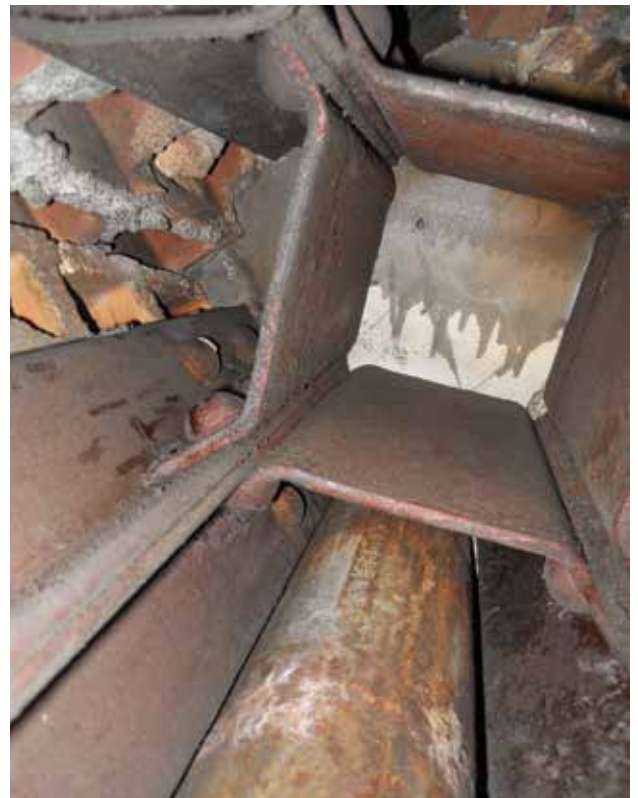
The configuration of the fabricated steel Gray column cross-sections involved four sets of vertical Carnegie Steel double angles located 90° from each other around the circumference of the section. These were connected to the adjacent angles via articulated, riveted gusset plates uniformly spaced vertically for the full height of the column. A total of four plates were located at each connection level (*Figure 16*).

Because of this unusual configuration, a finite element analysis (FEA) determined that the loads imposed on any one set of double angles by a beam reaction at any level would not be shared with any of the other three pairs of angles over the full height of the column. This condition occurred because of the inability of the riveted gussets to adequately transfer the vertical load of any one of the double angles to the other adjacent double angles. This situation, along with the findings of a weldability analysis conducted for the Gray columns, influenced the development and design of the connection of the new loft beams to these unusual existing columns.

Figure 16. Riveted gusset plate connectors at the Gray column vertical double angles.

Based on the results of the above analysis, it was determined that the welding procedures, including any required preheating, could comply with the requirements of Section 4.5 of AWS D1.7. However, although the results of the weldability analysis indicated the Gray columns could be field welded, the results of the FEA concerning the inability of a Gray column to distribute the imposed vertical loads uniformly across the section influenced the design of the new loft beam connections. In addition, there was a real potential for material strength reduction at any one of the vertical double angles due to the heat generated by the welding process, which could weaken the angles and cause a localized failure unless the column was shored the full height of the building. As a result, all new beam connections were designed to connect only to the internal gusset plates.

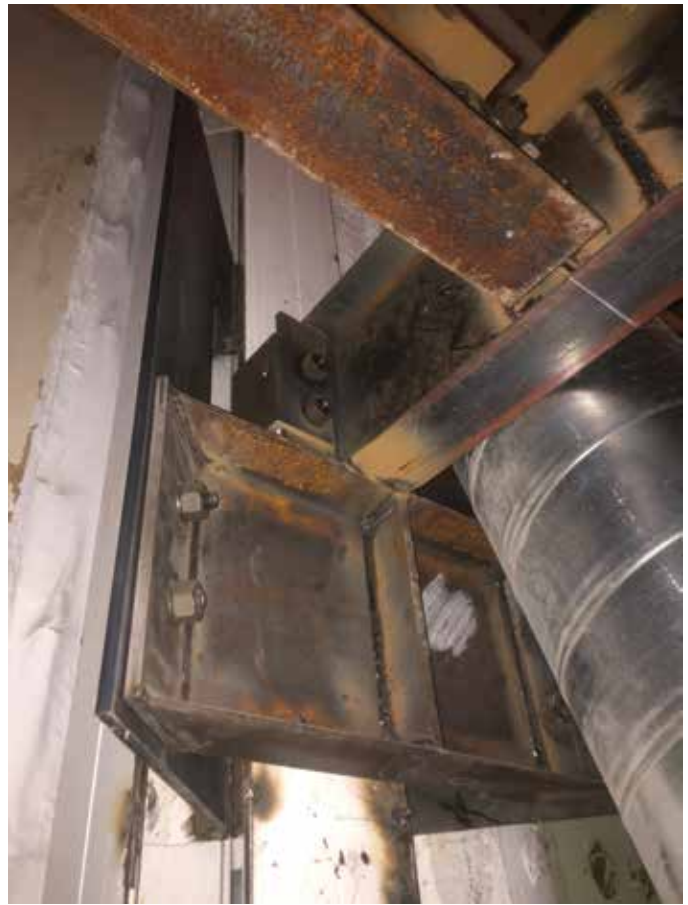
Figure 17. 1st-floor loft beam connection to existing Gray column.

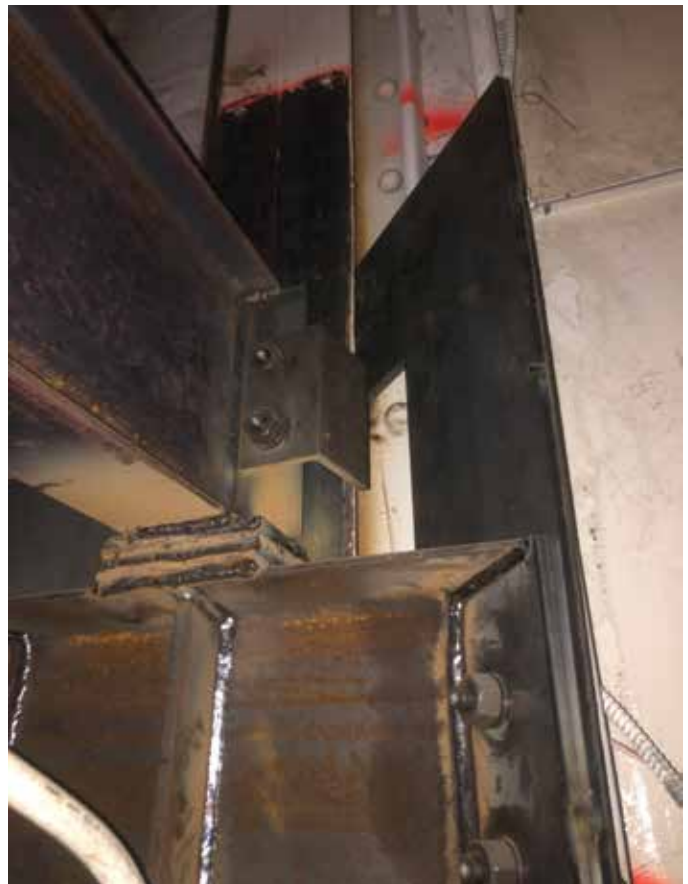
Figure 18. 1st-floor loft beam connection to existing Gray column.

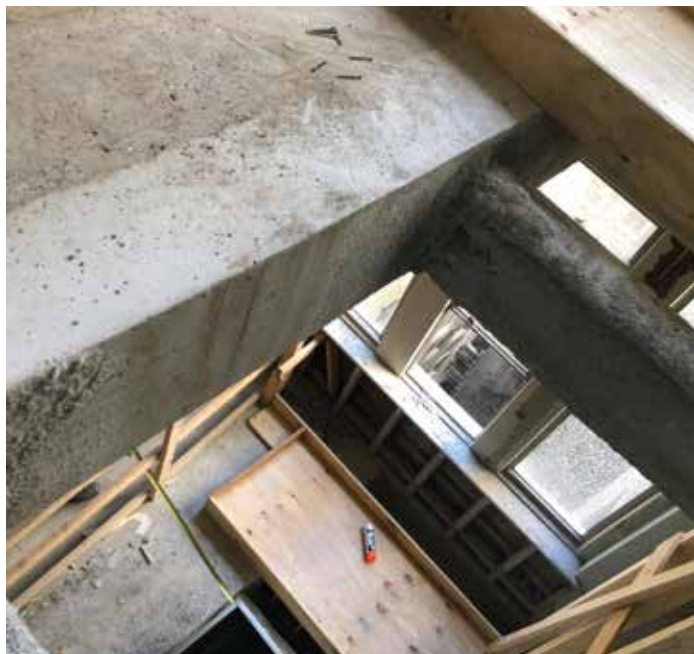
This approach avoided interrupting the arching action of any one row of tiles between the beam supports. Unfortunately, the contractor could not control the demolition at the openings well enough to avoid damaging the remaining row of tiles next to the opening. As a result, it was necessary to form and pour cast-in-place reinforced concrete beams between the supporting steel beams to provide adequate

Figure 19. New cast-in-place concrete beam at new openings in the arch floor to replace damaged tile.

support of the remaining damaged tile arch sections at the edge of the openings (Figure 19).

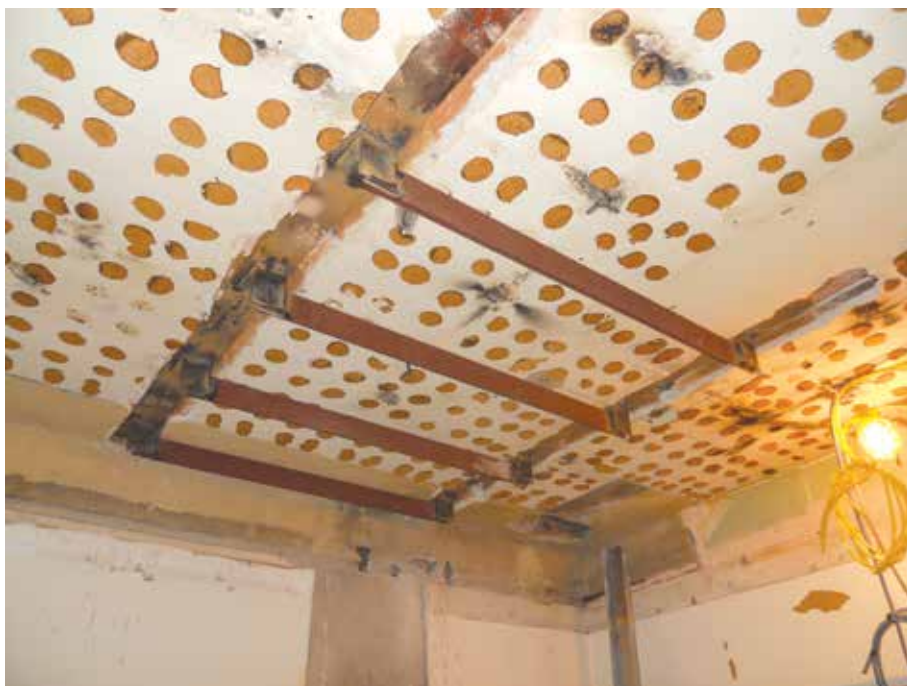
Unfortunately, the investigation could not identify any of the anticipated tie rods typically located at the exterior arch span, which is where the new openings were to be located, next to an exterior wall. Typically, tie rods for flat-arched clay tile framing are not visible because they are generally located at least 3 inches from the bottom of the tile. As a result, it is challenging to locate the steel rods using a ferrosensing device such as a Profometer. In addition, it is also difficult to locate the rods using GPR due to the significant number of internal cavities associated with hollow clay tiles. The best method of locating tie rods is via the use of X-Rays. In-situ radiography can determine both the spacing and diameter of the rods without damaging the tiles. However, this method of non-destructive testing was not feasible for the project.

Figure 20. New steel angles installed first at the arch span adjacent to the new chute and chase openings.

Absent tie rod location information, it was necessary to design supplemental ties, which consisted of steel angles located in the remaining arch span next to the openings that were welded to the bottom flange of the steel beams located at each end of the same arch span. These supplemental ties were required to resist the horizontal arch thrust force at the beam adjacent to the new openings without knowing the actual number of tie rods that would be damaged by the demolition of the tiles within the new openings. As a result, the new ties had to be installed before the demolition of the openings began (Figure 20).

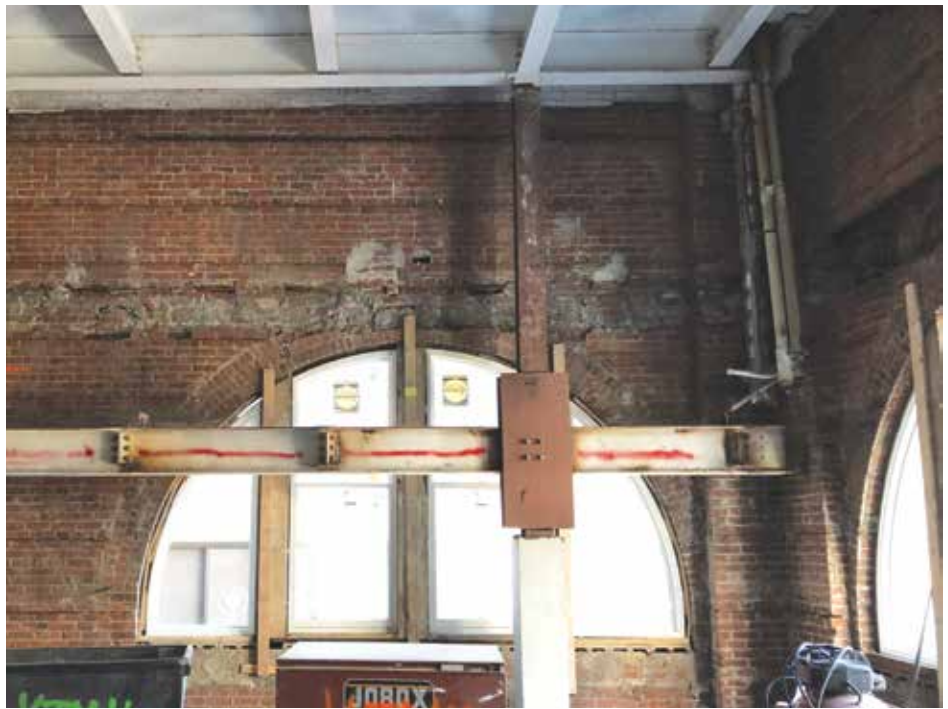
After the existing 2nd-floor mezzanine was demolished for the proposed new 2nd-floor loft, which was eventually eliminated from the adaptive reuse project, it was necessary to strengthen the existing remaining two-story steel wide flange columns that remained and extended up to support the 1960s 3rd-floor infill framing above. In addition, several of the existing Gray columns in the same area of the building were also strengthened because it appeared that the same members at one time had been braced by framing that had existed within the Witherspoon Hall space but had been removed when the 2nd-floor mezzanine was constructed in the 1960s.

Figure 21. Reinforced discontinuous column at 2nd-floor mezzanine cantilevered beam.

Horizontal, diagonal bracing was installed between the wide flange columns checked for the approximate two-story unbraced length and the existing Gray columns. Some of the wide flange columns had not been erected as a continuous vertical member at two 2nd floor mezzanine beam cantilevers. Instead, they had been interrupted by the same beams (*Figure R, online*). Reinforcing plates and stiffeners were installed to ensure the remaining stacked columns would behave as a continuous vertical member (*Figure 21*).

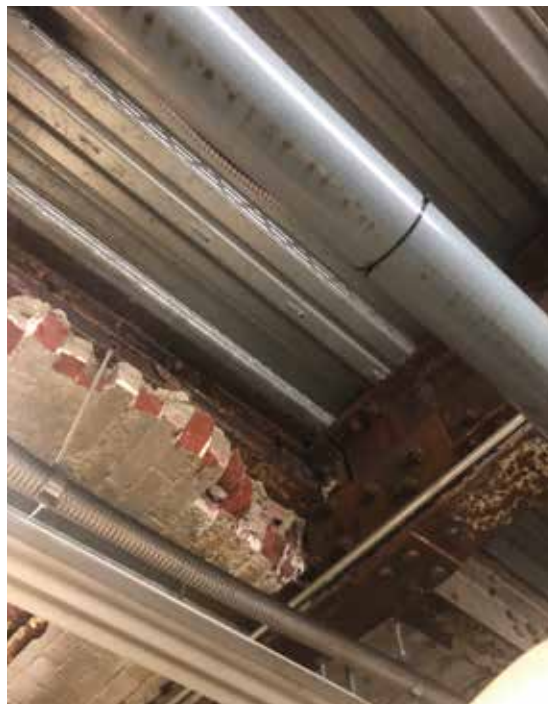
Assessment results associated with the existing supporting structure involved a considerable amount of investigation and exploratory demolition due to the complexity of the existing building below the 2nd floor in the vicinity of the dunnage in question. The investigation results indicated that the existing structure was adequate, including steel beams and a transfer girder over the mechanical sub-basement area that indirectly supported a portion of the dunnage above. However, at the existing 20-inch-deep Carnegie Steel B3

Figure 22. Existing 20-inch-deep, Carnegie Steel B3 transfer girder splice.

transfer girder, a splice in the beam near the midspan of the section was determined to be deficient for the new imposed loads (*Figure 22*). A new HSS steel column was installed between a new footing at the sub-basement slab and the bottom of the girder at the splice to reduce the span of the member.

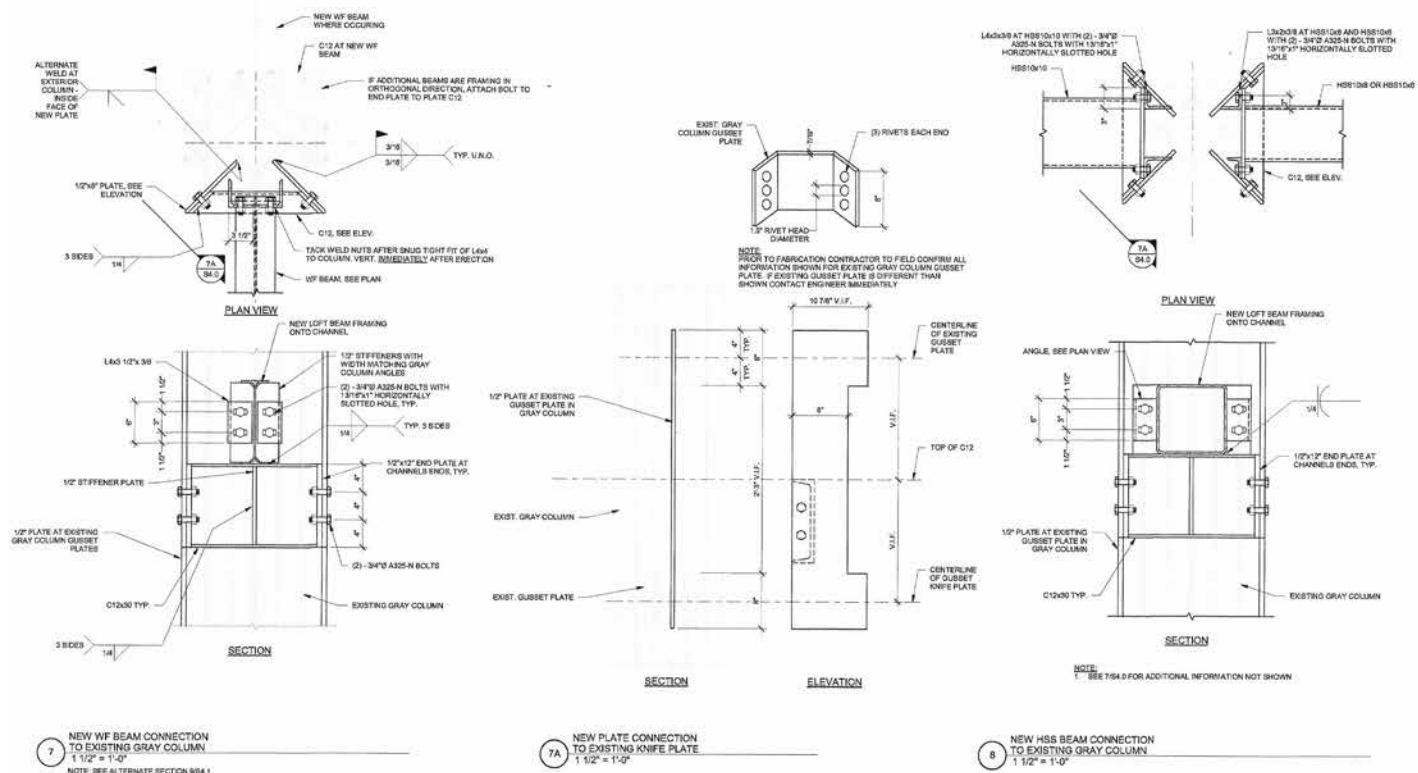
Figure P. Typical 1st-floor loft beam connections to existing Gray column gusset plate details.

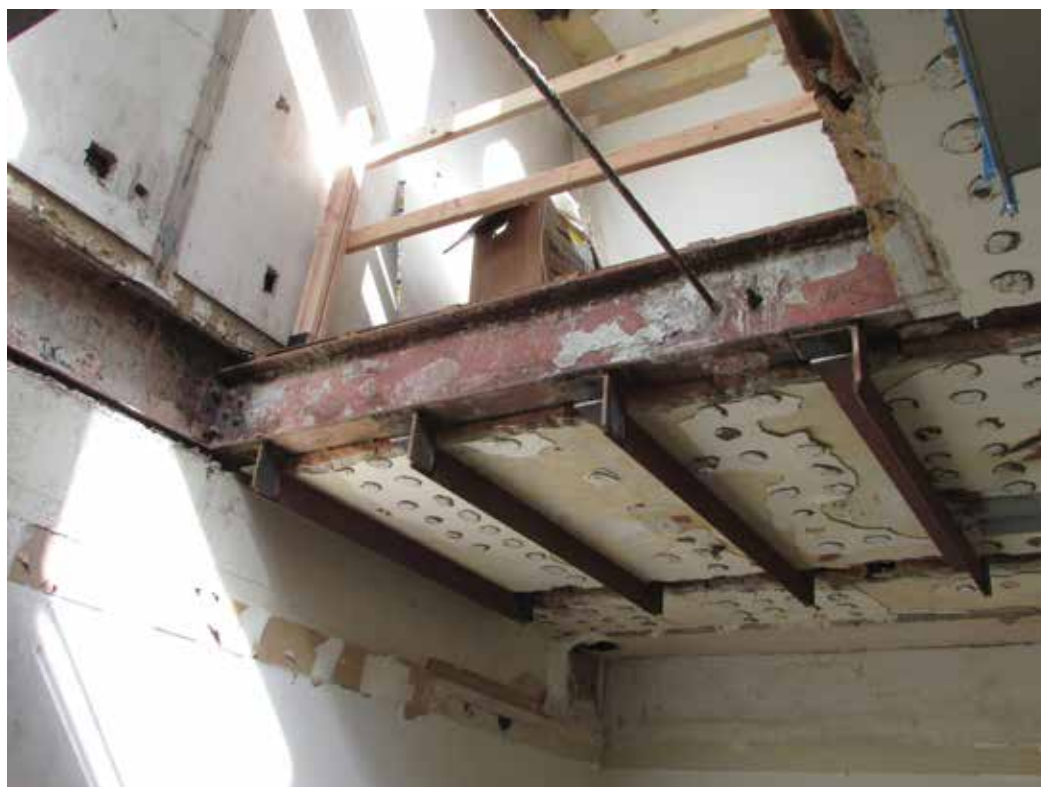
During the demolition process, the presence of tie rods was confirmed (Figure Q, online). The $\frac{3}{4}$ -inch-diameter steel rods were spaced at approximately 5 feet on-center and located near mid-depth of the existing 12-inch-deep

Carnegie Steel beams, which in turn were also spaced at approximately 5 feet on-center. A lab test of one of the rods removed from a new opening indicated a yield strength of approximately 50 ksi, which equates to a factor of safety of approximately 2.75 for the recommended maximum allowable stress of 18 ksi provided in the *Principals of Tile Engineering Handbook of Design* for the design of flat arch, hollow clay tile framing.

Figure Q. Existing arch tie rods at the new chase and chute openings.

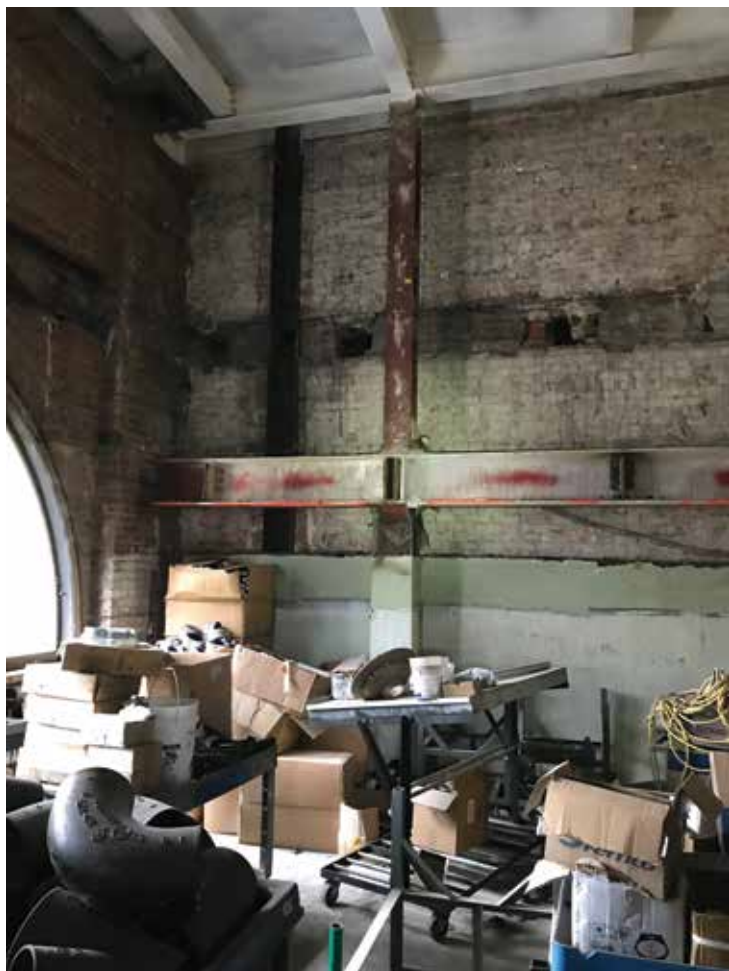
Figure R. Remaining 2nd-floor mezzanine cantilevered beam and discontinuous column.
