Niagara's Upper Falls Bridge Failure

By Frank Griggs, Jr., Dist. M.ASCE, D.Eng, P.E., P.L.S.

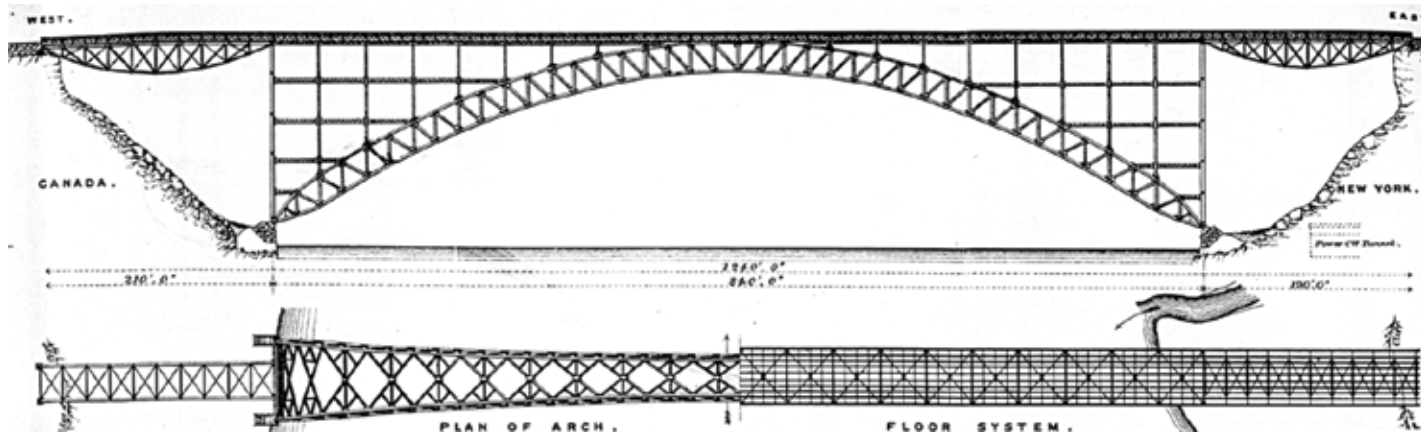
In addition to fire, decay, and floods, ice jams had taken out many of the early wooden bridges built in the Northeastern United States. History had shown that ice jams were frequent in this part of the Niagara River below the falls. Buck placed the abutments on the canyon walls at an elevation he believed to be above any recorded ice jams. Six months after the bridge opened, large quantities of ice came over the falls and formed a large ice pack. Usually, this ice was confined to the center third of the river due to strong eddies moving upstream on the sides. This ice pack reached thicknesses of over 100 feet, with up to 80 feet being below the surface and 25 feet above the surface. Buck wrote, the "high water level and the movement of the ice were investigated before fixing the span of the arch and the elevation of the abutments; according to the worst conditions previously known."

Plan and profile of the bridge.

However, the fates were on his side this time, and he straightened the bent struts immediately and replaced them in the spring. He wrote, “in order to guard against similar trouble in the future, heavy concrete walls were built around the abutments, extending as far out in front as possible, and the first two panels of laterals in the plane of the lower chord on each side of the river were changed from latticed struts to plate-webbed struts.”

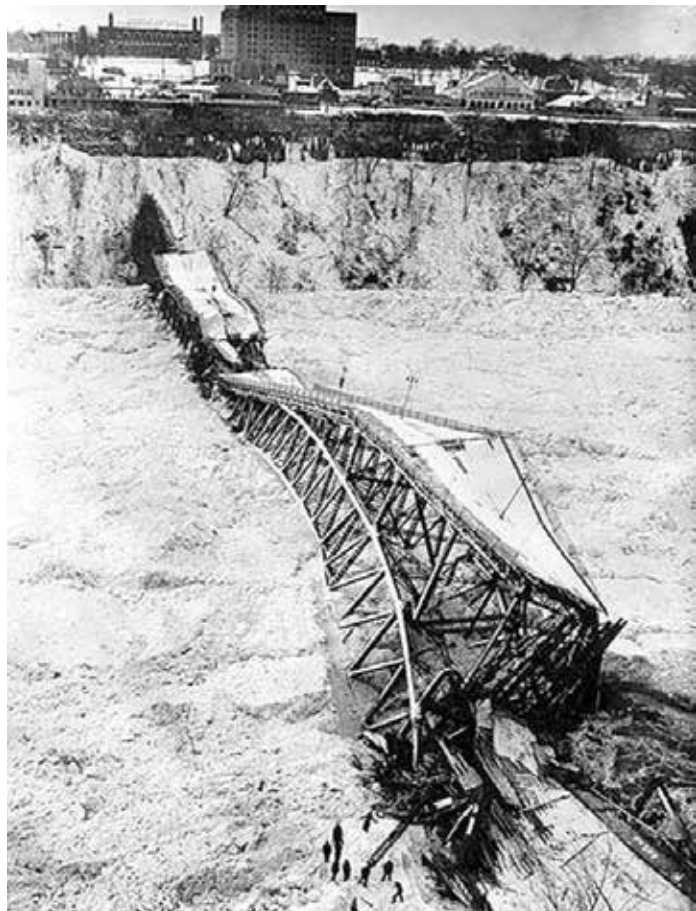
Those two sections at the ends slowly sloped downward in a shower of powdery snow, dirt, and tumbling rock. Then the two sections inside these began to rise as though in a frantic effort to escape that mangling death below, attempting to soar skyward. It was a last futile gesture. Slowly – it seemed minutes though it was but split seconds – the giant folded into the masses of ice. The result was a giant “W” for Winter resting on the river ice.”

The owners of the bridge immediately blasted it into three parts as it lay on the ice. After attempts to salvage the steel, they found that they could not remove any portion of it. So it sat there until, on April 12 at 7:10 AM, the ice let loose and the end span dropped into the water to be followed by the sinking of half of the arch on the American side. On the following day, at 3:25 PM, the remaining section of the bridge began to move down the river on the ice. As it moved, the “huge ice floe turned pointing the bridge section like the prow of a freighter as it sailed down the river with the current.” It was described as follows:

Bridge after the collapse.
