# RESTORING A CENTURY-OLD BUILDING

## THE NH COLLECTION NEW YORK MADISON AVENUE HOTEL RENOVATION

By Lauren Feinstein, P.E., Jordan Weinstein, P.E., and Kevin Poulin, Ph.D., P.E.

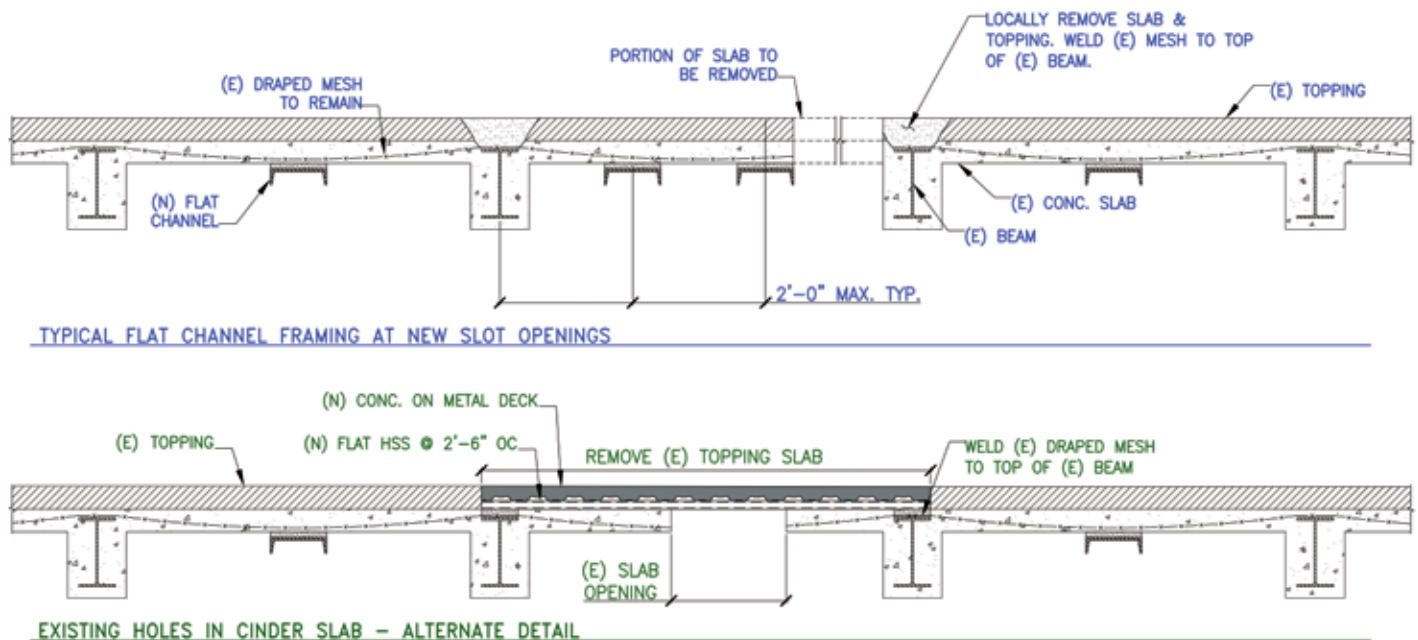
Figure 1. Draped-mesh cinder-concrete slab strengthening details at floor penetrations

SGH considered several issues for new openings in the draped-mesh cinder-concrete floor slab. The existing floor system typically consisted of a 3-inch-thick non-structural cinder fill with a 1-inch cement topping slab over a 4-inch-thick structural cinder-concrete slab with draped, steel-wire mesh that spanned one-way between encased steel beams. The draped steel mesh supports the slabs via catenary action. The 1968 *New York City Building Code* (NYCBC) governs modifications to archaic structural systems used on this project and specifically addresses openings and penetrations in this type of floor system. According to the 1968 NYCBC, a single opening greater than 18 inches or multiple openings totaling over 18 inches in any 10-foot width or span of slab must be framed. As the creation of new floor openings comprised a large portion of the structural

scope, SGH proposed two options (topside and underside) for slab strengthening (Figure 1). Both details satisfied the architect's strict head-height criteria and avoided increasing the floor load enough to trigger additional beam strengthening. The cinder fill was removed locally and replaced with a thin slab on deck that spanned to shallow HSS beams for the topside repair option. This system bypassed the existing slab and was supported entirely on the existing steel floor framing. For the underside repair option, the existing slab spanned as plain concrete between flat channels tight to the underside of the slab spaced at 2 feet on-center.

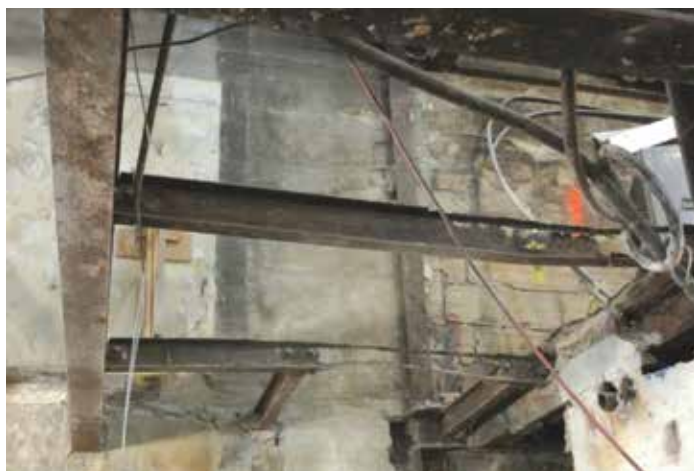
Figure 2a. Section loss at corroded cellar steel beams

Another unforeseen condition, concealed by ceiling finishes, was extensive corrosion and deterioration in the cellar floor. Maintenance staff informed the project team that steam pipes leaked for decades in the cellar and subcellar. This triggered a thorough investigation of the cellar structure to assess its condition. As shown in *Figure 2a*, some of the steel beams had nearly complete section loss. As shown in *Figure 2b*, all that remained of the wire mesh in deteriorated sections of the slab was rust staining on the concrete. After the contractor installed temporary shoring, SGH visually surveyed the underside of the cellar slab, looking for spalled or cracked concrete, and requested that the contractor sound these areas to locate additional delamination within the slab. SGH also identified steel beams with cracked concrete encasements that indicated expansive pressure from corrosion. SGH directed the contractor to remove the encasements and grind the corrosion to bare metal at these beams. SGH then measured and documented the remaining cross-sections and determined whether strengthening was necessary. This survey led to the removal and replacement of approximately half of the cellar slab and framing, in addition to some local strengthening of corroded steel columns.

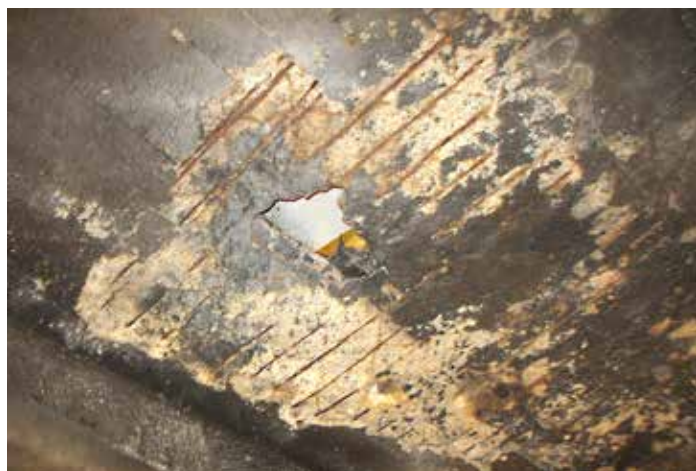
Figure 2b. Cellar slab deterioration

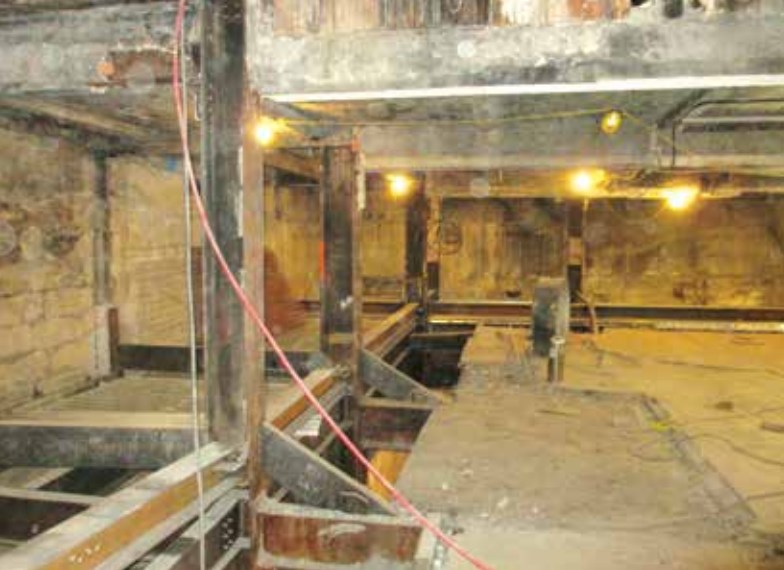
Figure 3. Cellar column temporary bracing.

Seven perimeter columns relied on the deteriorated portion of the cellar floor structure for bracing. For temporary bracing prior to slab removal, SGH designed a new grid of horizontal, inclined, and skewed steel braces, just above the existing cellar floor (*Figure 3*), which connected the affected columns to the remaining floor diaphragm, avoiding obstacles such as slab steps and floor openings. In addition, SGH designed replacement beams and slabs and worked closely with the contractor to sequence piecewise beam and slab demolition and replacement to ensure that the existing columns were continually braced during reconstruction.

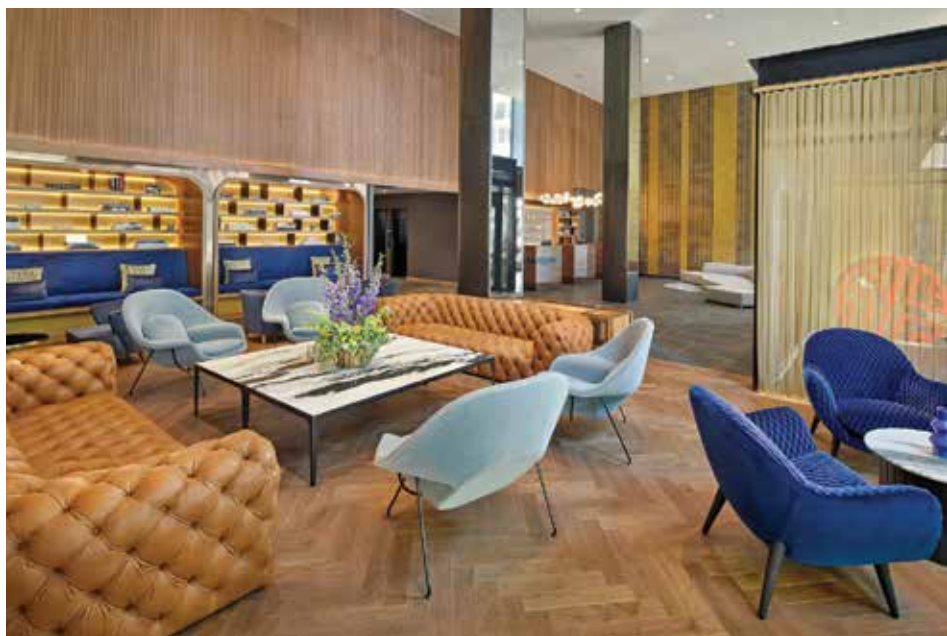
Figure 4. New spacious double-height lobby.

As part of the architectural transformation, HLW designed two large floor openings, the larger of which was 55 feet long by 35 feet wide in the second-floor slab, to create a spacious double-height lobby for the hotel (*Figure 4*). Several floor beams needed to be removed to create this space, resulting in seven columns becoming unbraced in one or both directions. SGH designed plate reinforcing for these columns to strengthen them for their newly doubled unbraced lengths. SGH sequenced the installation of

the strengthening plates to avoid temporary shoring of the columns; the contractor locally cut the flanges of the existing beams at the connections to the columns and installed slotted strengthening plates around the beam webs. The contractor demolished the slab and floor beams only after installing all column strengthening.
