Tacoma Narrows Bridge Failure 1940

Galloping Gertie, Part 2

By Frank Griggs, Jr., Dist. M.ASCE, D.Eng, P.E., P.L.S.

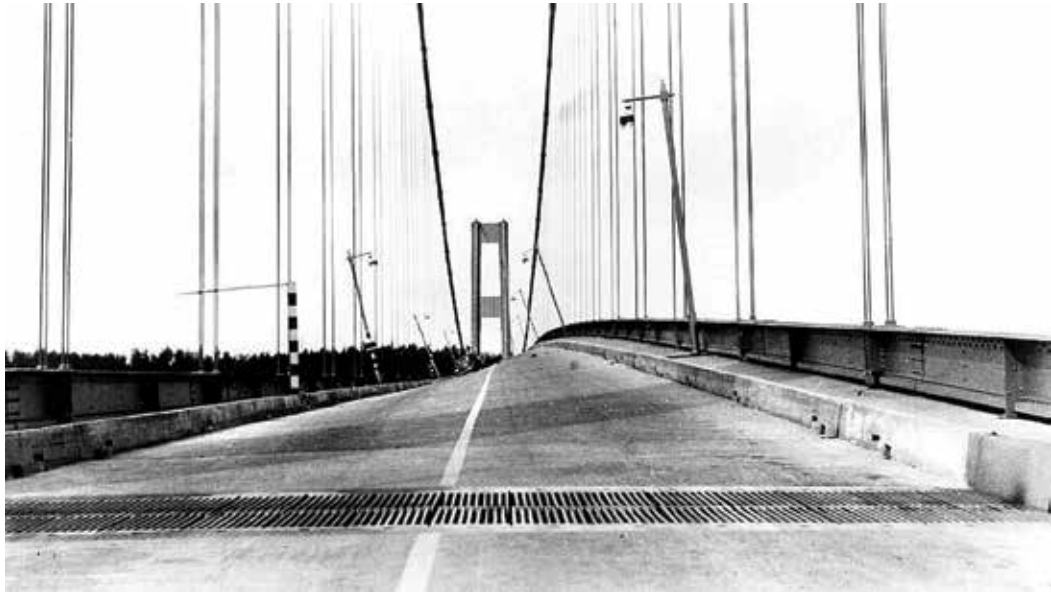
Tacoma Narrows Bridge twisting prior to collapse.

started as the north center stay broke, and the bridge began twisting even more violently in two parts. “Two cars were on the bridge when this wild movement began: one with Leonard Coatsworth, a newspaper reporter, and his cocker spaniel and the other with Arthur Hagen and Judy Jacox. All three people crawled to safety.” Shortly after 11:00 AM, the other stay broke, and the stiffening girders buckled in the middle, followed by the breaking of several suspenders. Most of the main span then dropped into Puget Sound. With a large portion of the center span deck gone, the towers tilted 12 feet towards the anchorages causing significant deflections in the side spans. The failure was complete.

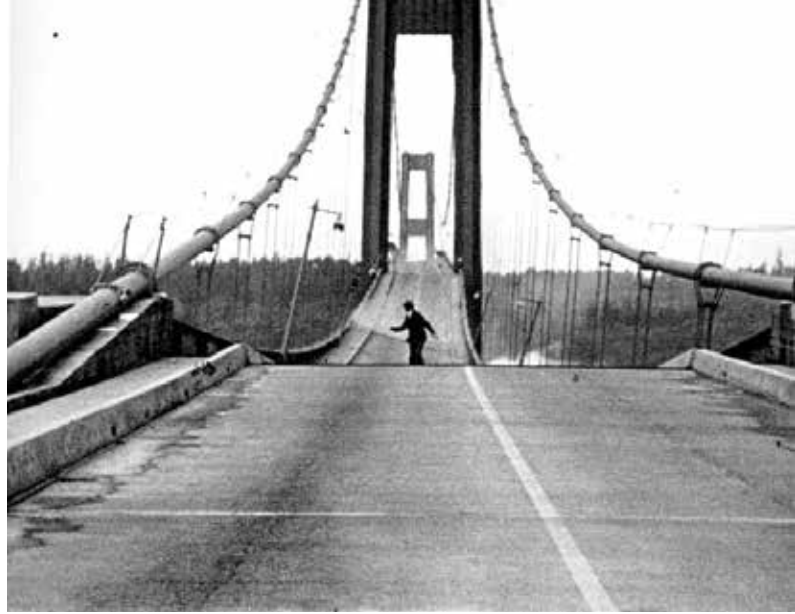
Photographer Howard Clifford, escapes the Tacoma Narrows Bridge during collapse.
