## Silver Bridge Failure 1967 (aka Point Pleasant Bridge)

By Frank Griggs, Jr., Dist. M.ASCE, D.Eng., P.E., P.L.S.

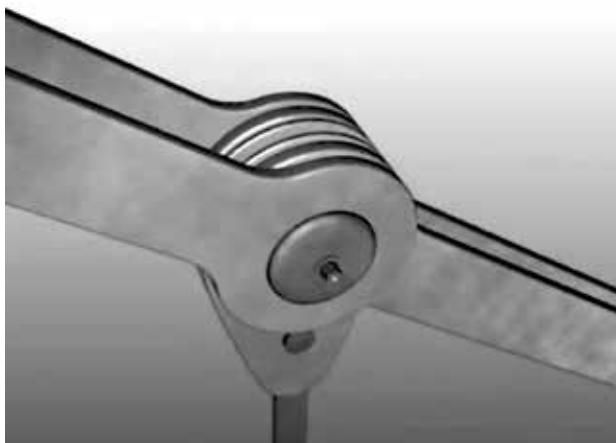
Point Pleasant Bridge pin joint above stiffening trusses.
