Tampa Bay (Sunshine Skyway) Bridge Disaster

By Frank Griggs, Jr., Dist. M.ASCE, D.Eng, P.E., P.L.S.

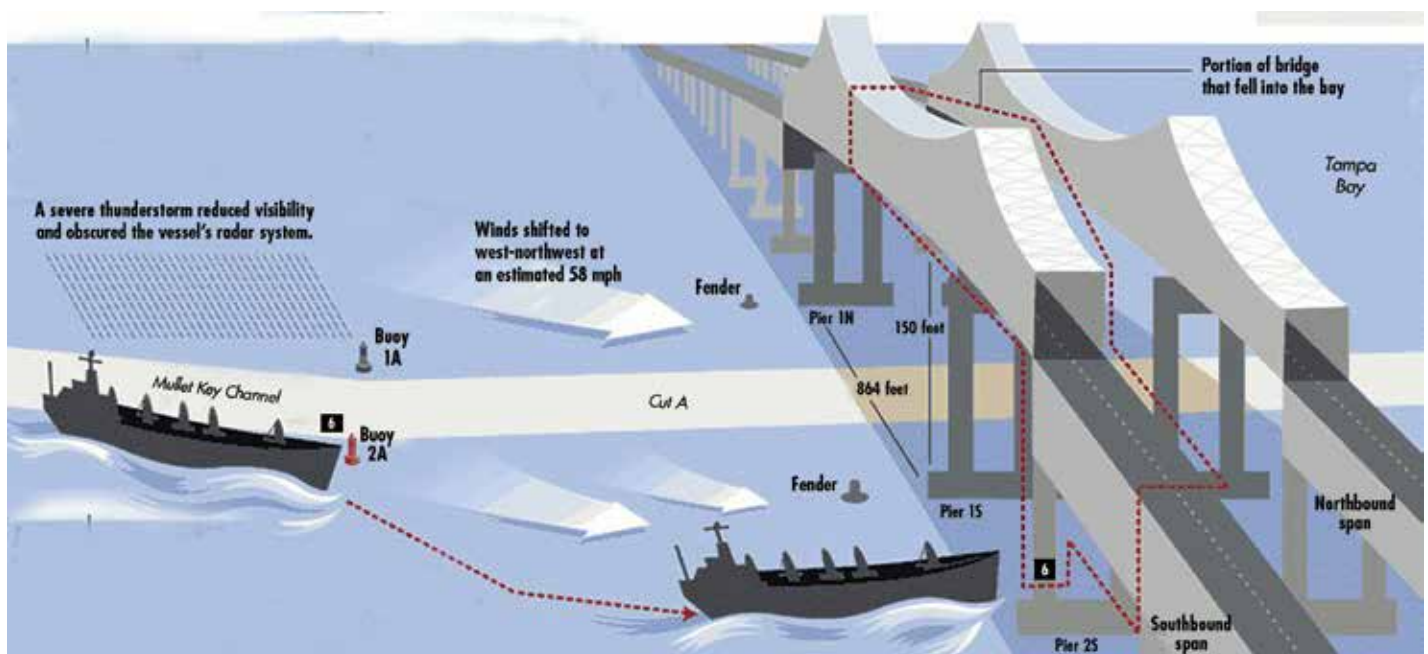
First, a severe thunderstorm blew in from the northwest, pushing the ship, which was riding high in its unloaded condition, outside the shipping channel. Lerro sent two lookouts to the bow of the bridge when the weather turned worse. He was to make an 18° turn to the left between buoys 1A and 2A, shown in the graphic. An unpredicted strong wind came up out of the north-northwest and blew the ship farther outside the channel. In addition, the ship's radar failed.

Path of the ship. Courtesy St. Petersburg Times.

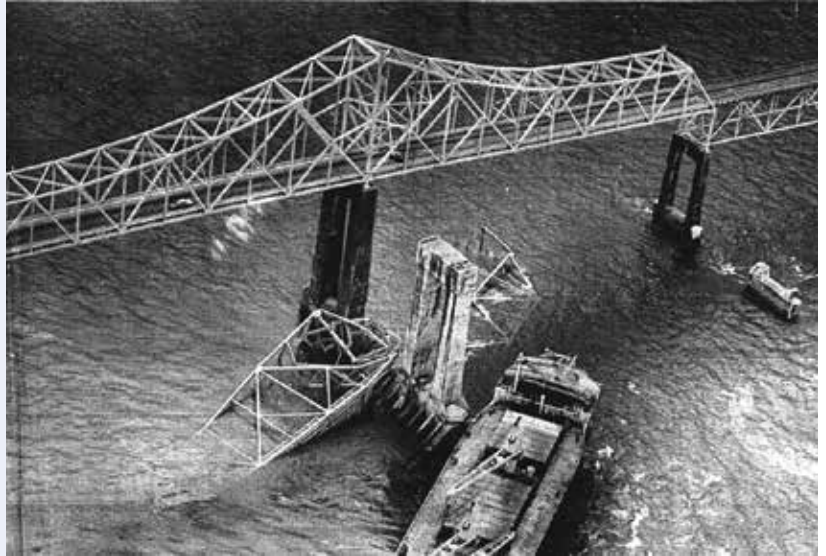
caused it to come into view. He tried to stop the ship by ordering a dropping of the anchor and the reversing of its engines, but everything he attempted could not slow the ship fast enough. Yet he was moving slow enough that he could not steer the ship away from the pier. The ship hit the main pier with a glancing blow causing no damage to the bridge, but then hit the anchor span pier head-on, causing its collapse at 7:33 in the morning. When that pier failed, the weight of the cantilever caused the anchor span to lift, overloading it until it separated from the far cantilever arm, and the anchor span, cantilever arm, and suspended span dropped into the bay with a portion of the bridge landing on the bow of the ship.

The mass and design of bridge piers and pier protection systems and the configuration, weight, and speed of vessels have a direct effect on the damage which may result from a collision. The bulwark and the forecastle of the SUMMIT VENTURE struck the pier column before the lower bow struck the pier crash wall. If the pier crash wall had been larger or a pier protection system had been installed at that location, the initial impact would have occurred near the waterline. Because the pier crash wall is anchored through the pier footer directly into the bay bottom and is larger and stronger than the columns, it is possible that sufficient energy might have been absorbed to reduce the vessel's forward motion and perhaps redirect the vessel before the bulwark and forecastle struck the column. While the pier still could have been damaged, only the vessel's mast would have struck the bridge span if the vessel had been redirected to starboard. The vessel could have passed under the bridge span if it had been redirected to port, and the damage to the bridge span might have been minimized...

Ship and bridge after the collapse; rammed pier center-right.

- In cooperation with the U.S. Coast Guard, develop standards for the design, performance, and location of structural bridge pier protection systems, which consider that the impact from an off-course vessel can occur significantly above as well as below the water surface.
