The Schoharie Creek Disaster

By Frank Griggs, Jr., Dist. M.ASCE, D.Eng, P.E., P.L.S.

The New York State Thruway bridge across the Schoharie Creek collapsed on April 5, 1987, during a flood, killing 10 people. Unlike many of the failures discussed previously, this was in the lifetime of many readers.

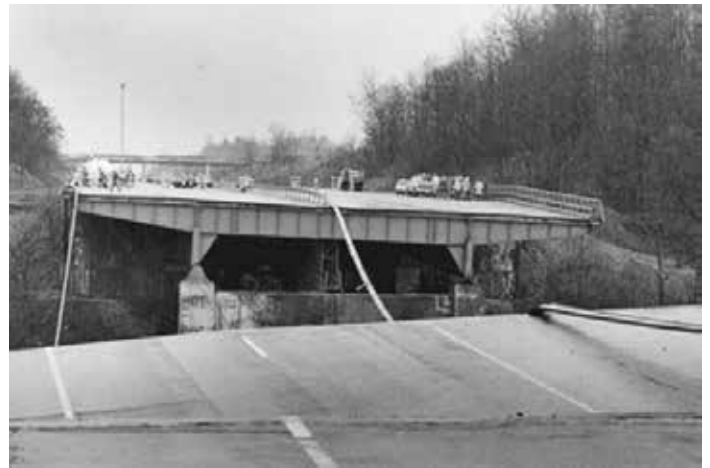
The Schoharie Creek Bridge collapse.

The spring of 1987 was very wet for upstate New York and New England. Over six inches of rain had fallen on April 3rd and 4th, and, coupled with snowmelt, water came roaring down the creek on April 5 in what was determined to be a 50-year flood. Pier No. 3 was washed out around 10:45 AM, and spans 3 and 4 dropped into the creek. With debris in the channel, the flow was directed to Pier No. 2, which also was washed out, and span 2 dropped into the creek. At the time of the collapse, there was one car and a tractor-trailer on the bridge, and before traffic could be stopped, three more cars ended up in the creek. A total of 10 people lost their lives in the disaster. The body of the tenth victim was found two years later downstream in the Mohawk River.

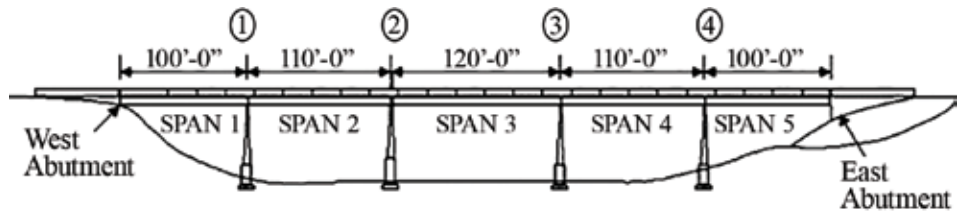
Plan of the bridge showing piers and span lengths; spans 3 and 4 failed.

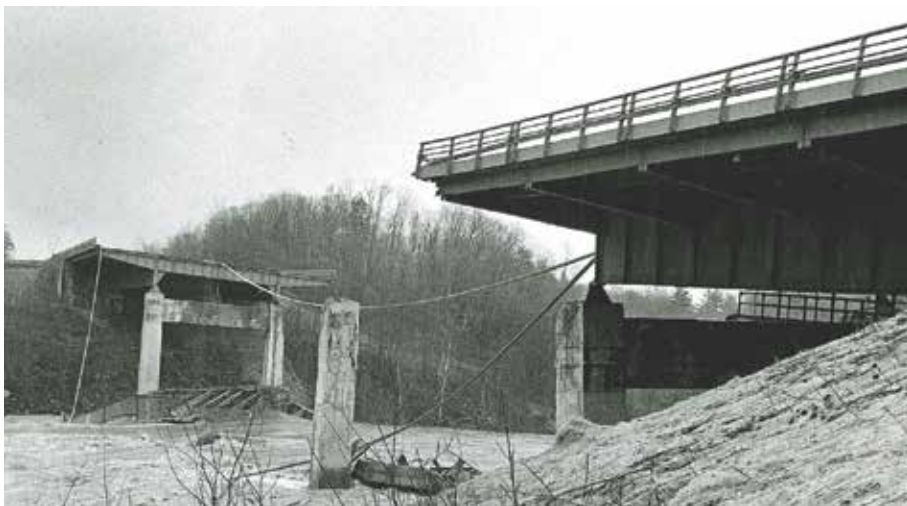
Bridge with three spans out.
