Failure of Equalization Basin at Water Treatment Plant

By Hal K. Cain, P.E., and Michael A. Amos, P.E.

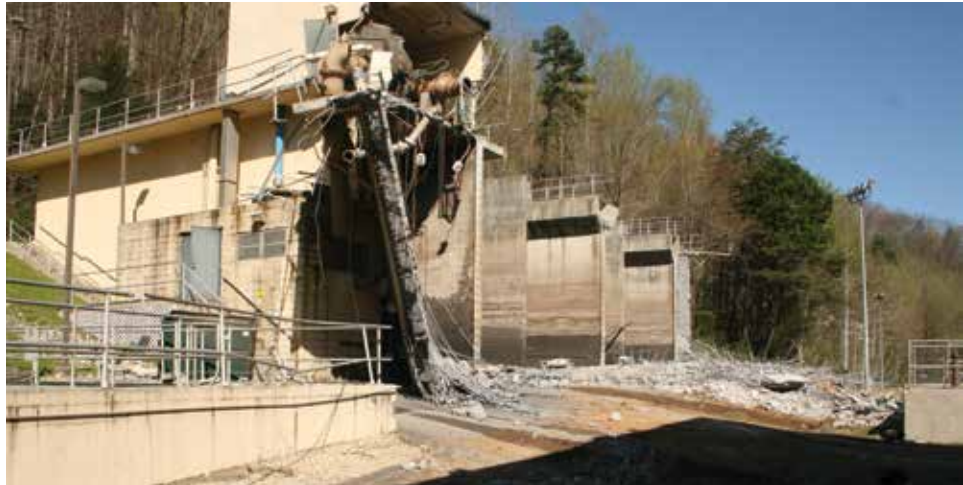
Figure 1. Overall view of the collapsed east wall of the Gatlinburg Wastewater Plant equalization basin looking from south to north.

On April 5, 2011, following very heavy rains, the east wall of the basin collapsed in a catastrophic failure resulting in two fatalities. At the time, it was reported that the basin was filled to a depth of approximately 26 feet. The basin was constructed without overflow structures, and there was evidence on the outside of the west wall that the basin had overflowed before the failure (Figure 6).

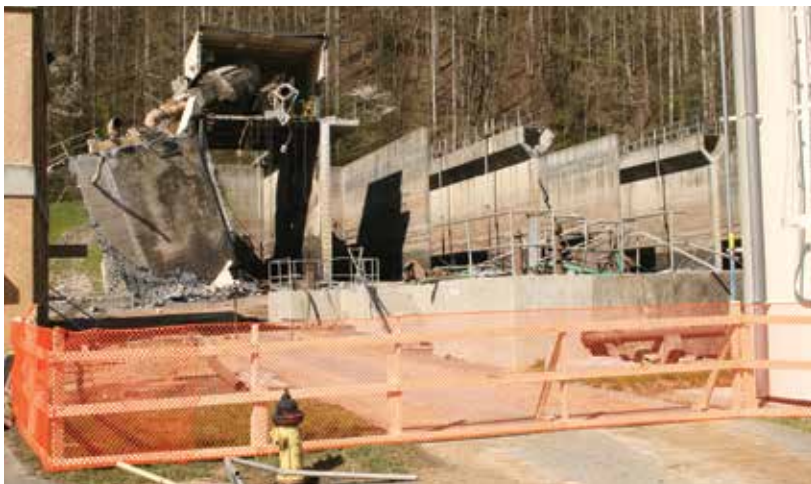
Figure 2. Front view showing the collapsed east wall of the Gatlinburg Wastewater Plant equalization basin.

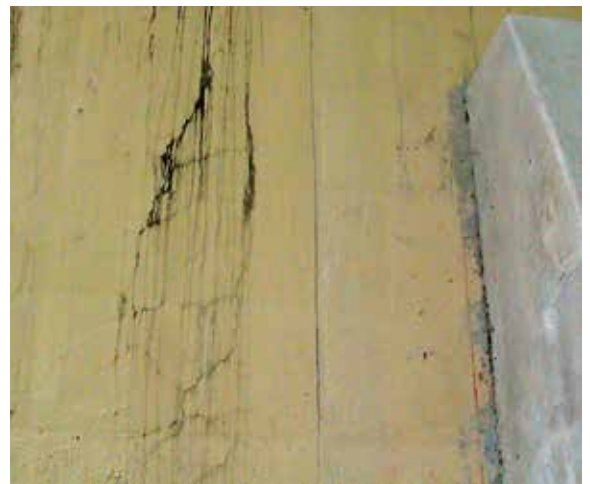
Figure 3. Cracks in the north wall caused by the excessive displacement of the wall. The added buttress is shown to the right of the photo.

Shortly after the basin was placed into service, the north wall began to bow outward by approximately 4 inches during a very heavy rain period. At that time, the tank level was reported to be approximately 26 feet. This was well above the normal operating level of approximately 10 feet. The resulting lateral displacement caused cracks to form in this wall and the perimeter walkway (Figures 3 and 4).

The study did indicate that the deflection and the resulting cracks were likely caused by the ends of the 63-foot-long north wall acting

in a pinned-pinned condition rather than a more rigid fixed-fixed condition. Further, the walkway that ran the entire length of the north wall and that extended 4.5 feet from the face of the wall appeared to be acting as a horizontal stiffener beam. This was most likely not the intent of this element; however, its presence most likely lessened the observed displacement caused by the high water levels.

Modifications were made to the north wall of the structure. They included the addition of an exterior buttress (Figure 5) and a recommendation to limit the water retention height in the tank to 26.5 feet. The buttress was installed, but there was no indication that level control systems were installed.

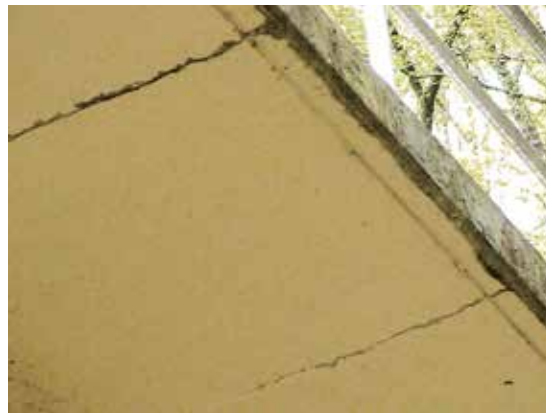
Figure 4. Cracks in the upper walkway along the north wall. This was caused by the excessive displacement of the wall.

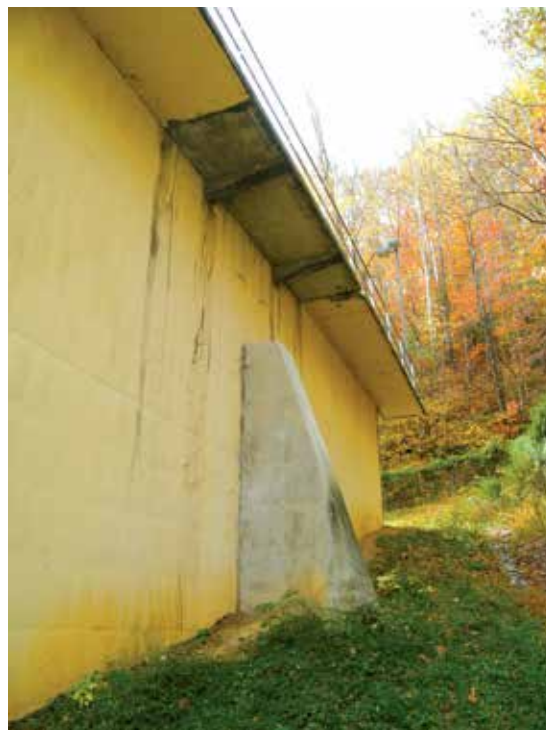
Figure 5. Concrete buttress that was installed along the north wall of the basin shortly after the basin was placed into service. The wall is cracked in the area in front of the buttress.

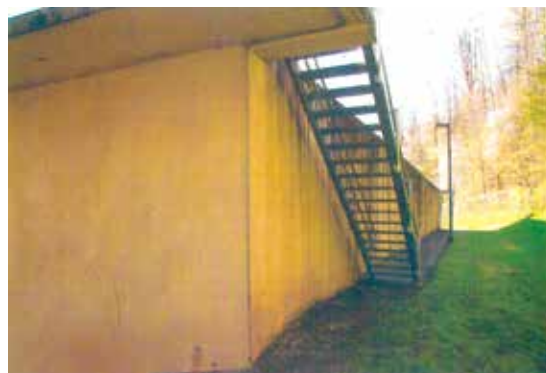
Figure 6. View shows the structure's west wall and evidence of overflow and wastewater to a height of 30 feet 5 inches in the basin.

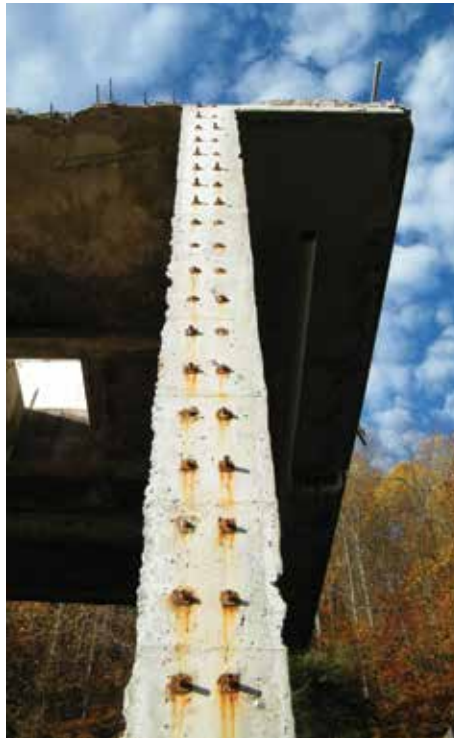
Reinforcing bar couplers were used to connect the baffle walls to the east and west walls of the structure (Figure 7). The couplers were similar to a Dayton D50 – #5, product code 77100. Cain and Associates calculated the maximum tensile force in a pair of couplers attaching the baffle walls to the east wall to be approximately 43 kips at the height of approximately 9.5 feet above the basin floor. The load at yield for a pair of threaded #5 bars is 27.12 kips based on a yield stress of 60 ksi and a cross-section area at the cut threads of 0.226 in². The required ultimate design strength should have been no less than 70.95 kips based on the calculated load of 43 kips and the direct tension factor of 1.65 as defined in ACI 350.

Figure 7. Looking up at reinforcing bar couplers placed at the east end of a baffle wall. The couplers are placed at 12-inch vertical and 7-inch horizontal centers.

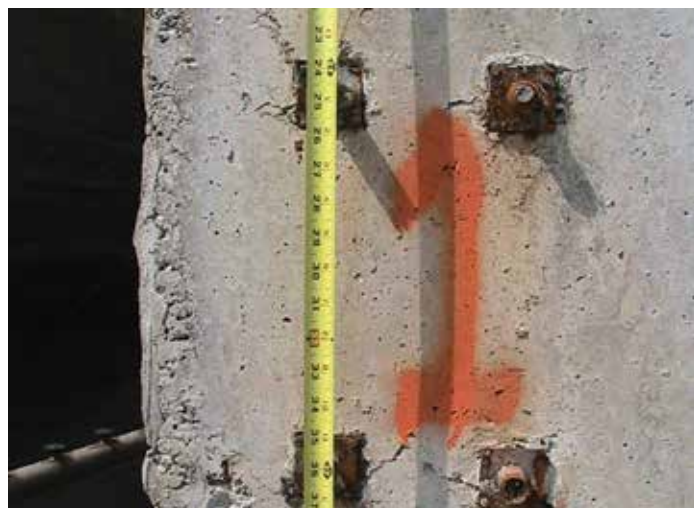
There was some evidence of corrosion of the couplers, but this did not appear to be a significant factor in the failure. Instead, the overstress of these members, cyclical loading, and resulting fatigue over the structure's life were more likely contributing factors to the failure (Figures 8 and 9). In addition, the placement of the couplers was such that the threads could not be fully engaged at some locations due to the proximity of the adjacent hooked bar.

It is more likely that the ultimate collapse of the east wall was caused by the tensile failure of the reinforcing bar couplers. Once the initial failure occurred, a subsequent instantaneous chain reaction failure was caused by the transfer of loads to adjacent couplers.

Figure 8. Reinforcing bar couplers and location where reinforcing failed in direct tension.

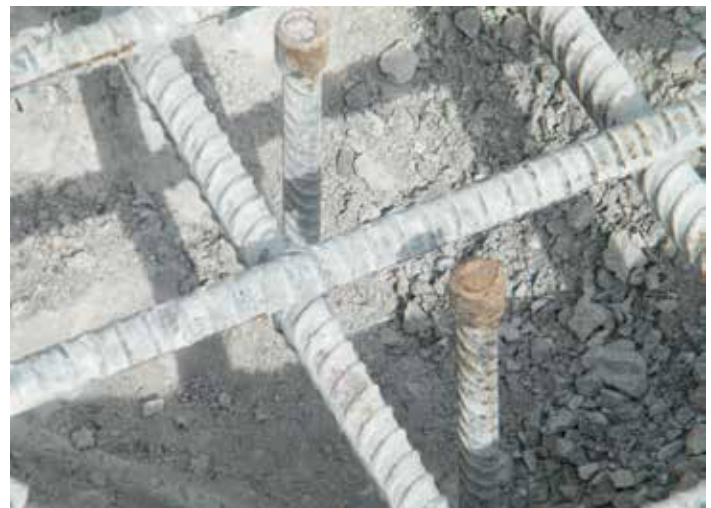
Figure 9. Reinforcing bar coupler that failed in direct tension.
