REHABILITATION

of the Historic McElmo Flume

By Carlo Citto, P.E, Ronald W. Anthony, FAPT, and Douglas Porter

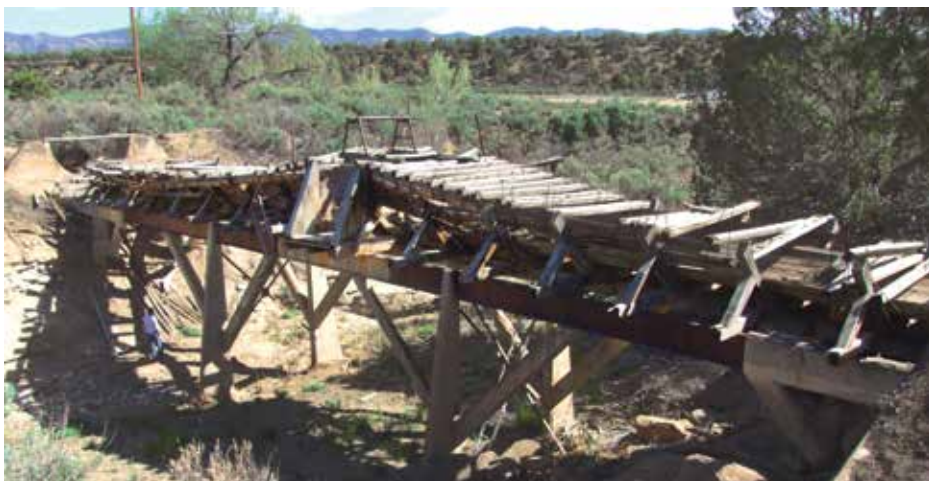
Over time, the Flume suffered from lack of maintenance and damage by severe natural events, including runoff from a heavy rainstorm in 2006 that collapsed its northern section and strong winds in 2010 that damaged staves and bents on the southern section. Prolonged exposure to severe weather resulted in corrosion of the steel elements, concrete spalling, and scour of the foundation. As a result, by 2012, the Flume was at risk of collapse.

Figure 2. The McElmo Flume in 2012 in a state of partial collapse due to damage from severe natural events.

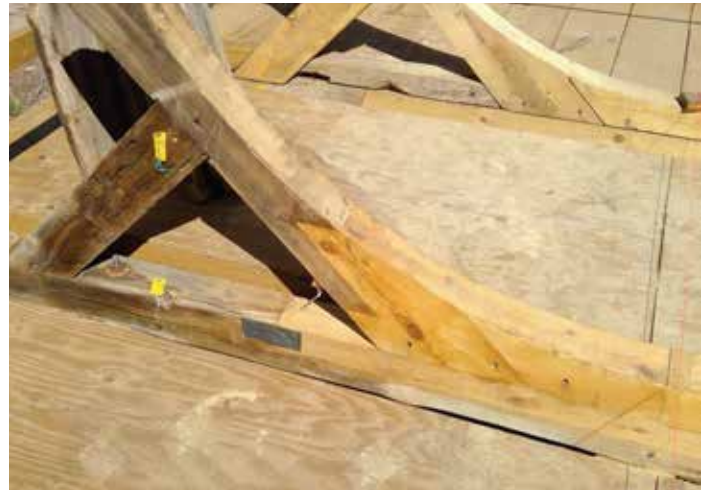
Wood condition varied from good to poor, with 40% of the timber in the bents in an advanced state of deterioration. Approximately

Figure 3. A typical repair of a bent by splicing new timber.

Finally, the flume timbers were repaired, and the stave pipe was reinstated using salvaged and supplemental staves. Surviving historical elements were numbered and disassembled, so deteriorated elements could be repaired with dutchmen and splices or replaced in kind (Figure 3, page 35). Salvaged staves, supplemented with new staves matching the original profile, were installed to complete the half-pipe and engage the steel rods and spreaders.

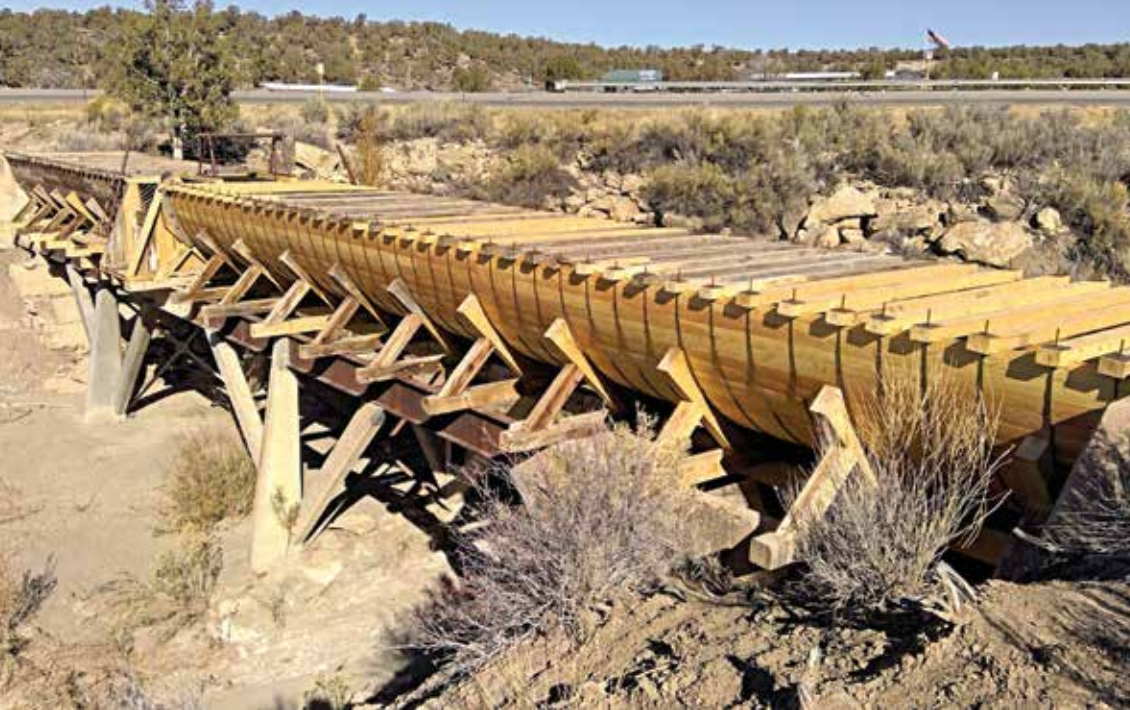
Figure 4. The McElmo Flume after rehabilitation.

The work was completed in two phases: The treatment of the substructure included the construction of concrete footings for the unsupported bents and the placement of rip-rap to stabilize the arroyo bank during high runoff events. The concrete and steel elements were repaired so that support for the wooden flume superstructure was maintained. Deteriorated concrete was removed, encased steel cleaned, and the exposed surfaces prepared to receive patching material; new concrete was used to restore the original cross-section. The heavily corroded steel plates that supported wood stringers were replaced with self-weathering steel plates.
