Expediting Dry Canyon BRIDGE REPAIR

Solution: Heat Straightening

By Matthew Miller, P.E.

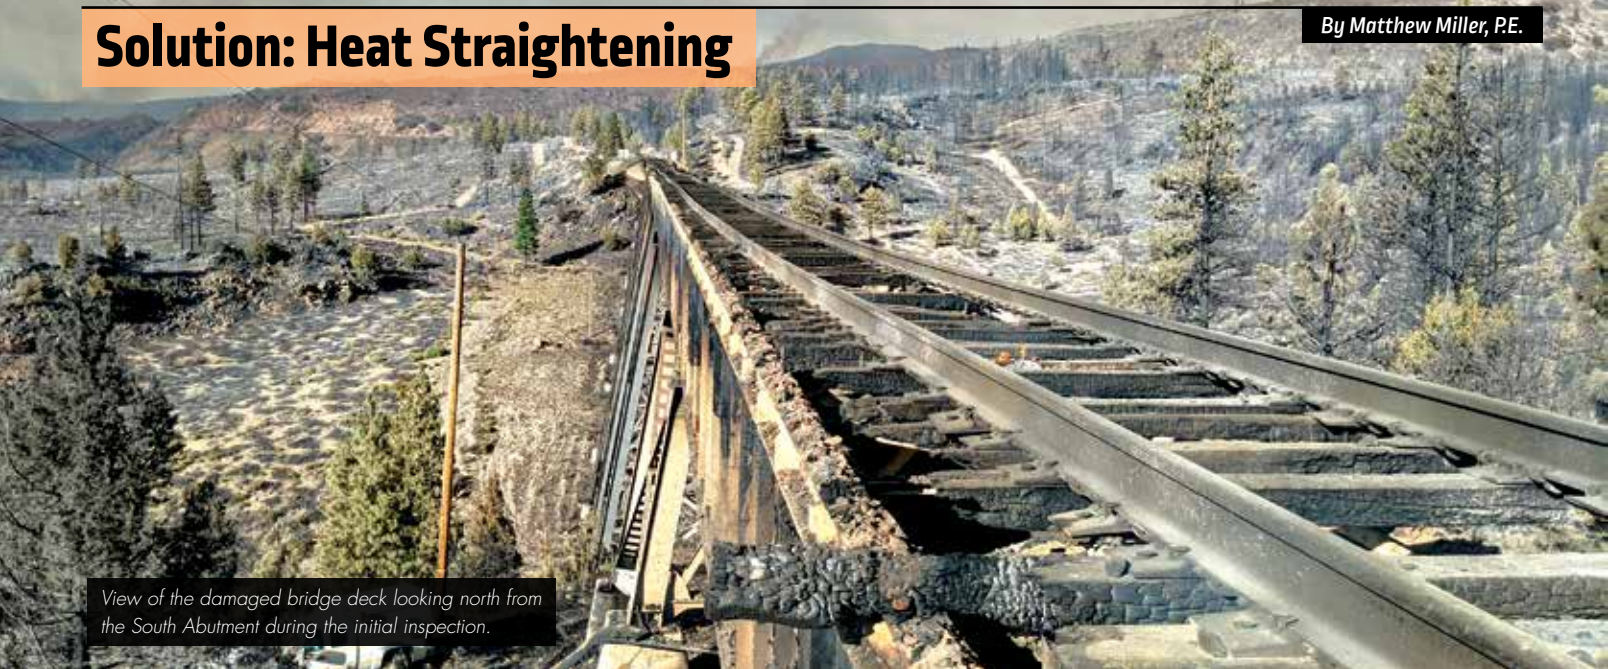
View of the damaged bridge deck looking north from the South Abutment during the initial inspection.

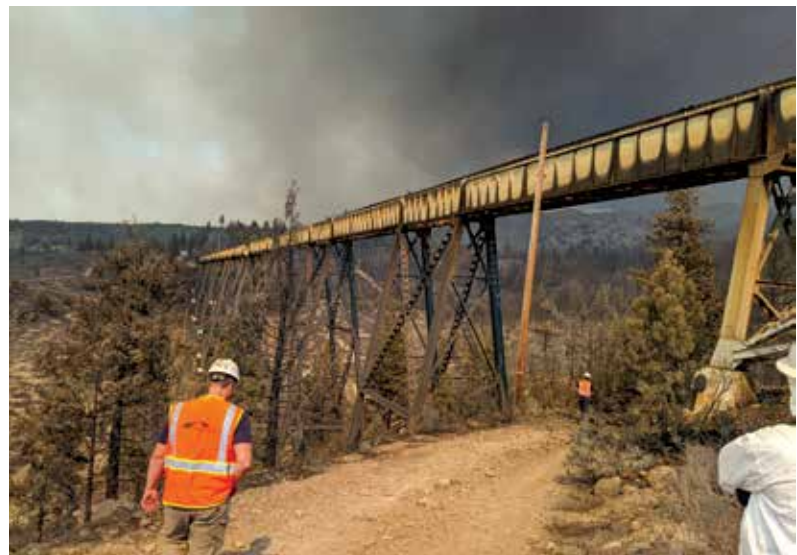
View of the west side of the damaged bridge looking north from the south embankment.
