Casting Some Light On... RENOVATIONS WITH CAST IRON COLUMNS

By Jessica Mandrick P.E., S.E., LEED AP, Karl Rubenacker, P.E., S.E., and Lizhong Wang

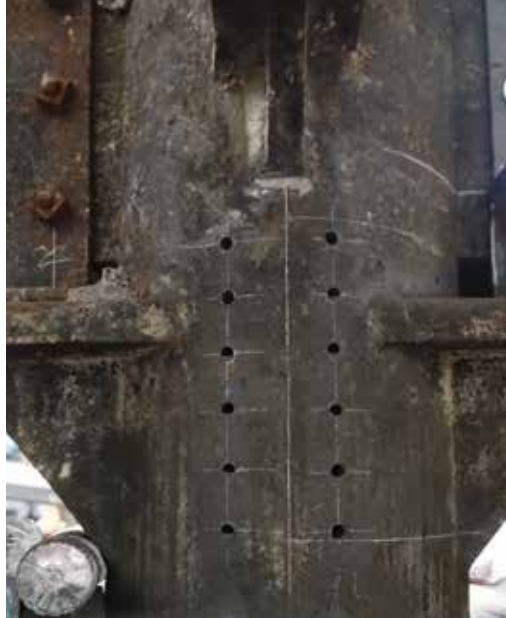
Welding to cast iron is difficult due to its high carbon content, which can lead to brittleness and cracking of the weld material. As such, all connections to existing cast iron were made via drilled and tapped bolts (Figure 3). The tapped holes and bolts were typically $\frac{3}{4}$ inch in diameter or smaller and extended into the cast iron column for its full thickness. The tap and drill diameters were selected to achieve a minimum of 75% thread engagement. Where columns are round, the connection plates are curved to match the diameter of the column. The bolts to cast iron were specified as A307 grade, not high strength because A307 is more ductile, and the bearing on the cast iron column controls at the bolt interface. The Structural Engineering Association of New York (SEAoNY) has also put together resources on cast iron columns, reporting engineers satisfactorily using holes up to 1-inch-diameter at 4-inch spacing.

Figure 3. Drilled and tapped holes in a cast iron column for new lower beam.

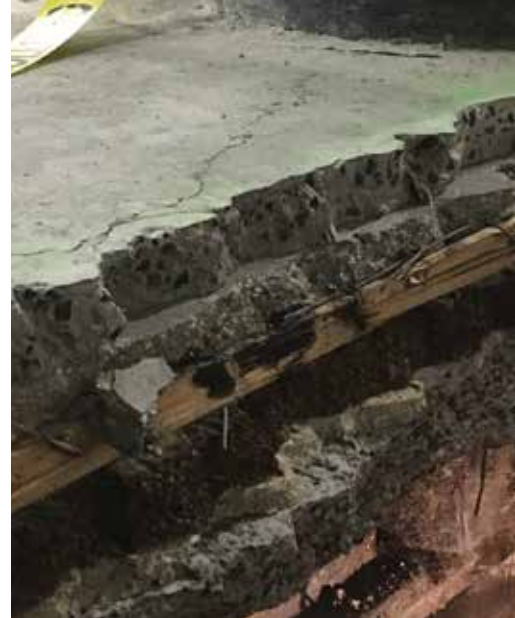
The drawings for the 1896, 1903, and 1911 building construction are lost to time. As such, extensive probes were conducted throughout the building to verify column diameters, column wall thicknesses, column seat dimensions, framing sizes, and slab reinforcing. Due to the fire encasement on the columns, only half of the column was exposed. Therefore, a tree caliper was used to verify the column

Figure 4. Floor build-up observed during demolition.

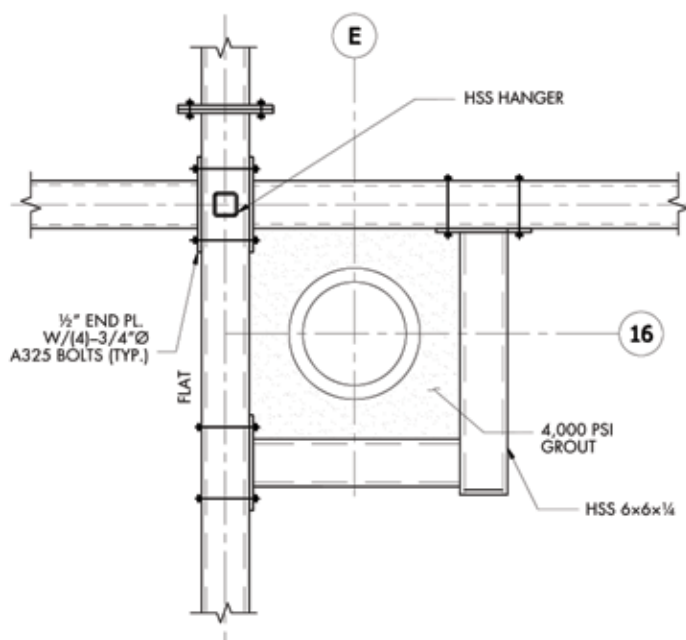
Figure 5. Detail of cast iron column temporary braces.

The area of the lowered ground floor consists of twelve interior columns and twenty-one bays of framing. To laterally support the columns uniformly, similar to the support provided by the slab in the existing condition, the steel bracing members terminated in steel collars filled with grout encasing the column (Figure 5). Where the collar was offset from the brace, the tubular steel bracing members were designed to carry the axial bracing force and the resulting eccentricity. Braces were

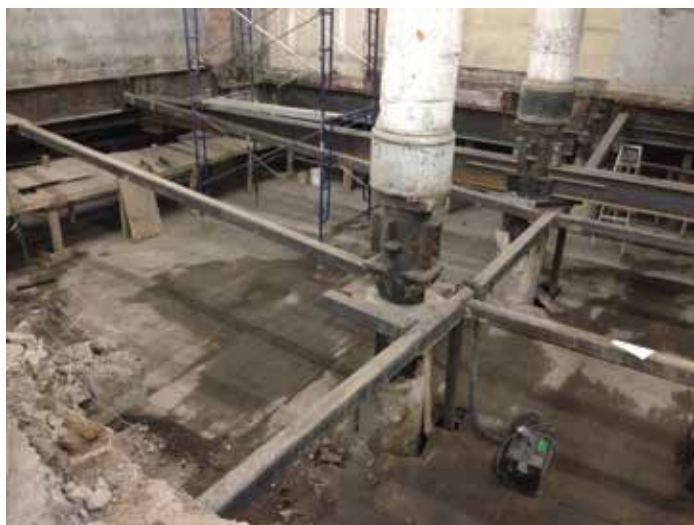
Figure 6. Lateral bracing of cast iron columns with floor removal.

positioned below the slab, allowing unimpeded access to frame the new floor above (Figure 6). The braces were gravity supported to the foundations below. They sloped up at the perimeters of the opening to bear against the structural slab in the adjacent areas of the building. Nodal bracing forces considered cumulative loads from the possibility of multiple columns in a row buckling simultaneously.

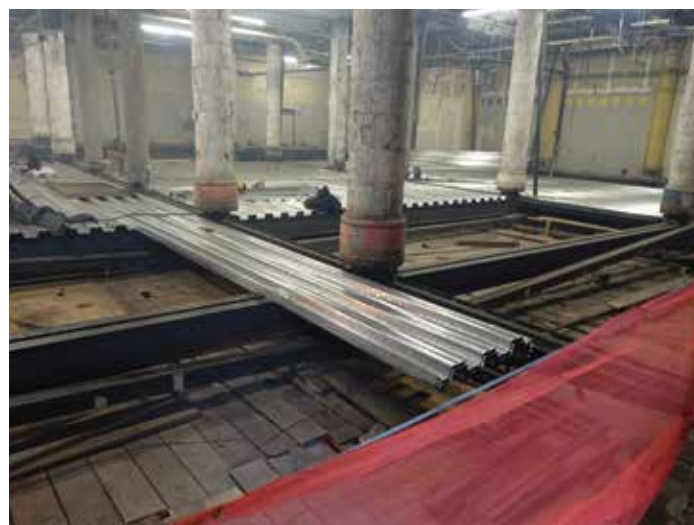
Figure 7. W14 double girder and metal deck being installed at retail bays.

The existing slab was demolished to make way for the new lowered floor. The pairs of existing 21-inch girders were removed and replaced with pairs of new composite W14s. The new girders were coped to bear or hang from the existing seats. The existing 10-inch infill beams

were removed and replaced with a new composite slab with 12-foot spans (Figure 7).

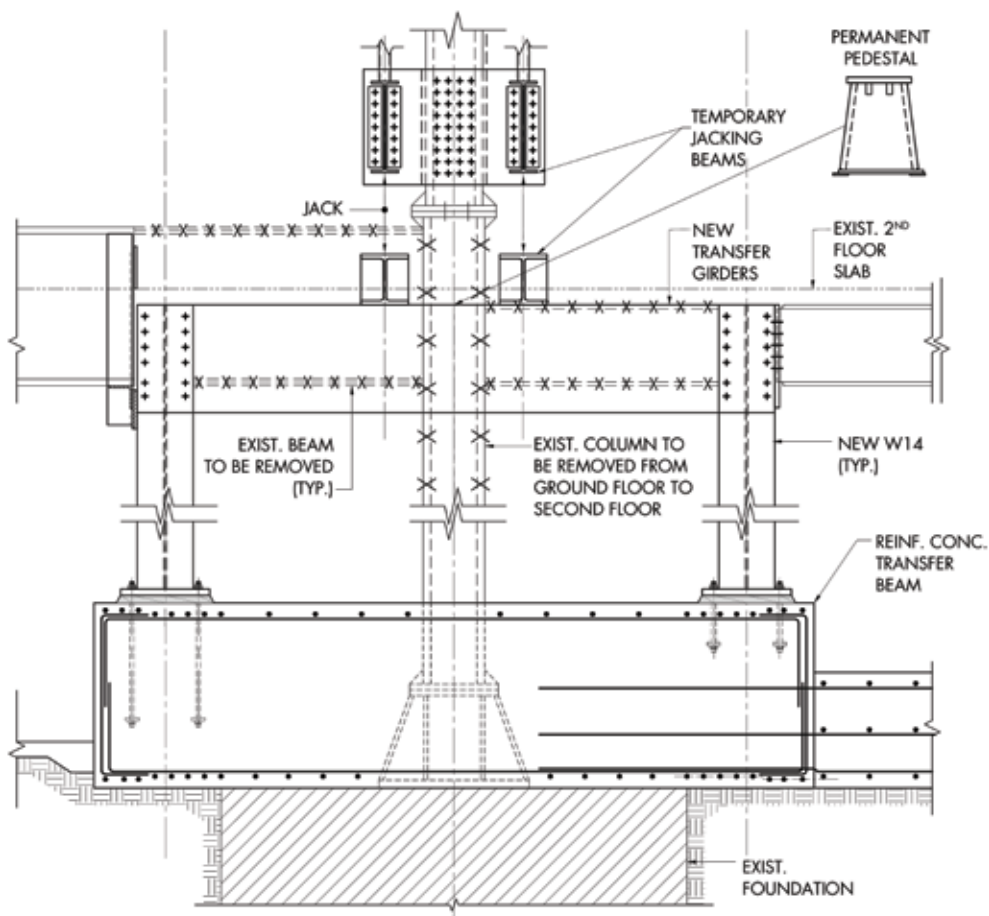
Figure 8. Elevation of cast iron column removal.

The load was jacked from the existing second-floor column into the new steel through a permanent steel collar with up to 144 drilled and tapped bolts (Figure 8). This collar is connected to temporary jacking beams on either side of the existing column. A pair of jacks were used to transfer the existing load on the column into the new transfer beams and pre-deflect them before removing the cast iron column below (Figure 9). After the load transfer, the existing first-floor cast iron columns were removed with exothermic cutting rods.

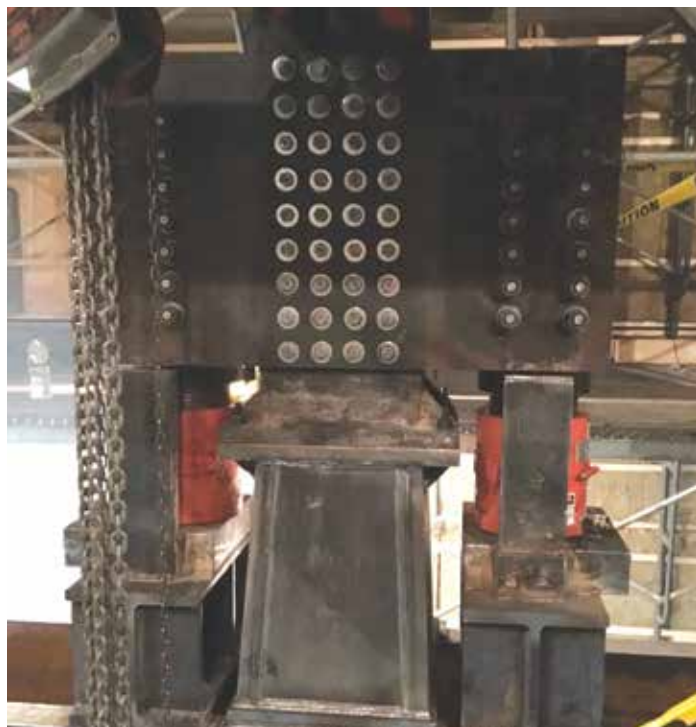
Figure 9. Jacking assembly.

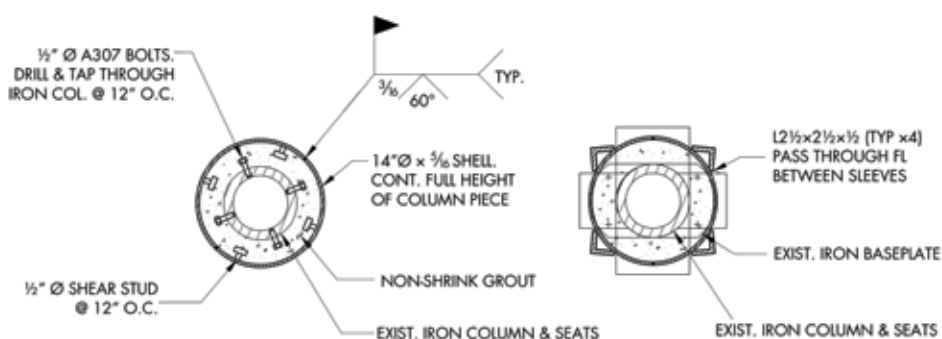
New mechanical systems for the building, as well as a green roof, rooftop assembly space, and roof terrace, imposed additional loads at the building's upper levels. This led to the overstress of some columns at the top of the building when checking their capacity by the 1916 formula. Due to the high live load capacities of the original floors, and the lower live loads from the new occupancies, this overstress quickly dissipated, and the columns on the lower floors did not need to be reinforced.

Figure 10. Reinforcing shells.

The method of reinforcing consisted of steel half pipe shells with welded shear studs on the inside (*Figure 10*). The cast iron column was drilled and tapped with a series of A307 bolts. The half pipe shells with shear studs were joined to the cast iron column by structural grout poured into the interface. This grout bore on the cap plate of the larger column on the floor below. The reinforcing was checked in multiple ways: to provide load transfer between the shear studs and tapped bolts using the grout interface, using the added shell to brace the inner column, and passing loads through the shell/grout through bearing on the columns below. Where reinforcing was required at more than one upper floor, four steel angles were threaded between the existing beams to carry the load from one reinforcing shell to another.
