CENTRAL STANDARD

Crafthouse AND Distillery

Repositioning a Historic Building as an Urban Destination

BY BEN SHOCK, P.E.

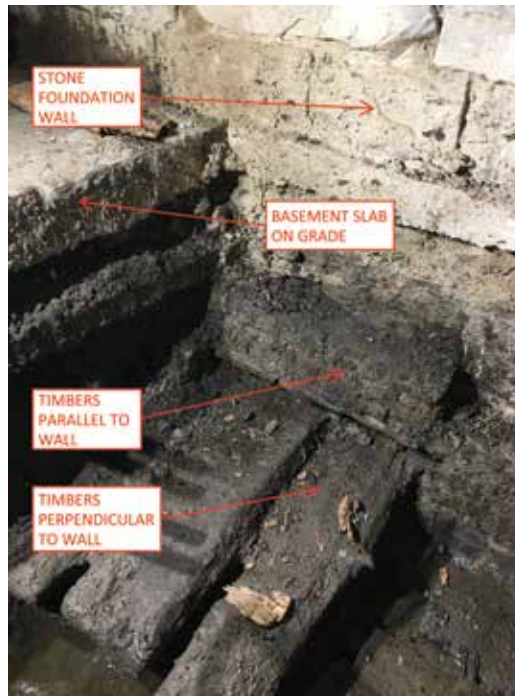
To determine if foundation stabilization would be necessary, HGA excavated a test pit in December 2020 to examine the original foundations and assess their condition. They discovered that in 1874, the builders used a system known as timber grillage, where brick and stone walls were built directly on a grid of timbers – similar in size to railroad ties but placed tightly together and oriented in two layers in alternating directions (*Figure 2*). Timber piles were not found in the test pit or any subsequent excavations. (It is the author's experience that

Groundwater was encountered only 12 inches below the top of the basement slab, requiring the pit to be dewatered before the timbers could be inspected. The groundwater relates to the natural topography at the time of construction. In 1874, the project site was located at the transition between solid ground and a marshy area that was being infilled to create what is now called Milwaukee's Historic Third Ward. It may seem counterintuitive that untreated timbers can be used for foundation systems in wet areas. Yet, as long as the timber sections remain fully submerged, oxygen is driven from the wood fibers, and the oxygen-loving organisms that cause decay cannot survive.

The gradual lowering of the water table in Milwaukee over the past 150 years has caused many timber foundations in the area to dry out and experience decay, along with accelerated settlement. In these cases, foundation retrofit is typically cost-prohibitive, and demolition generally follows. The author feared that decay might be the cause of the settlement at Central Standard's project. The test pit, however, revealed intact timbers. Instead, soil borings taken in January 2021 pinpointed the actual cause of the settlement – consolidation of the marshy, organic soil. Thus, the timber grillage foundation system was functioning as originally installed. However, its original design was flawed, and the organic soils could not support the weight of the building without excessive settlement.

Figure 2. Photo at test pit – Southeast corner of the basement, under the main entrance.

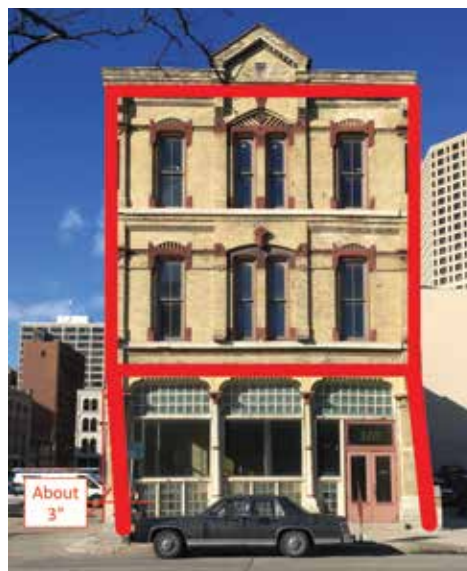
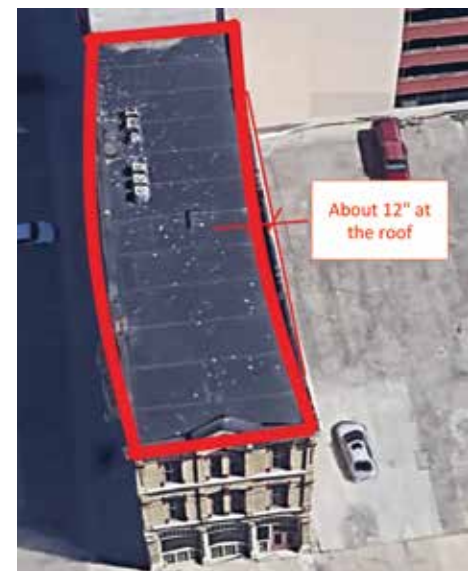
Uneven vertical settlement of the foundations initiated a westward tilt in the building's walls and columns. At the south façade, as shown in *Figure 3*, the horizontal displacement was noted between the sidewalk elevation and the top of the first story. The structure is primarily a rectangular brick box, except for the lower part of the street façade where no shear wall or bracing exists. The author imagined a conversation held in 1874 between the architect and the builder to discuss which was more important – building integrity or windows. The windows were obviously judged to be more critical, resulting in an incomplete lateral system. This needed to be addressed by HGA.

In addition to the displacement at the south façade, horizontal displacement also occurred between the north and south walls, as shown in *Figure 3*. Calculations by HGA revealed that the existing tongue-and-groove subfloor was severely under-designed in terms of diaphragm strength and stiffness and could not

Figure 3. Exaggerated view of building displacement (left) and an aerial view from Google Earth (right) before renovation. The decorative street façade faces south.

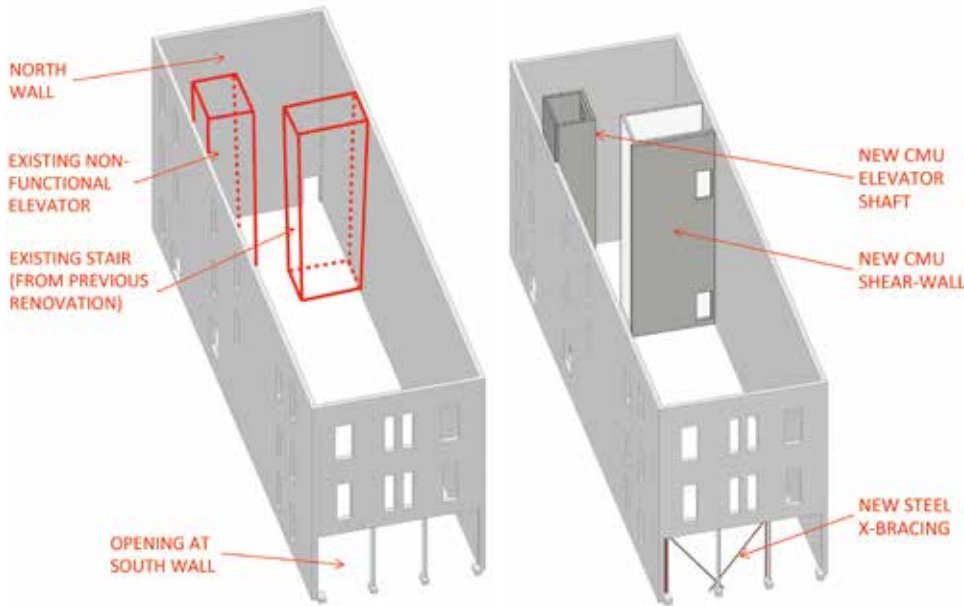
resist this horizontal movement. A stair was added in a 1990s renovation to meet fire-safety requirements, worsening the situation and further weakening each floor diaphragm's integrity (*Figure 4*, page 24).

As shown in *Figure 4*, an existing stair and non-functional cargo elevator blocked diaphragm access to the north wall. Although the

Figure 4. Elevator and stair prevent the diaphragm from extending to the north wall (left). New structural components (right).

elevator was being upgraded to a modern system, it needed to remain in the same location. Similarly, relocating the stair would not be practical. HGA's solution was to introduce a concrete masonry unit (CMU) elevator shaft and an additional shear-wall tight against the existing stair. All CMU walls were heavily reinforced – sometimes with two #7 bars in a single cell – requiring mechanical bar couplers. Excavations were required under the basement slab to install micropile-supported foundations for support of the new shear walls (see next section). Carpenters modified the existing framing at each level to create space for the shear walls.

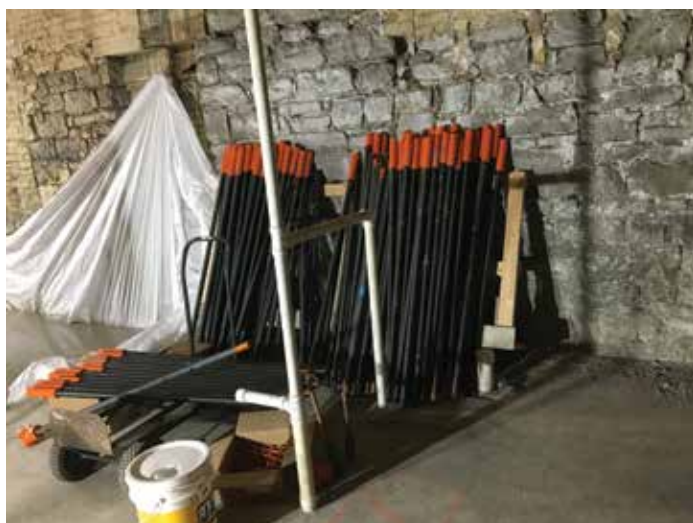
Figure 5. 1½-inch threaded steel bars for micropiles, staged in the basement.

Micropiles were selected for the deep foundation system primarily because they can be installed with minimal overhead clearance. The hollow steel bars were supplied in 4-foot lengths (Figure 5) and spliced using threaded couplers.

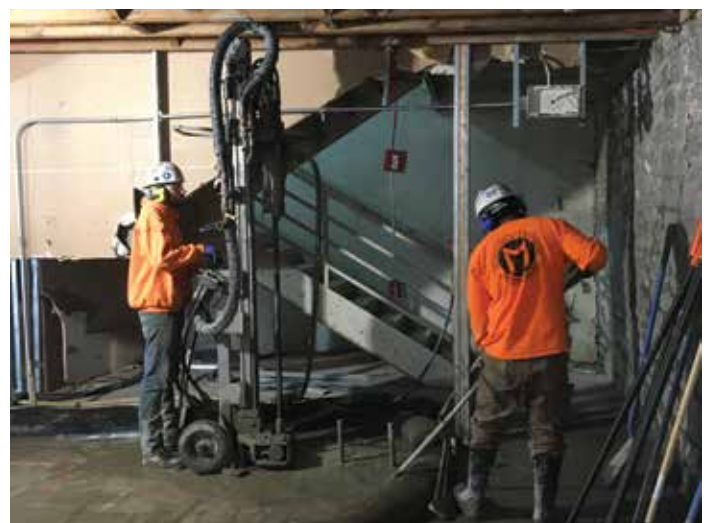
Figure 6. Micropiles being installed through the basement slab adjacent to the existing stair.

rig was then bolted to the slab above each location in turn. Figure 6 shows this process. When all micropiles in an area were completed, the existing slab was removed. Next, a concrete grade beam was constructed around the exposed tops of the micropiles (Figure 7). At the location of the new elevator pit, where no slab was available for anchorage, a heavier track-mounted drill unit was used (Figure 8). This machine's self-weight counteracted the upward reaction caused by the micropile installation.

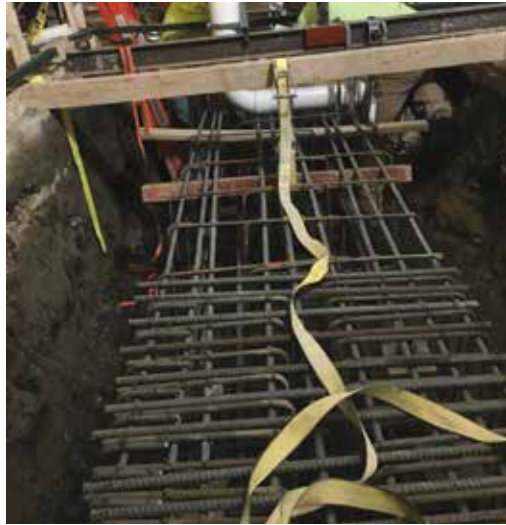
Figure 7. Grade beam reinforcement placed around the tops of micropiles, adjacent to existing stair.

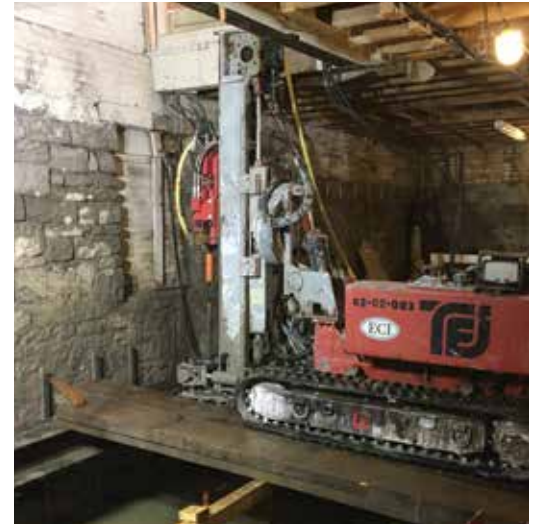
Figure 8. Micropiles being installed under the new elevator pit.
