Tendon Tail Cutting

Is the Process Compromising the Service Life of Encapsulated PT?

By Kent K. Sasaki, P.E., S.E., and Kaat Ceder, P.E.

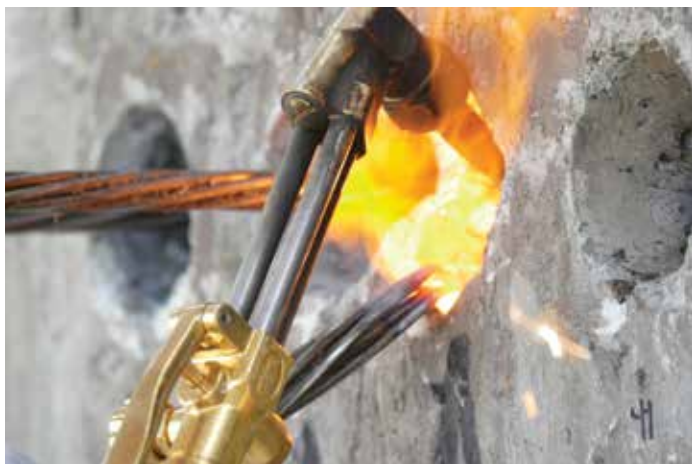
Figure 2. Cutting a tendon tail using an oxyacetylene torch.

There are generally four techniques to cut tendon tails: an oxyacetylene torch, abrasive wheel, hydraulic shears, and gas plasma cutters. In the authors' experiences, the use of an oxyacetylene torch (herein referred to as “torch”) is the typical method used at most construction sites unless another method is specified by the engineer-of-record in the contract documents (Figure 2). No industry standard currently specifies which cutting methods should be used.

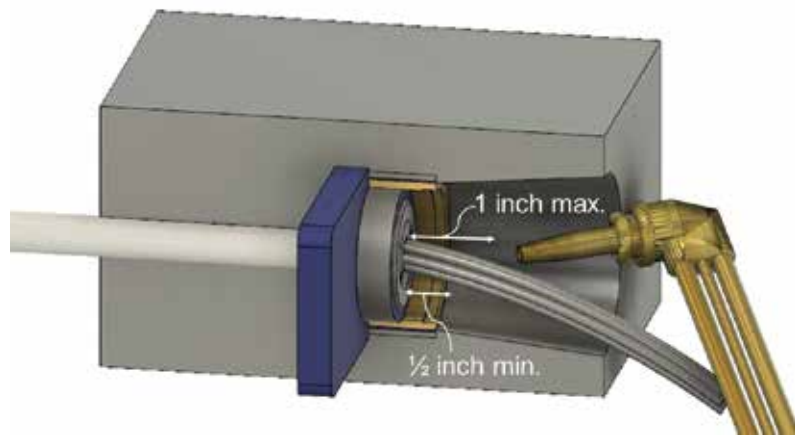
However, the geometry of the small formed stressing pocket limits the positioning of the torch and torch visibility of the tendon and the stressing end anchorage by the operator. This increases the potential for damage to the stressing end anchorage and the tendon tail not being cut to the appropriate length (Figure 3). Proper tail lengths are addressed in the Post Tensioning Institute's manual – PTI M10.3-16, *Field Procedures Manual for Unbonded Single Strand Tendons*.

Figure 3. Rendering of the torching of the tendon tail in section. Tendon tail length tolerances are based on PTI M10.3-16.

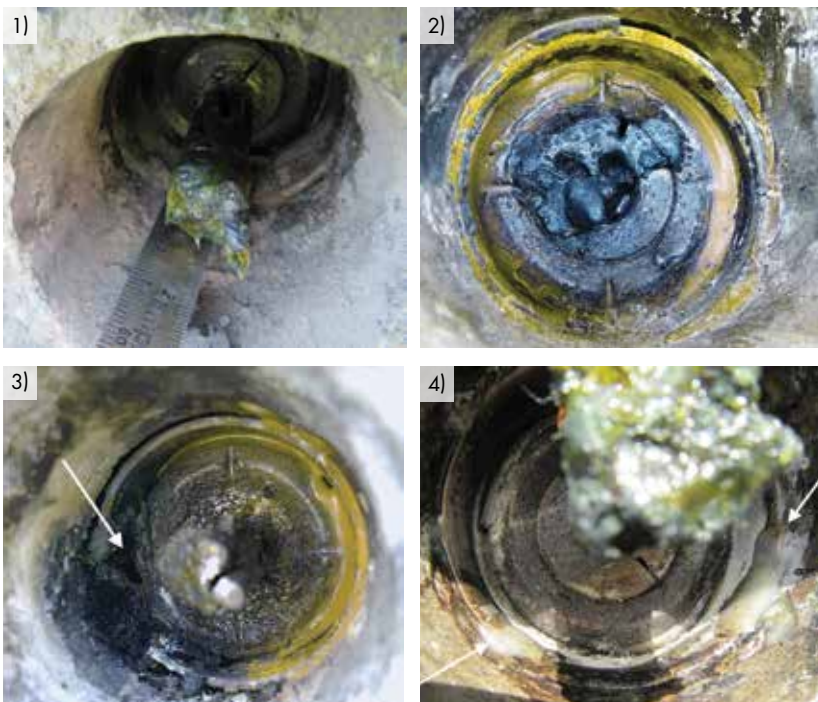
The conditions observed at these stressing end anchors can be generally grouped into the following categories. *Figure 4* shows an example of each category.

- 1) *Tendon tail too long*: If the tendon tail is not cut short enough, the grease cap cannot be fully seated and provide the required seal. Frequently this results in the tail also puncturing the grease cap, promoting moisture ingress. This condition was observed at more than one-third of the opened stressing pockets.

- 2) *Tendon tail too short*: If the tendon tail is cut too short, the tendon tail may not puncture the temporary plastic seal holding the grease inside the grease cap.

- 3) *Molten and deformed anchorage ring*: Prolonged and elevated temperature exposure to the torch flame within the confined space of the formed stressing pocket melted or deformed the anchor ring and prevented the proper seating of the grease cap.

- 4) *Debris in anchor ring*: Debris in the metal ring, whether molten metal or plastic, impedes the seating of the grease cap. Often this debris can be from the cutting operation, and the condition may coincide with Category 3.

All four of these categories can reasonably be attributed to the difficulty of positioning a torch inside the small, formed stressing pocket and the limited visibility of the anchorage components during the cutting operation.

Figure 4. Examples of Category 1) through 4) as described in the Field Observations section of the article (clockwise from top left).

- 1) Specify tendon tail-cutting methods that do not include the use of an oxyacetylene torch in the construction documents. Alternatives include hydraulic shears or plasma cutters.
- 2) Ensure that qualified inspectors observe the stressing anchorages before and after the installation of the grease caps and confirm that nothing is impeding a good seal and full encapsulation.

- 3) Provide adequate work platforms that allow individuals to be in a good working position to cut the tendon tails. For example, provide a platform where an individual can stand upright while cutting the tendon tail rather than leaning over the edge of the slab to cut the tendon tail.
