# UC BERKELEY'S NEW *Biosciences Hub*

## New Life for the Berkeley Art Museum Building

By Allen Nudel, S.E., Masume Dana, S.E.,  
and Andrew Salber, S.E.

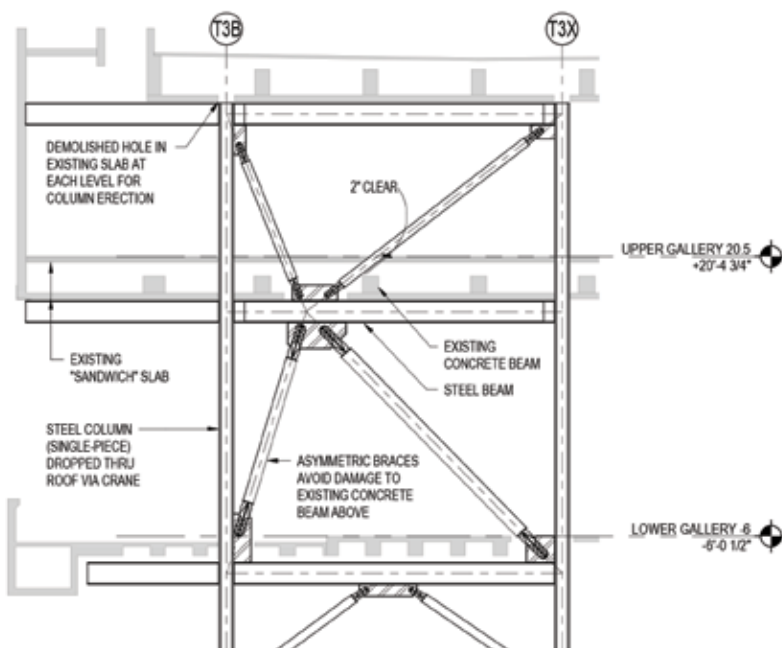
Asymmetric braced frame elevation.

The existing concrete shear walls were very rigid. Rigid steel braced frames were selected to achieve drift compatibility between the existing and new structures. A Buckling-Restrained Braced Frame (BRBF) system was used to allow for fine-tuning the stiffness of the braced-frame system; the core area of each BRB could be increased as required to match the stiffness of the corresponding concrete wall. The BRBF system was added to each upper gallery level in both the radial and tangential directions, forming a complete four-sided lateral system for each level. Introducing the retrofit braced frames into the analysis model significantly reduced the expected drift of the building, reducing strain in non-ductile concrete elements, limiting damage to the rest of the structure, and meeting UCB's seismic performance requirements. The final BRB core areas were determined after several iterations of computer analysis, and the analysis confirmed compatibility between the existing and new structural elements.

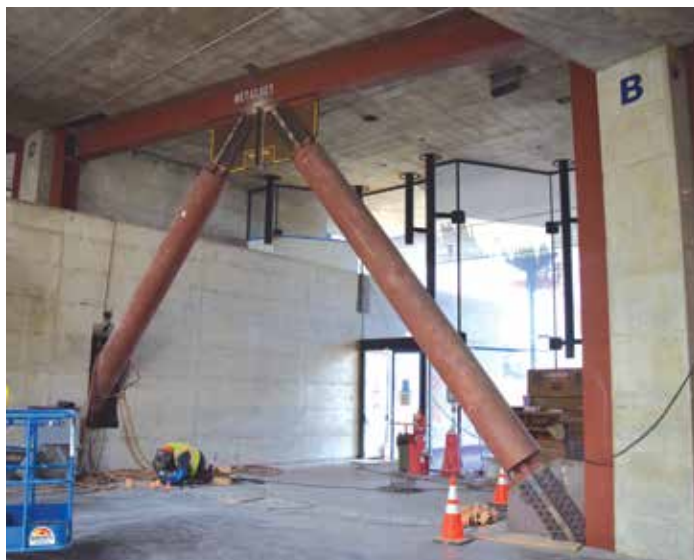
Installing braced frames adjacent to existing concrete.

Columns were located within 2 inches of the existing concrete walls, and column splices would have involved blind-side CJP welds, which posed numerous challenges for welding and inspection. To avoid this, an erection sequence was selected in which column base plates and 4-foot-tall column stubs were installed, after which the remainder of the approximately 60-foot-long column was dropped in a single piece through the roof, upper galleries, and other floors. Tight coordination of demolition and new steel allowed for demolition that was barely larger than the cross-section of the steel column. A similar constructability modification involved using non-symmetric braced frames to avoid existing structural gravity elements at the upper gallery levels. The non-linear analysis model was used to evaluate the steel elements for forces resulting from this asymmetry. Field verification was critical to avoid costly and schedule-impacting clashes during steel erection with tight clearances between existing and new structures. The importance of field verification was emphasized through all communications with the Contractor during project meetings, RFIs, and shop drawing reviews. A collaborative team spirit was critical to the success of this project.

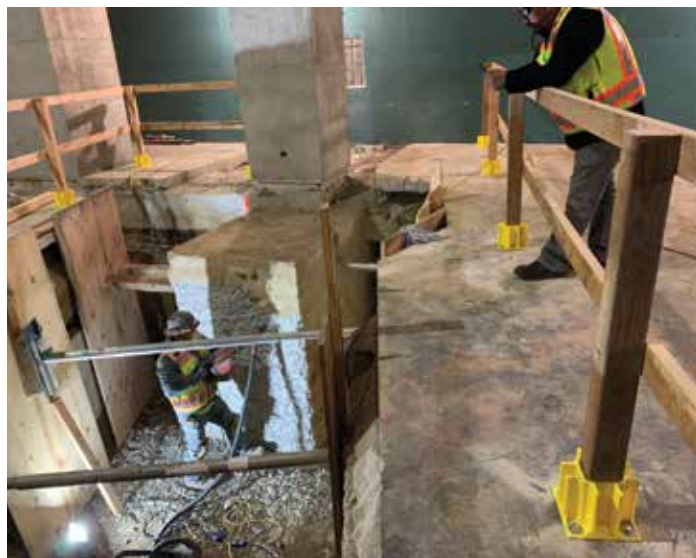
Scarification of existing foundation concrete.

At the foundation level, the new steel columns do not align with the existing drilled piers. Early in design, it was determined that new deep foundations would be infeasible due to tight-overhead restrictions in the existing basement levels. To support the new steel columns, a transfer foundation system was designed in which a large, sub-grade concrete transfer beam spanned between existing drilled piers to support the new steel columns.
