STRUCTURAL DESIGN

Differential Deflection in Wood Floor Framing

By Zeno Martin, P.E., S.E. and Jim Anderson, P.E.

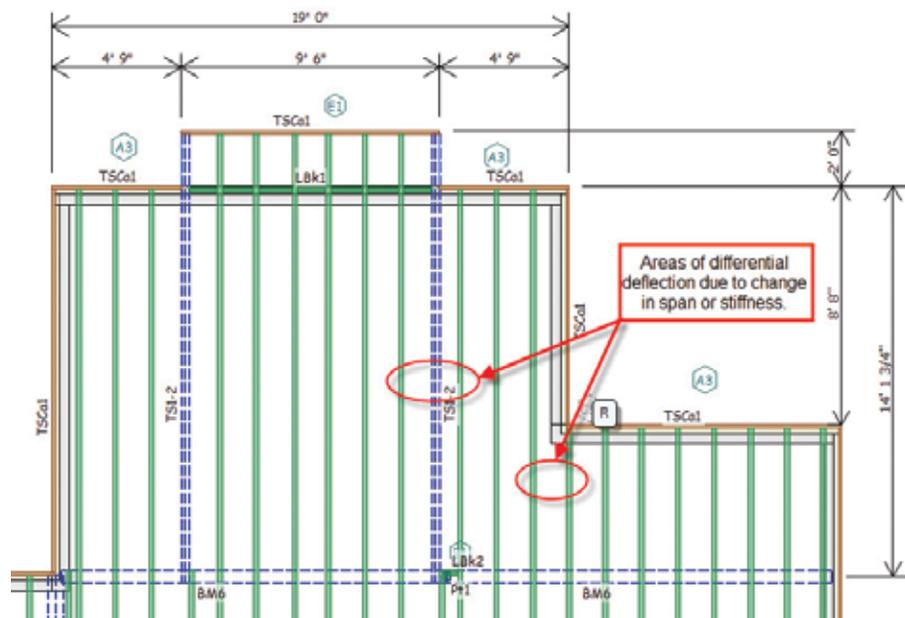
There is an important design consideration for wood floor framing that is not likely to be found in building codes or design standards – differential deflection. This issue is often overlooked, but can lead to significant performance problems. Differential deflection, as described here, is the change in elevation from one framing member to the adjacent member. Differential deflection may escape consideration. Building code requirements and design standards for deflection typically pertain only to the deflection along the span length of an individual member. Problems related to differential deflection can arise when one long span member deflects in flexure, within building code limits, while the adjacent member does not, often due to different support conditions or stiffness (Figure 1).

Figure 1: Areas with potential for differential deflection due to change in span or stiffness of adjacent members.

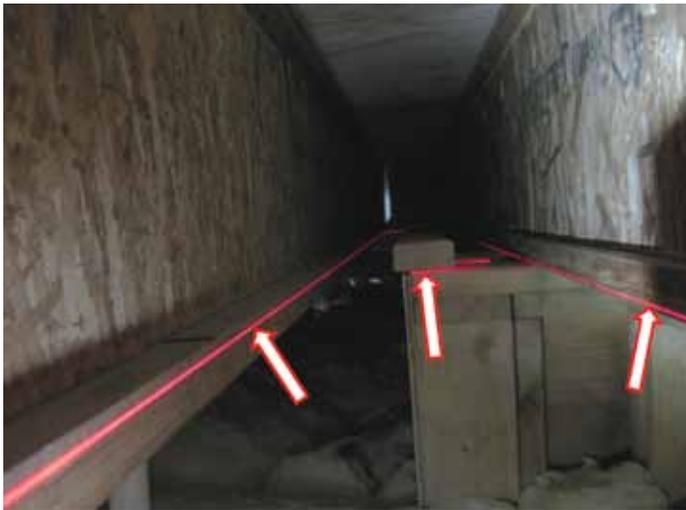
A large custom single-family wood frame home had wood I-joists spanning 22 feet under a living room and spaced at 16 inches on center. Near mid-span, a partition wall for the level below was built tight to the bottom flange of one of the floor joists such that mid-span deflection was prevented. Floor dead loads were relatively high in this case due to hydronic heating with a 1.5-inch thick Gyp-Crete topping and a stone tile floor above. The resulting differential deflection was around 1 inch vertical over 16 inches horizontal (Figure 2). The resulting performance problems included objectionable floor sloping as well as excessive stone tile cracking, which occurred due to the resultant differential deflection.

Figure 2: Wood I-joist on right bears on wall framing while the adjacent I-joist (left) spans 22 feet and is free to deflect under load. The laser level line (arrows) shows the I-joist on the left is roughly 1 inch lower than the adjacent one on the right.

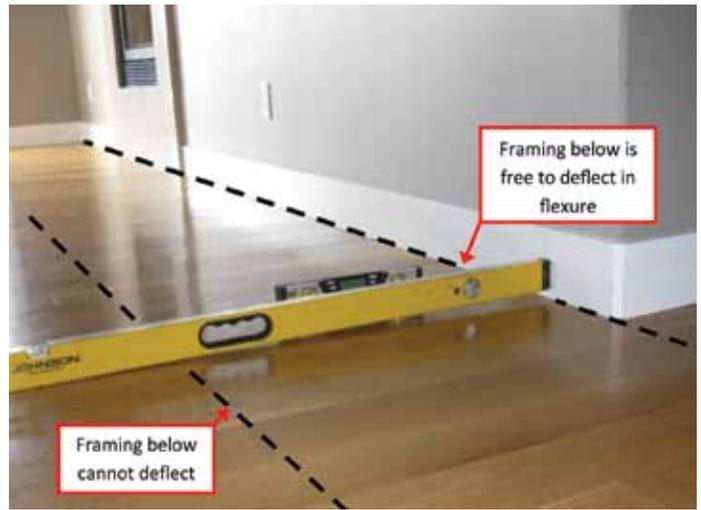
Figure 3: Kitchen floor ridge and floor sloping toward wall. Dash lines represent framing direction below floor.

Soon after the owners moved into their new home, they noticed that the kitchen floor was sagging near an adjacent hallway (Figure 3), which caused concern. Investigation revealed that the cause was due to the fact that a partition wall below prevented some of the wood I-joist floor framing from deflecting while the adjacent wood I-joists were free to deflect over their 17-foot span, creating the differential deflection and objectionable slope.

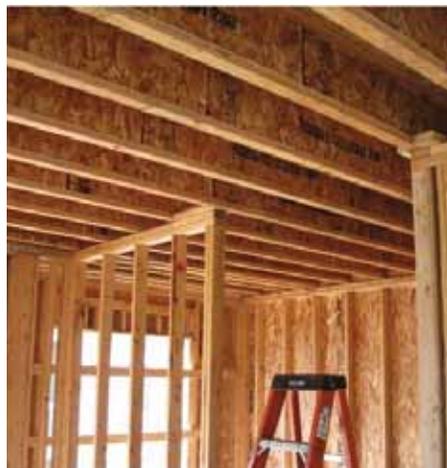
Non bearing partition walls below can produce differential deflection if they are framed tight to the underside of the joist (a common practice for residential structures) compared to adjacent joists that have no walls (Figure 4). When walls are framed tight to the bottom of joists near mid-span, they act as a bearing support and prevent deflection. If non load bearing walls are in the focus area, details to properly gap the wall at the top should be included to prevent transferring of load and inadvertent “high” spots or “ridges” in the floor surface above.

Figure 4: In areas with non-load-bearing walls, consider gapping the wall to ensure all joists deflect equally.
