STRUCTURAL FAILURES

Design Deficiencies in Edge Barrier Walls in Parking Structures

By Mohammad Iqbal, D.Sc., P.E., S.E., Esq.

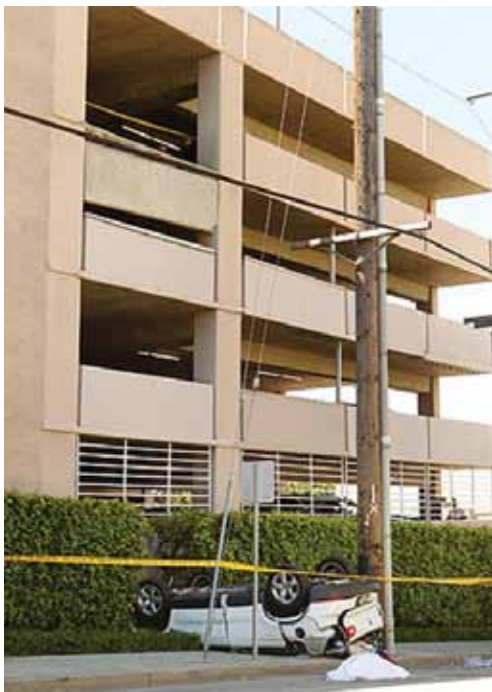
Figure 1. Barrier wall failure and car plunges down.

Figure 1 shows a parking structure located in the City of Los Angeles, CA, where a moving vehicle came in contact with the cantilever barrier wall on its fourth floor. As a result, the wall-slab joint failed in brittle mode and the car plunged down to the street. Subsequently, the driver and sole occupant of the vehicle was fatally injured. Such incidents are not uncommon. *Figure 1* shows that the barrier wall system failed at the joint between the vertical wall and horizontal slab, without any cracking or other visible damage to the wall as the result of the car impact. Apparently, the cantilever wall rotated about its base and collapsed because the concrete in the wall-slab joint ruptured in a brittle mode. It showed that the wall-slab joint is the weakest link in the barrier system. The issue is whether the barrier system was capable of resisting the code-prescribed 10,000 pound ultimate impact load. The evidence suggests that it does not have the capacity to resist the prescribed load. Rather, its capacity is about one-fourth of the prescribed load. As such, the barrier system has a significant design deficiency.

The incidents such as one shown in Figure 1 have demonstrated that the edge wall, upon impact, fails suddenly and swings open, letting the vehicle plunge down. The root cause of the sudden premature failure is the joint that does not have an adequate mechanism or load path to transfer the cantilever wall moment and shear to its supporting slab. This is a design deficiency. The test results over the last 70 years on such joints have predicted that the joints would fail in a brittle mode and their strength should not be relied upon without proper reinforcement. However, the profession did not heed the warning.

To avoid any further loss of life, it is suggested that the wall-slab system should not be used in the parking structures as a vehicular barrier. The main reason for the call is that the slab is too thin to properly install the rebars required to confine the concrete in the joint region. Further, it is recommended that such barriers that are already in place in constructed facilities should be retrofitted.

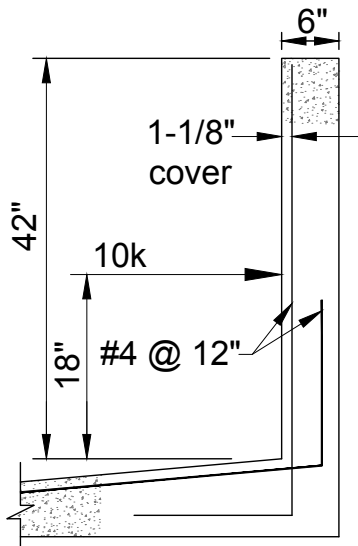
Figure 2. Wall-slab barrier system.

or no scrutiny as to how the cantilever wall bending moment and shear are transferred to the floor slab. The assumption that the wall shear force and bending moment at the base of the wall are fully transferred to the slab through the joint region appears to have no basis. Apparently, the assumption was made without researching the wall-slab joint test results available. The literature search shows that over the last 70 years numerous experimental studies on behavior of the joint were conducted and the results were published by ACI and the American Society of Civil Engineers (ASCE). The studies have shown that the joint is inherently weak in transferring the bending moment and shear force from one member to the other, and that it should not be relied upon without verifying its efficiency through experimental work.

cracking and stress concentration. Joints subjected to bending are divided into two types: opening type and closing type. The joint shown in Figure 2 is called an opening joint, as the bending moment causes flexural tension on the inside face of the joint. Experimental studies have shown that opening joints are seriously deficient with commonly-used rebar detailing. However, with proper detailing, the joint efficiency can be improved. The joint efficiency, ξ , of a two-member assembly can be expressed as:

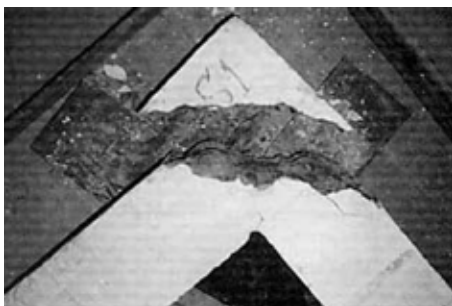
Figure 3. Brittle mode failure of slab-wall type joint under opening moment.

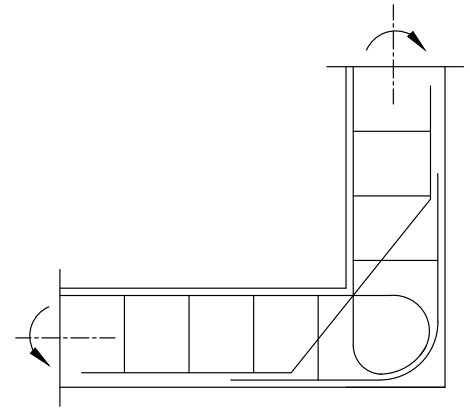
Figure 4. Reinforcement pattern in joint for $\xi = 94\%$.

ties. Figure 4 shows a rebar configuration used in a joint assembly in which the efficiency, ξ , improved to 94%. Obviously, such rebar arrangement is not feasible for a 6-inch wall and slab joint such as shown in Figure 2.
