STRUCTURAL FORENSICS

Prescription for Repair

The Triage, Life Support and Subsequent Euthanasia of an Existing Precast Parking Garage – Part 1

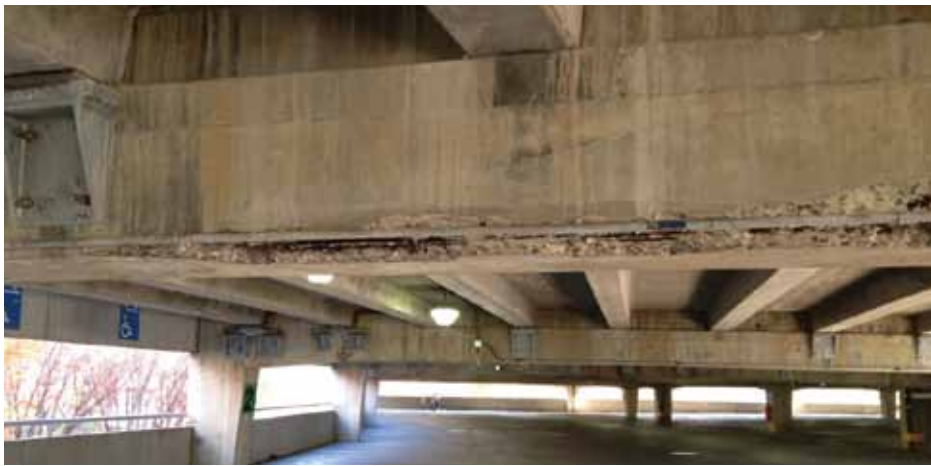
Figure 2: Spalling due to deteriorated strands at precast girder.

- 3) Three bays of framing on the third level were blockaded from vehicular traffic due to extremely severe spalls and corrosion of the bottom prestressing strands of the three girders that supported these areas (Figures 2 and 3). The deterioration of the prestressing strands varied from severe to complete loss of section at this location.

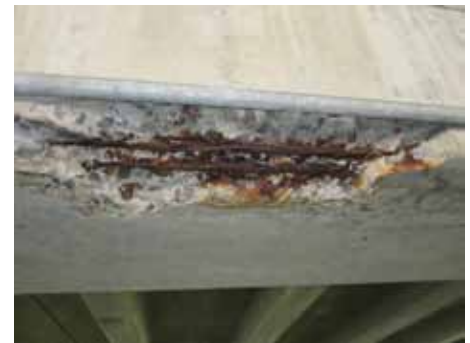
Figure 3: Corroded and failed prestressing strands at precast girder.

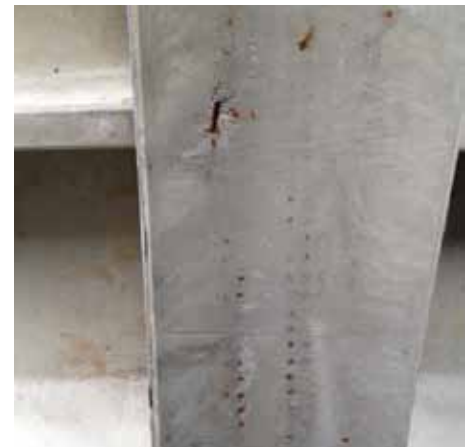
The girders supporting the second level generally exhibited fewer deficiencies than those supporting the third level. The cast-in-place, post-tensioned concrete inverted “T” girders that supported the 24-inch-deep precast double tees exhibited very few deficiencies. However, some minor spalls and corroded reinforcement were evident at isolated locations (Figure 4).

Figure 4: Rust staining due to internal corrosion of post-tensioned girder reinforcing.
