A Case Study

Multistory Wood Frame Shrinkage Effects on Exterior Deck Drainage

By Zeno Martin, P.E., S.E. and Eric Anderson, P.E., S.E.

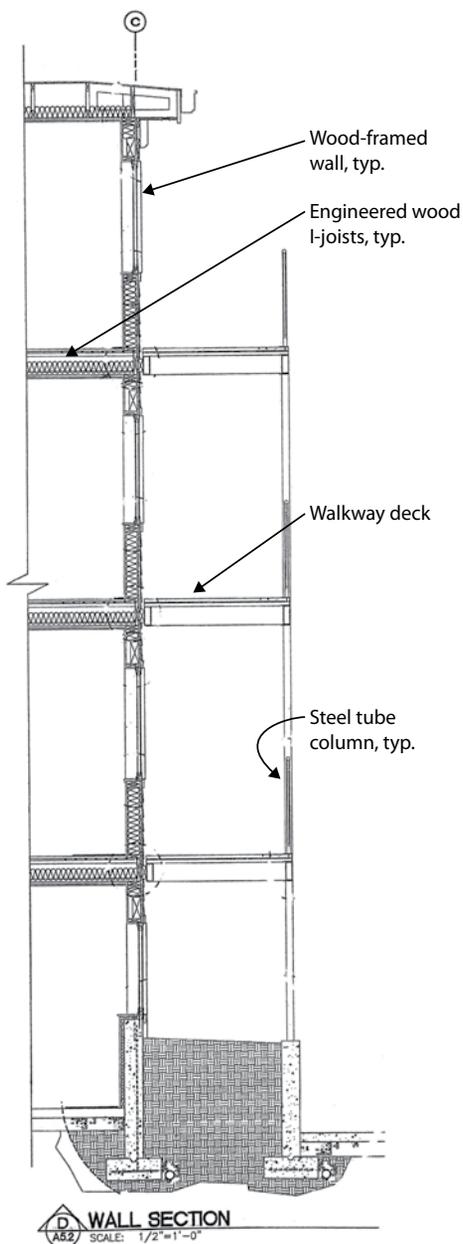
This article examines a case study of multistory wood frame shrinkage and settlement causing exterior waterproof decks to slope back toward the exterior wall. In this case, the deck is supported on one side by a ledger at the wall framing rim board and by exterior steel columns on the other side (Figure 1). The steel column supports did not have the same shrinkage and settlement over time as the wall framing and, as a result, the differential led to back-sloping exterior decks. These back-sloping decks concentrated rain runoff toward the wall and deck ledger area. Significant decay

Figure 1: Section of wood framed wall system showing deck framing with steel deck support columns.

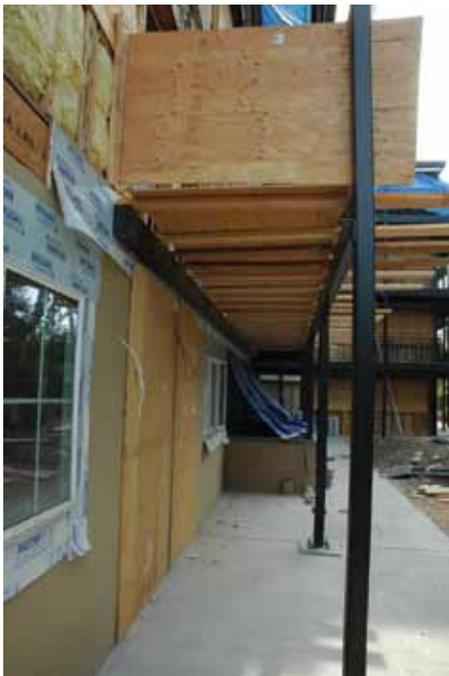
Figure 2: Deck ledger attached to the inner wood framed wall and outer steel posts. (Note: Project is under construction in photo.)

1 summarizes results of deck slope measurements. Approximately half of the deck areas were constructed in accordance with Figures 1 and 2, where the deck ledger was attached to the rim joist such that the deck could rotate relatively freely toward the wall – a so-called “free” condition in Table 1. The other half of the decks were constructed

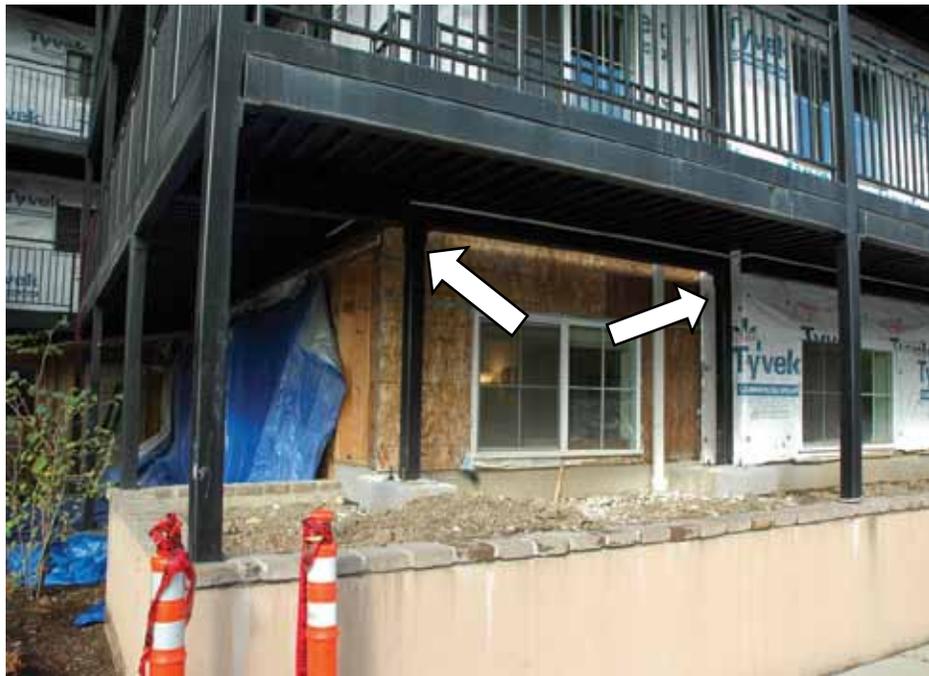
Figure 3: Deck framing supported by steel posts adjacent to the wood framed building wall creating a "fixed" deck condition. (Note: Project is under construction in photo.)

where the ledger was supported by a steel post adjacent to the building wall restricting inward deck rotation (*Figure 3*) – a so-called “fixed” condition in *Table 1*.

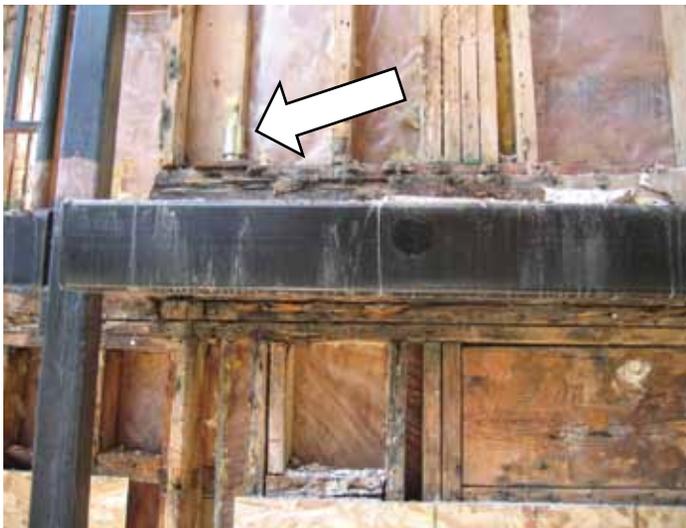
The building’s wood shear wall system was constructed using shrinkage compensating devices at the overturning hold down locations. These devices ensure that the shear wall hold down system remains tight even after wood shrinkage or settlement occurs. In this case, the shrinkage take-up devices were found to be extended (*Figure 4, page 36*) confirming that shrinkage and settlement had occurred, assuming the take-up devices were originally installed tight. Unlike the shear walls, the exterior decks had no provision to ensure that proper drainage slope was maintained in the event wood frame shrinkage and settlement developed. In this instance, resultant deck back-sloping led to significant damage to the wood framed walls related to concentrated moisture intrusion at the deck attachment locations (*Figure 4*).

Figure 4: Typical shear wall hold down shrinkage take up device extended (arrow).

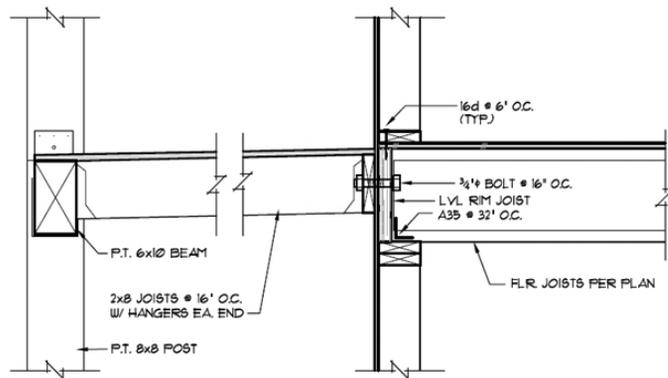
The building in this case study was constructed with steel posts to provide outer edge deck support. The resultant shrinkage differential may have appeared more predictably obvious as a result. However, similar behavior has been observed by the authors for a multistory building constructed with exterior entry decks supported on wood posts at the outer edge (*Figure 5, page 36*). In the latter case, there was no observed resultant sheathing or framing damage, but ponding or accumulation of water on the decks near the wall was evident.

The combination of shrinkage and settlement (i.e., compression of framing “gaps”) was estimated to average 0.38 inch per floor for the case study described. The observed magnitude of shrinkage and settlement corresponds reasonably well to the “conservative” recommendation of 0.36 inch per floor for this type of building per Commins (2007). As described, heavy rains during initial construction and resultant wood decay from moisture intrusion induced by deck back-slopes may have contributed to the relatively high magnitude of shrinkage and settlement observed in this case study. Another similar case examined by the authors (*Figure 5*) measured only approximately 0.125 to 0.20 inch of combined shrinkage and settlement per floor.

Figure 5: Wood post deck support columns.

To maintain desired deck slopes after shrinkage and settlement has occurred, provisions could be made to install an adjustable post or post base. These provisions would need to accommodate cumulative settlement at each story. Alternatively, a leveling bolt adjustment could be installed at the deck to exterior post

attachment, or at the deck to building connection at each level. Caution would be necessary to ensure these structural adjustments would not damage the building or flashing details while adjustments are made.
