The Palliation of a Terminally Ill Parking Garage

Part 5: The Follow-up

By D. Matthew Stuart, P.E., S.E.,
F. ASCE, F.SEI, SECB, MgtEng
and Ross E. Stuart, P.E., S.E.

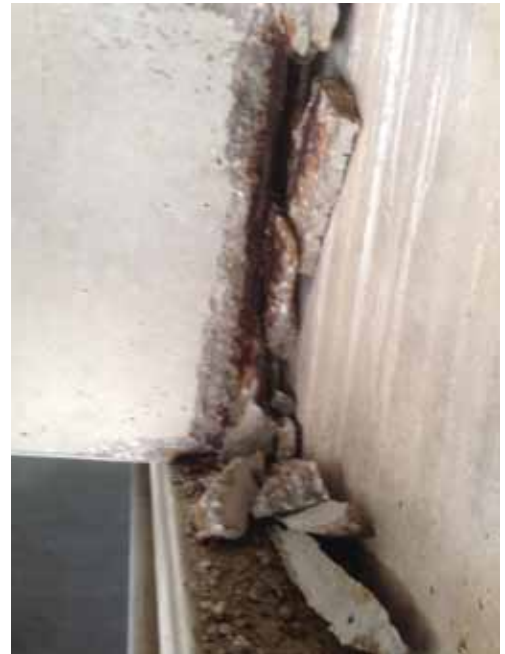
Figure 1.

Level 3 Precast Double Tees – The 24-inch-deep precast double tees experienced an increase in deterioration of approximately 2% for cracks and 11% at spalls. During the original investigation, cracking and efflorescence was concentrated in the double-tee flanges in the area of the garage closest to the southern or outer arc of the

facility. During the follow-up investigation, it was observed that the cracks in the flanges had migrated down into the stems of the double tees, almost exclusively at the end bearings. The new cracking was severe enough to create large spalls, exposing the embedded reinforcing of the double-tee stem (Figure 1). The exposed reinforcing, which appeared to be associated with the embedded bearing plate assembly, exhibited significant corrosion. Where the cracking was not severe enough to result in spalling of the concrete, the cracks exhibited corrosion by-product (rust) stains, which indicated subsurface deterioration of the internal reinforcing.

The rapid deterioration of the precast double tees observed at the third level on the outside arc of the garage occurred as a result of three primary factors. First, as indicated in the 2012 Report, the water-soluble chloride content by weight of cement in the double-tee flanges exceeded the ACI recommended limit for precast concrete. Therefore, any internal embedded reinforcement in the double tees would be more susceptible to corrosion.

Second, the affected double tees were located at the outside arc of the garage at the low point of the sloped third level, such that precipitation – including road salts brought in by vehicles – collected in this area. Even though no deicing salts were directly applied to the upper level of the garage, this resulted in a concentration of the contaminated drainage runoff on the surface of deck above the deteriorated double-tee stems. At these same locations, failures and gaps in the sealant used at the joint between the ends of the double tees and support girders, as documented in the 2012 Report, allowed the collected moisture and road salts to penetrate down into the same area of the double-tee stem ends that were exhibiting the worst deterioration.

Third, the 2013-2014 winter weather, which included record-breaking snowfall and an increased frequency and magnitude of freeze-thaw cycles, had also contributed to the accelerated deterioration of the double-tee stem ends. This is because the cracks there were susceptible to damage from freeze-thaw cycles. The damaged cracks allowed for the infiltration of the contaminated moisture into the embedded stem-end bearing assembly reinforcement, which then resulted in corrosion of the steel.

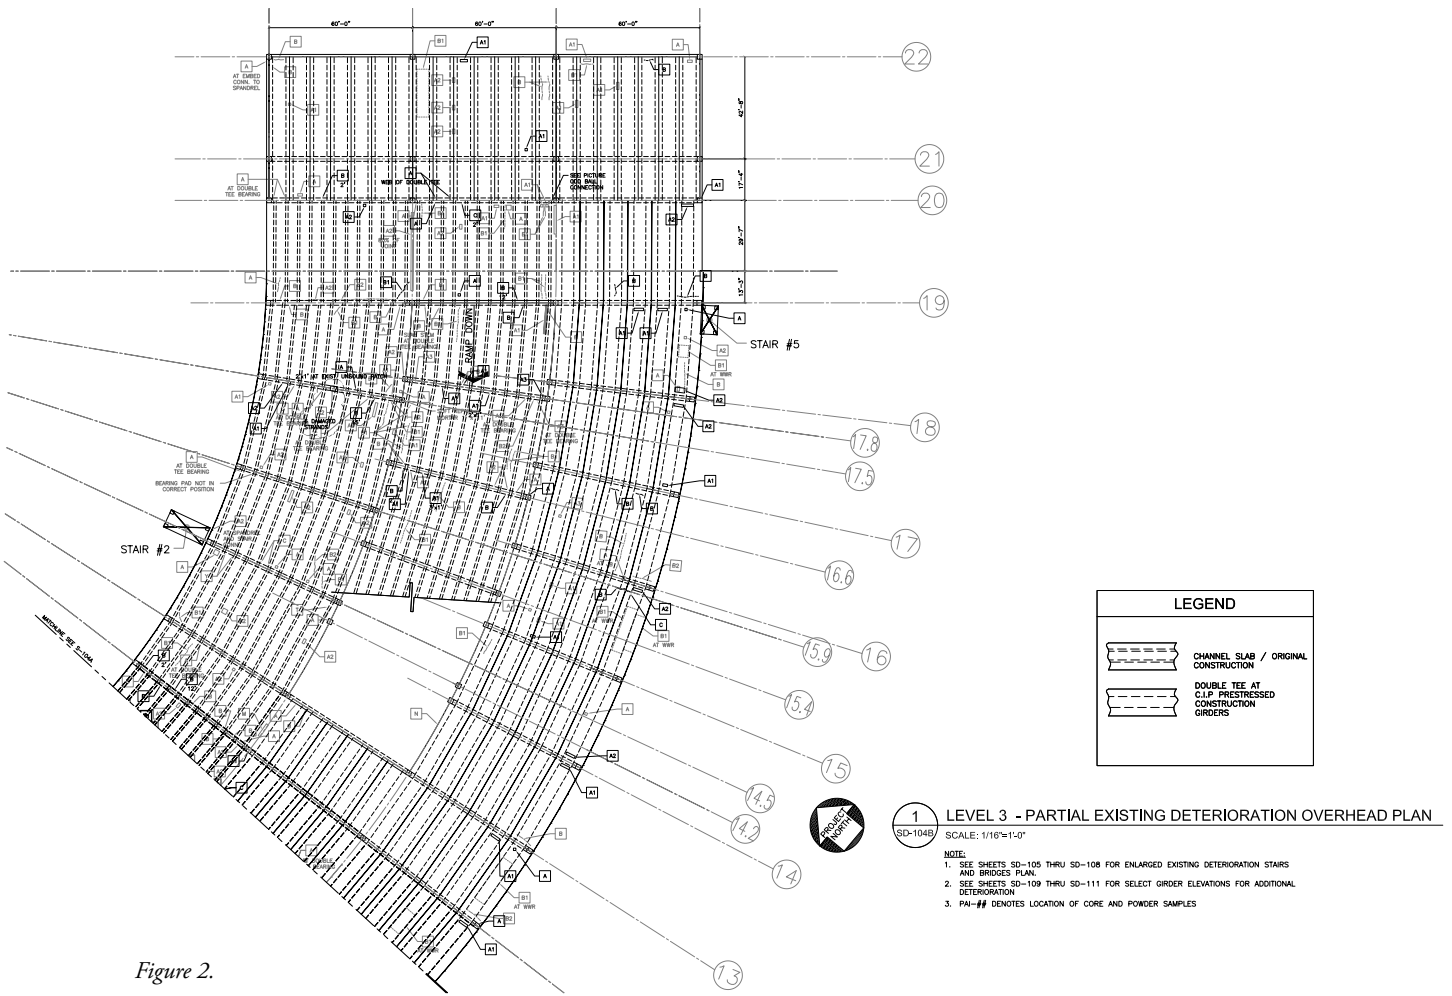
Figure 2.

Level 3 Existing Barricaded Area – At a portion of the third or top level, which had been previously closed off, additional deterioration was evident at the girders located at the perimeter of the barricaded area. At one of the perimeter girders, the exposed prestressing strands had additional section loss, with six strands exhibiting a total or nearly complete loss of cross-sectional area.

based on the observed loss of six strands, the reduction in the capacity of the girder would be approximately 35%.

The imposed loads on the third-level girders are 100 pounds per square foot (psf) of dead load and 40 psf of live load. A 35% reduction of the total load on the girder was required to offset the observed loss of prestressed reinforcement due to corrosion. Therefore, all of the 40-psf live load – which corresponds to 29% of the total service load and 35% of the total factored load – needed to be removed from the girder. As a result of this critical situation, Pennoni notified the Owner of the condition immediately after the condition assessment and recommended that the areas closed to parking on the third level be increased so that no live loads could be imposed on the referenced perimeter girders at the original barricaded area (see Figure 2, page 49).

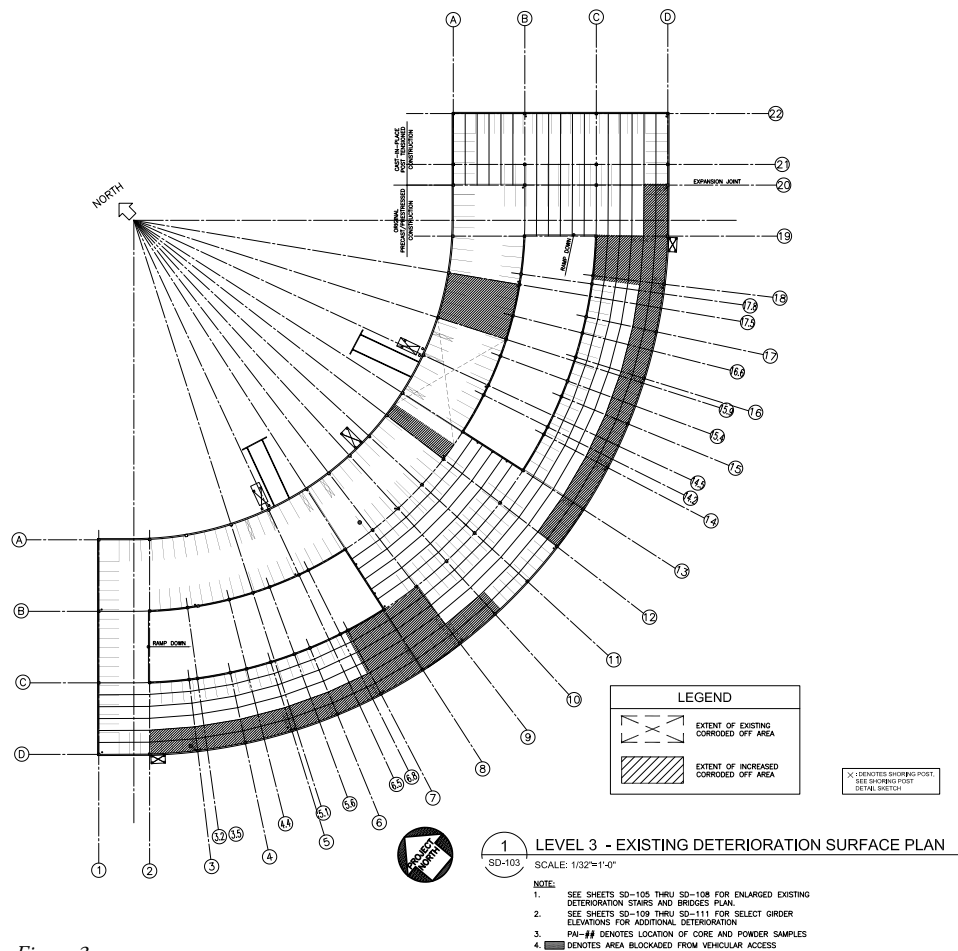
Figure 3.

The level and severity of the corrosion, spalls and damaged concrete at the stem ends of the double tees indicated that the structural integrity of the bearing conditions had more than likely been compromised at a number of locations. This was of particular concern because there was very little (if any) redundancy available in the existing bearing assembly; therefore, the failure of this portion of the member would be non-ductile (i.e., without warning), which would result in a third-level double tee suddenly and catastrophically collapsing onto the next lower level. This dynamic impact would more than likely also cause, in turn, the collapse of the second-level double tee immediately below. Pennoni notified the Owner of this unsafe condition immediately after the condition assessment and recommended that several of the double tees be shored. Subsequent conversations with the Owner determined that the recommended shoring could not be installed immediately due to extended lead times involved with retaining a shoring contractor, leading to the decision that the affected areas should be immediately closed from use (Figure 3).

As a result of the accelerated deterioration that occurred between the end of 2012 and the start of 2014, Pennoni recommended instead that regularly scheduled monthly condition assessments be conducted at the garage, and that the repair work associated with the previous report be initiated within the next year. This approach, in conjunction with the 2014 emergency remediation measures, will ensure that the facility remains partially usable and safe until the new garage can be constructed. ■
