# STRUCTURAL REHABILITATION

## Prescription for Repair

*The Triage, Life Support and Subsequent Euthanasia of an Existing Precast Parking Garage – Part 4*

*By D. Matthew Stuart, P.E., S.E., F. ASCE, F.SEI, SECB, MgtEng and Ross E. Stuart, P.E., S.E.*

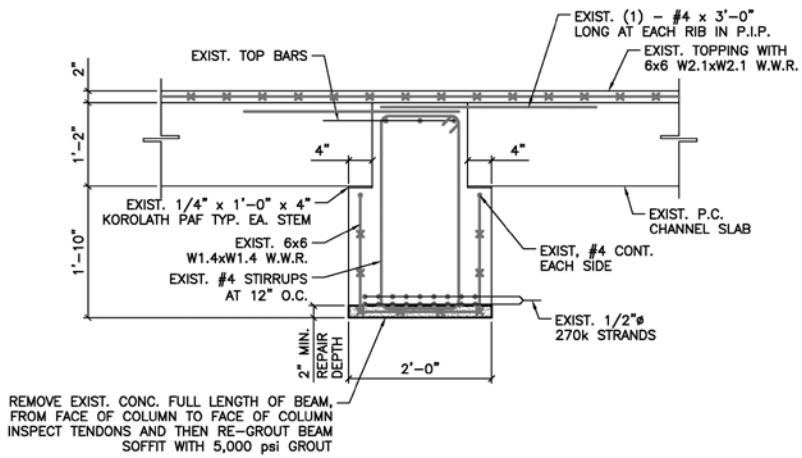
Figure 1. Beam soffit repair detail.

- 1) Remove approximately two inches of existing concrete at the underside soffit of all level-three cast-in-place, post-tensioned girders and precast, prestressed girders, and approximately 25% of the level-two precast, prestressed girders, for the full length of the beams in order to inspect the condition of the tendons and mild reinforcing. If no further repairs were required, replace the removed concrete with high-strength grout, otherwise repair the girder reinforcing as required (Figure 1). These repairs would restore full use of the third level for parking, albeit with limited service life, and were needed to provide an adequate substrate for item #2 below.

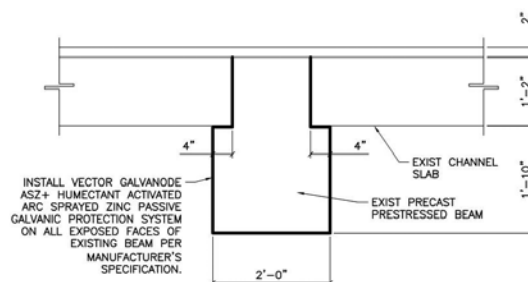
Figure 2. Beam galvanic protection detail.

- 2) Install a passive galvanic protection system, such as Galvanode ASZ+ manufactured by Vector Corrosion Technologies, by coating the sides and bottoms of all cast-in-place, post-tensioned and precast, prestressed girders with the repair product (Figure 2). A detailed discussion of the protection mechanism and installation of this type of product is available in the manufacturer’s literature. The passive galvanic system should limit the amount of future deterioration of the girders for an additional five years based on the recommendations of the manufacturer.

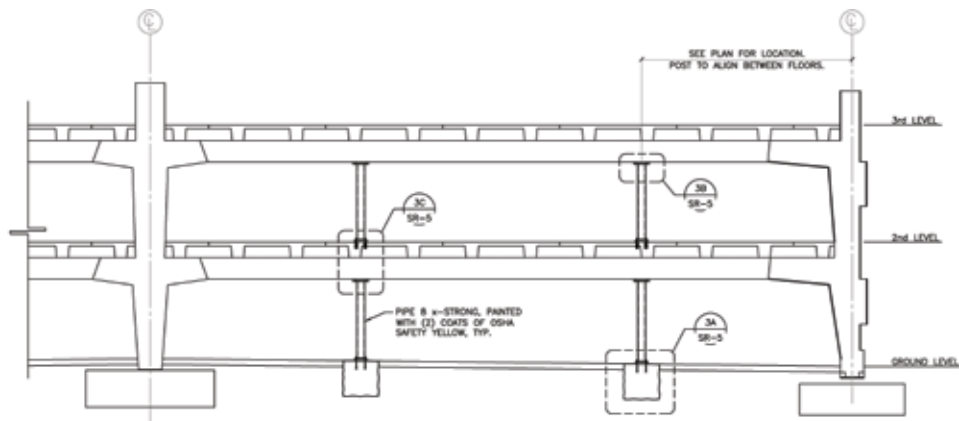
Figure 3. Beam shoring elevation.

- 3) Due to the lengthy anticipated funding, design and construction timeline for a new garage – beyond the extended five-year service life provided by the passive galvanic system – it was also recommended the concrete girders be shored (Figure 3). The purpose of the proposed shoring posts, located at third points of all of the girders

in the garage, was to reduce the stresses imposed on the beams due to transient loads, such as those from cars and snow. However, installation of the shoring would not reduce the existing residual dead load stresses, because it was impractical to jack the beams up at each shoring location in order to relieve the existing dead load.

Implementing the shoring scenario reduces the imposed stresses on the beams by 25%, such that only 75% of the existing reinforcement needed to be available to resist the super-imposed loads. Therefore, it would be reasonable to allow for a 25% reduction in the amount of required reinforcement, due to corrosion, before the beams are considered to have reached the end of their practical service life.

The shores would be located approximately 20 feet away from the supporting columns, and align with the end of the parking stall striping. In this way, the shoring posts would not affect the driving aisles; however, some parking spaces would be lost because the beam locations

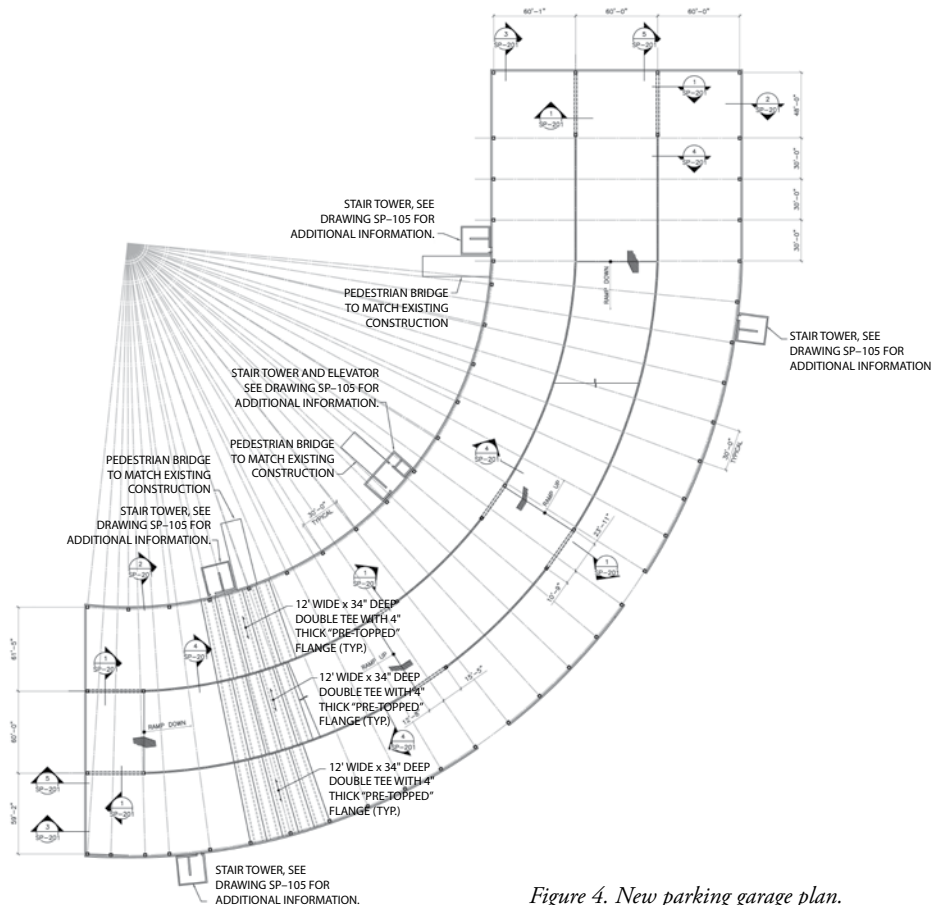
Figure 4. New parking garage plan.

As part of the project, conceptual structural and parking arrangement drawings for a proposed new five-story, 2,050-space garage were developed (Figure 4). In addition to assisting with the determination of the estimated construction cost of about \$54 million, these plans were to demonstrate the construction of a new garage was feasible at the proposed site location, which coincided with the location of the existing garage.

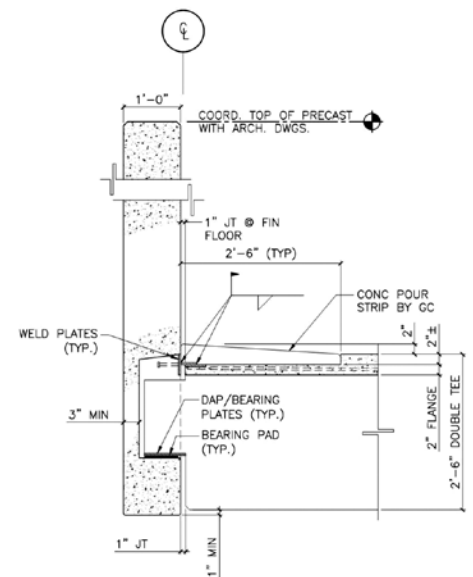
Figure 5. New parking garage spandrel detail.

Although the existing garage was framed using double tees of varying lengths that spanned parallel to the driving aisles, and consequently over a shorter distance than the girders, the proposed new garage was conventionally designed to allow for the double tees to clear span across the driving aisle and parking spaces. This would allow all of the double tees to be fabricated to the same length, with tapered flange edges similar to a pie piece. A more conventional approach to framing the garage avoided the end bearing problems that exist in the original structure. It also allowed the girders to span a much shorter distance and, in most cases, allowed the perimeter spandrels to function more efficiently as load-bearing members, rather than just panels (Figure 5).
