Lessons Learned from the **JOPLIN TORNADO**

By Curtis Geise, P.E., S.E.

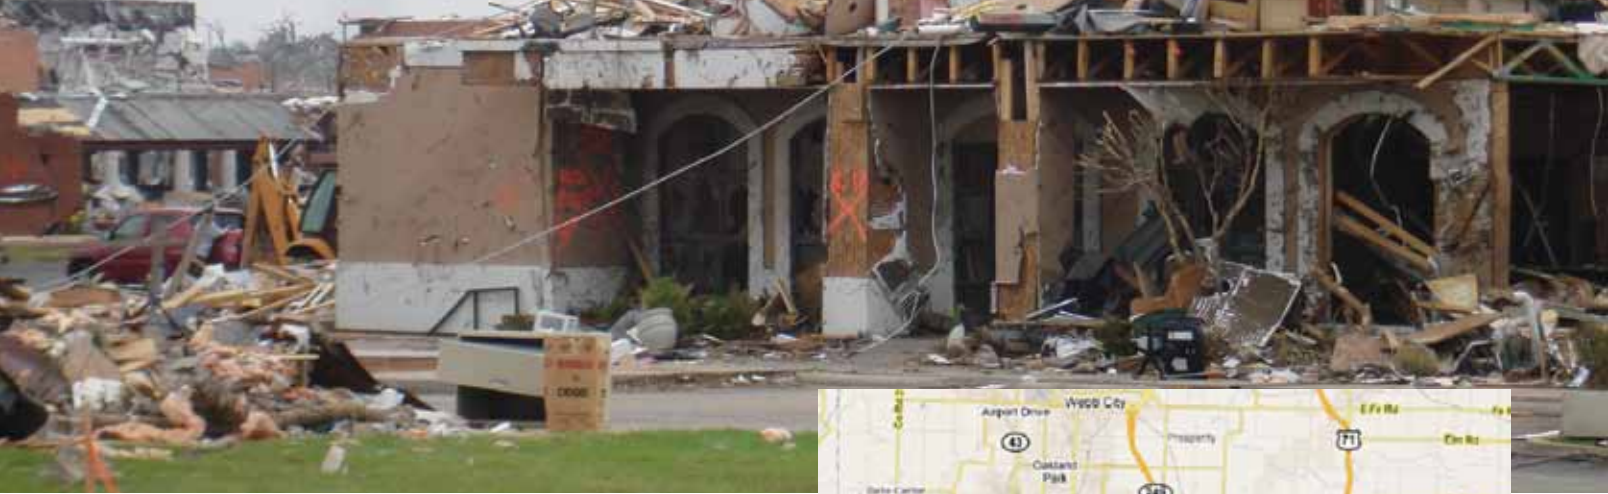
Non-residential building remains standing despite major damage.

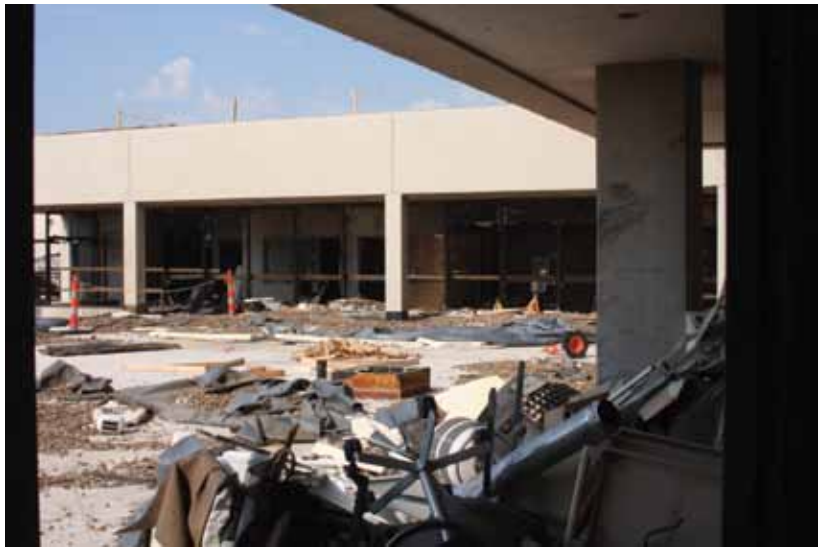
St. John’s Hospital damage; note the ballasted roof, lightweight concrete and glazed curtain wall destruction.

The winds of the Joplin Tornado caused significant damage to envelope materials of several important buildings, including the St. John's Hospital complex. The hospital facilities may have been able to treat some of the injured had these items not catastrophically failed. Critical structures should conform to the same practices required in regions where windborne debris is a concern during a hurricane.

During high wind events, both hurricanes and tornadoes, loose roof ballast is ineffective at preventing roof blow-off. In fact, roof ballast often becomes airborne debris that typically destroys glazing systems and exterior finishes and may directly injure people. Many hurricane-prone regions of the country have enforced codes restricting or eliminating their use.

8) Require essential buildings to have impact-resistant glazing systems and door units, similar to those required in hurricane-prone regions.

9) Prohibit the use of ballasted roofs in all construction.

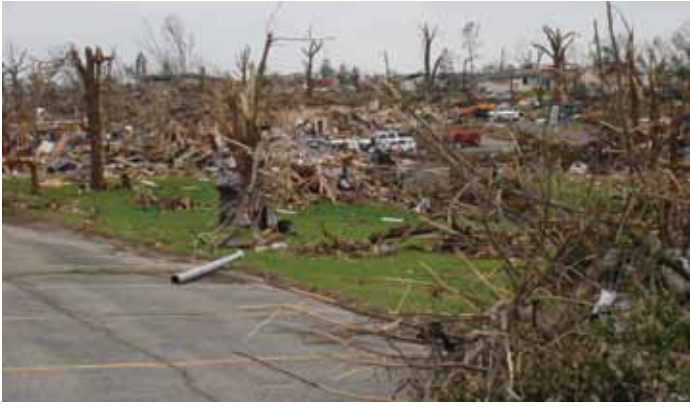
Devastation near the center of the path of the EF-5 Joplin Tornado.
