# New York State Capitol Restoration

By Susan L. Knack-Brown, P.E. and Nicholas T. Floyd, P.E.

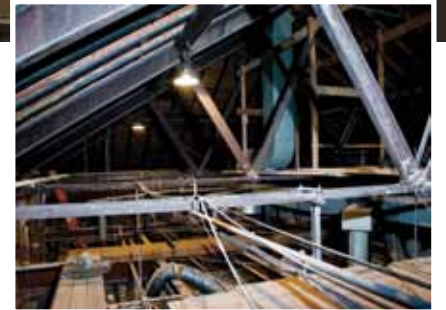
Figure 4: Assembly Staircase attic before and after installation of new skylight, laylight, and staircase lighting. Before photo courtesy of Laurie Donald, Bernstein Associates Photographers, for OGS.

The staircases are constructed with load bearing masonry stairs and perimeter walls, and each is rectangular in plan with a long dimension of approximately 50 feet. The staircase roofs are constructed with long span iron trusses, perpendicular iron purlin members, and rafters which supported the original skylight glass but had since been modified to support wood decking and roofing. While there was little documentation of the original laylight framing grid pattern or attachment, the thick perimeter masonry walls are capped with a stone cornice that clearly supported the original laylight frame's perimeter. Remnants of the original laylight framing hangers on the roof trusses were also identified. Using this information, the design team developed a gridded framing structure specific to each laylight that used the same methods of structural support as the original laylight frame (Figure 4).

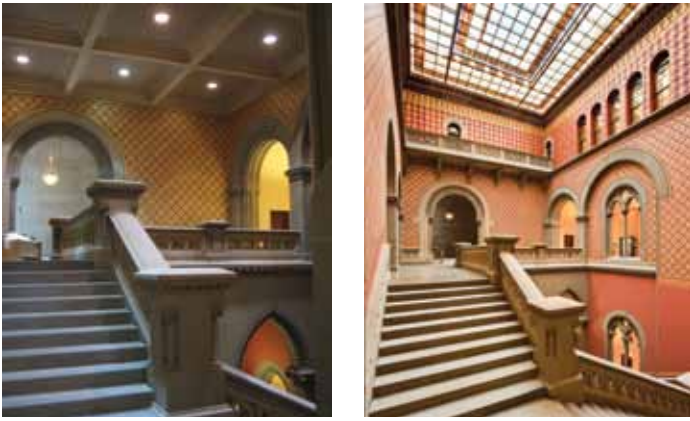
Figure 5: Assembly Staircase before and after restoration work. After photo courtesy of Laurie Donald, Bernstein Associates Photographers, for OGS.

sandstone accents (Figure 5). Within the restored space, this staircase also included an ornately carved stone balcony and wood windows and doors looking into the space from the surrounding circulation areas. Unfortunately, all of these features, along with the laylight and skylight, were removed during the infill work. Restoring them required a careful preservation effort of documenting the painted-over colors and patterns; designing the new wood windows and doors based on remnants of the originals; replicating the detailed sandstone carvings that had been removed or damaged by the infill work; and designing a complimentary laylight based on limited original documentation.

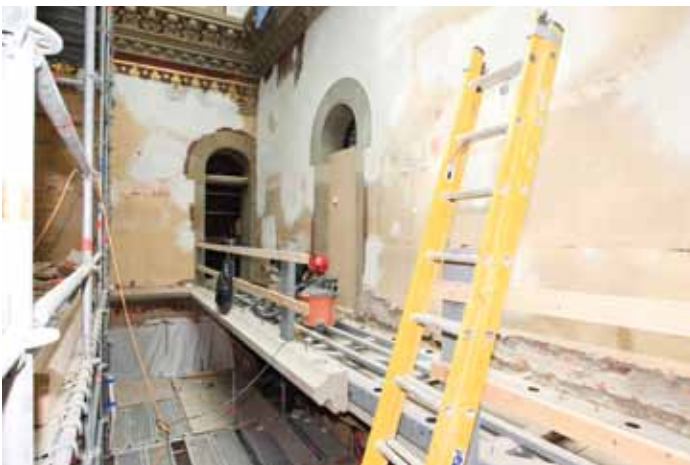
Figure 6: Balcony steel frame and sandstone cladding installation during construction. Courtesy of Laurie Donald, Bernstein Associates Photographers, for OGS.

Restoring the balcony required not only careful architectural detailing of the carved stonework, but a creative structural design, as it was no longer feasible to deeply embed the supporting stone brackets and floor into the load bearing walls (as was done in the original design). The project design instead utilized a horizontal steel truss fastened to the surrounding masonry walls to support a sandstone stone cladding that mimicked the bracket and floor slab appearance (Figure 6). The stone railing was similarly reinforced with steel posts that were clad with sandstone.

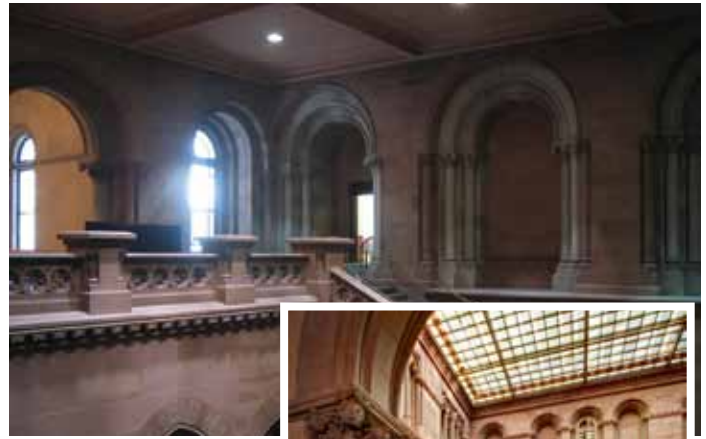
Figure 7: Senate Staircase before and after restoration work. After photo courtesy of Laurie Donald, Bernstein Associates Photographers, for OGS.

In contrast to the lavishly colored Assembly Staircase, the Senate Staircase is monochromatic and constructed with extensively carved red sandstone and capped with an opalescent glass laylight above (Figure 7). Similar to the Assembly Staircase, careful preservation efforts were required to replicate the damaged, intricately carved stone finishes and to clean the exposed stone of both general soiling and of mastics, markings, and staining left behind by the infill construction.
