Tower Stabilization during Buttress Repairs

By David T. Biggs, P.E., S.E., DistM.ASCE, Hon. TMS

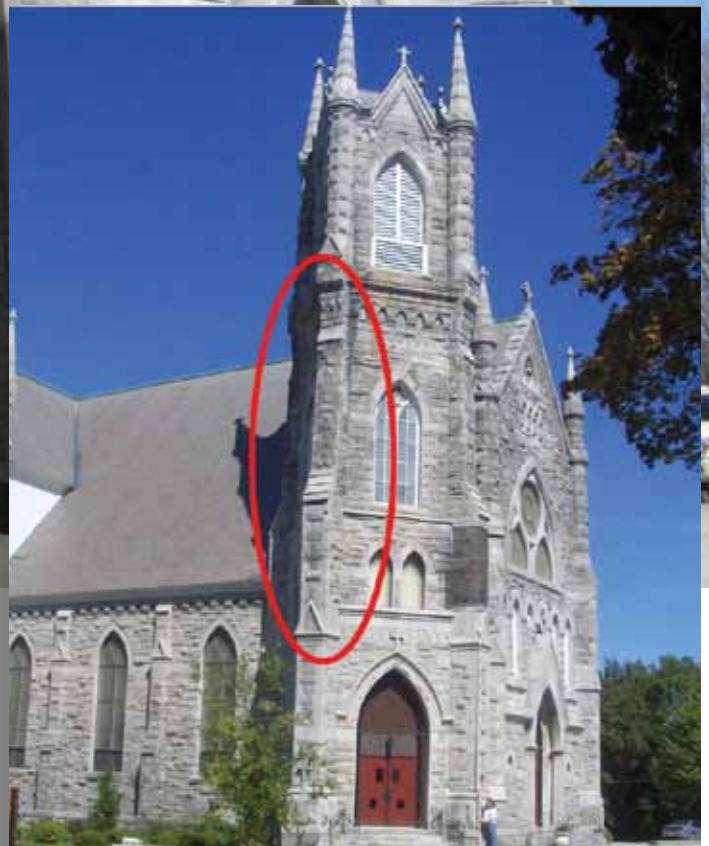
Figure 1: 1892 Church – Vermont, USA.

A church in Vermont with an 80-foot-tall tower (Figure 1) was completed in 1892. The walls are multi-leaf brick and the exterior is faced with limestone that is 6 to 8 inches thick. The corner buttresses have a core of rubble stone. Based upon visual observations, water was saturating the buttresses and deteriorating the exterior mortar. Random cracks were noted in the mortar joints and several stones were displaced outward from the buttresses.

Investigations indicated that the face stones of the buttresses were not well connected to the core. While the walls had header stones, there was an inadequate number of header stones to interlock the rubble core with the face stones of the buttresses. This was primarily evident over the mid-height of the buttresses. Both the upper and lower portions of the buttresses were in good condition; only the middle sections were deteriorated. See the oval on Figure 1 that highlights the distressed area. All four buttresses were affected.

The lack of interlock of the face stones in combination with freeze-thaw action caused the exterior leaf stone to shift and crack the mortar joints. Removal of several stones further indicated that water infiltration

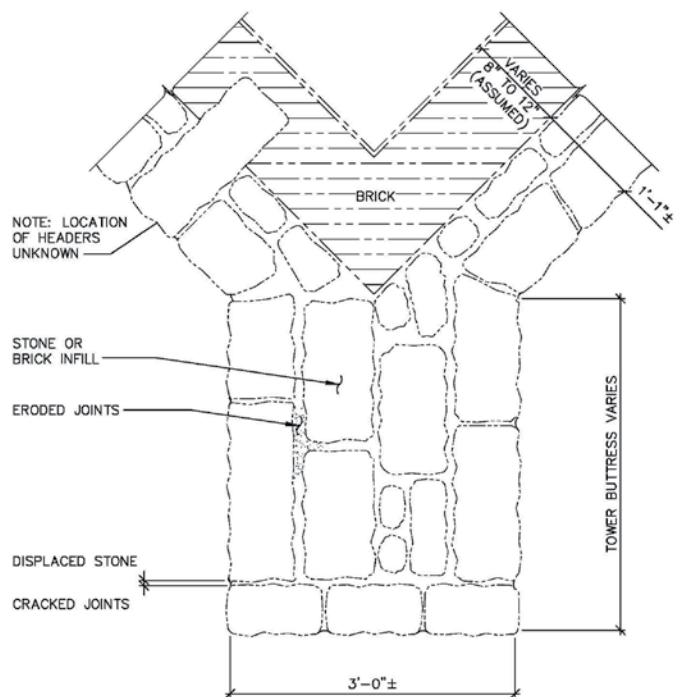
Figure 2: Existing buttress.

and freeze-thaw had deteriorated the binding mortar inside the buttresses. Voids had developed due to the erosion of the interior mortar in both the buttresses and random areas of the walls of the tower. The walls were approximately 22 inches thick; the buttresses were approximately 3 feet thick. Figure 2 shows the section through one of the buttresses.

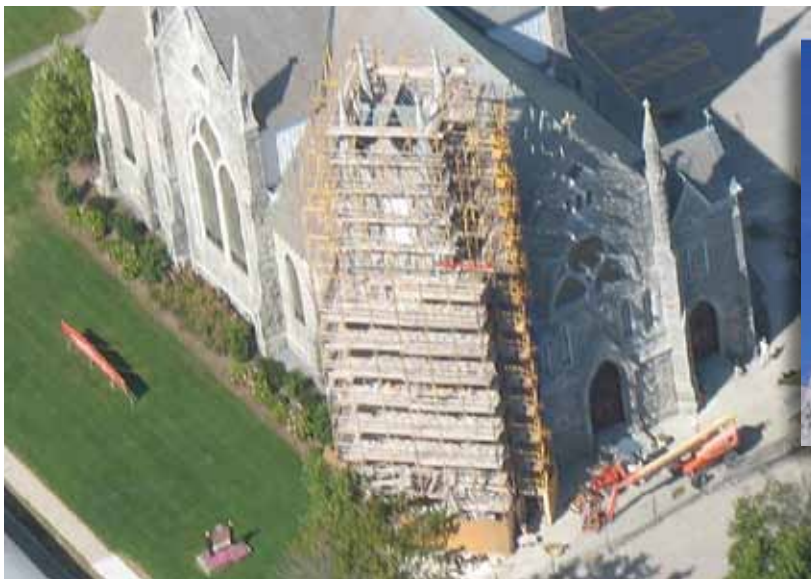
Figure 3: Tower with personnel-access scaffolding. Courtesy of Micahel Gnazzo.

One option was to build a massive scaffolding structure to shore and underpin the removal area. The cost was deemed excessive and alternate methods were considered. After several analyses, the work was planned so that it could be performed on two buttresses at a time by removing opposing corners to balance the load on the tower. The scaffolding that was used was only needed for personnel access and to stage materials. It was not used for tower support (Figure 3).

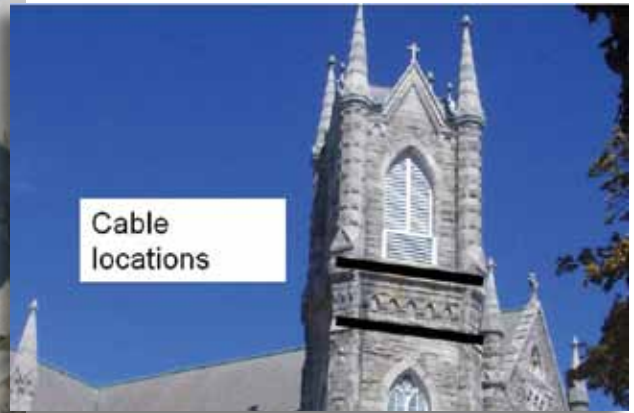
Figure 4: Tower with proposed cable locations.

The goal of the stabilization procedure was to hold the top of the tower in place so that the buttress removal and reconstruction could occur without heavy shoring. The scheme utilized steel cables wrapped around the top of the tower. Figure 4 shows the tower before reconstruction, with the proposed cables located. The buttresses below the lower cable were to be removed and reconstructed down to above the main door entrance.

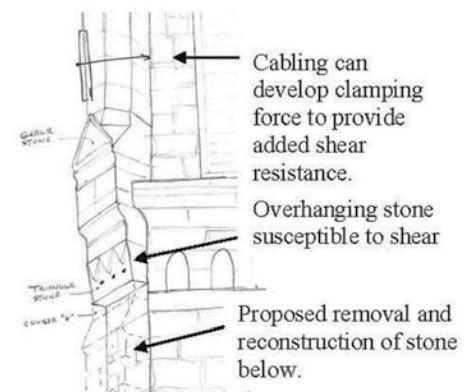
Figure 5 shows a graphic with the buttress removed below leaving the upper portion overhanging. Figure 6 shows that the removals below would produce an eccentric load on the remaining

Figure 5: Overhang created by removals.

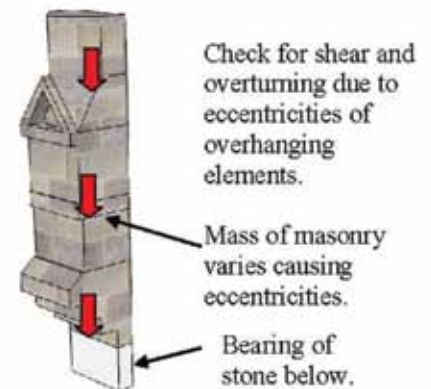
Figure 6: Upper stones produce eccentricity at overhang.

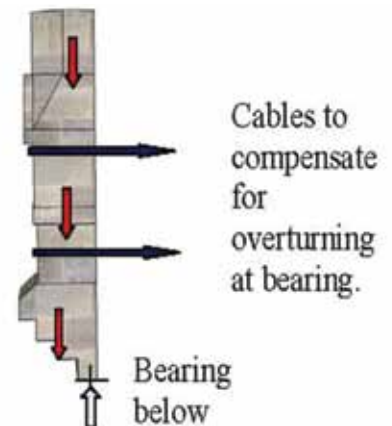
Figure 7: Overturning restraint with cables.

masonry. Figure 7 (page 31) shows that, with very little bearing area remaining below the corners due to the removals, cables were needed to overcome overturning and provide a clamping force that would increase the shear capacity of the upper masonry at the corners.

The two cables in Figure 7 were wrapped around the tower and tightened. The corner stones that were clamped by the cables were protected from damage by crush plates made up of a piece of steel pipe with a wooden filler that is formed to the edge of the stones (Figure 8). Alignment tabs were welded to the pipe for the cables. The extra cable shown in the lower portion of the photograph is not stressed.

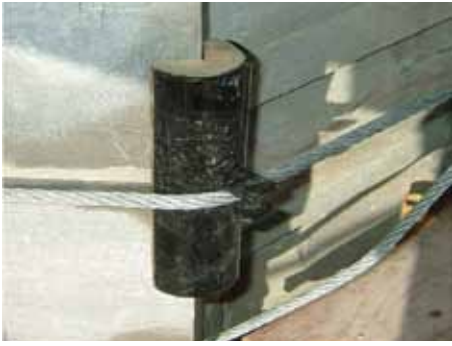
Figure 8: Corner protection for cable on stone.

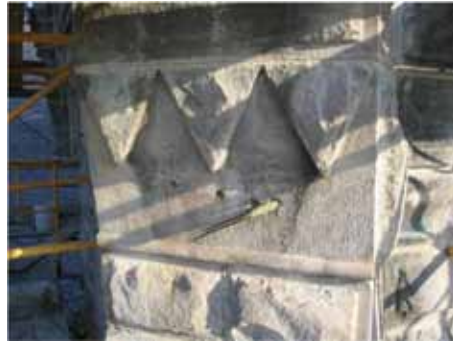
Figure 9a: Pinning upper stones before lower buttress removal.

Prior to actual buttress removal, the stone just above the area was reanchored using drilled-in pin anchors to provide localized support and stability. Figure 9a shows the stainless steel pins being installed. These 1-inch-diameter steel pins were drilled and adhesive anchored into the backing material. After the restoration was completed, the pins were subsequently cut below the face stone and a patching material was used to cover the hole.

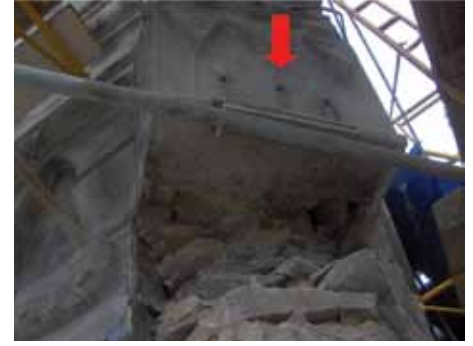
Figure 9b: Partial buttress removal below the the pinned stones in Figure 9a.

Figure 9b shows the area below Figure 9a after the stones of the buttress below were removed. The pins from Figure 9a are shown by the arrow.

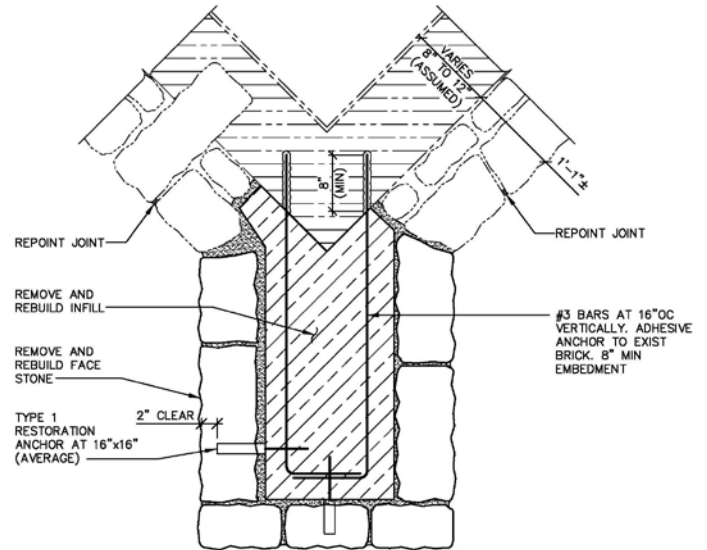
Figure 10: Detail of buttress reconstruction.

Figure 10 shows graphically the reconstruction of the buttress. The core of the buttress was reconstructed and anchored to the brick backing wall using #3 reinforcing bars drilled and adhesive grouted 8 inches into the brick. The reinforcement was installed at 16 inches on center over the height of the buttress. Stainless steel ties were used to provide additional bonding of the face stones to the core of the buttresses by attaching them to the #3 bars (Figure 11).

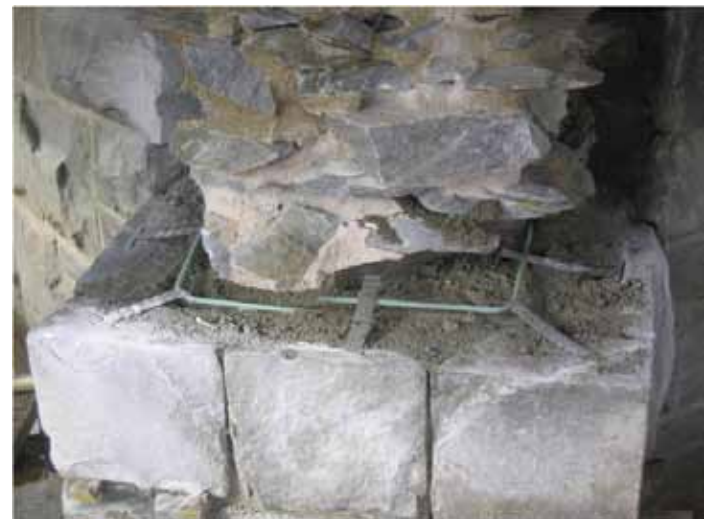
Figure 11: Stainless steel anchors to bond face stones.
