New Theory on Egypt's Collapsing Pyramids

By Peter James

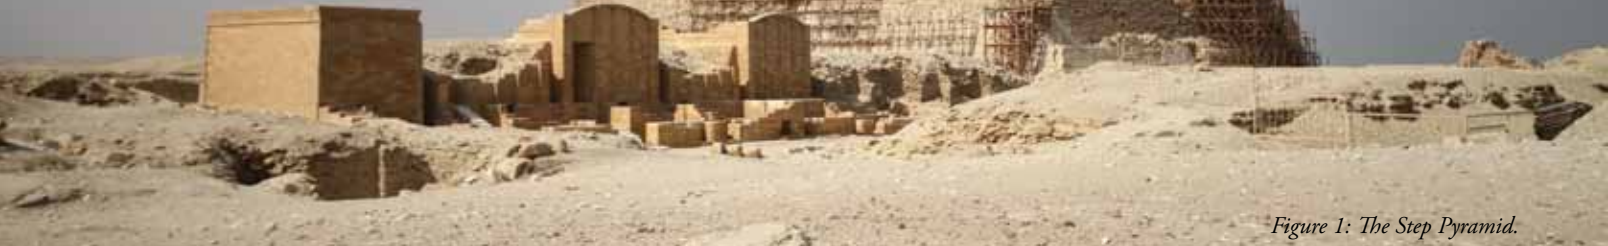
Figure 1: The Step Pyramid.

While work on the Red Pyramid was confined to strengthening the granite slabs immediately above the burial chamber's corridor, Cintec's next project, the Step Pyramid (*Figure 1*), required more careful planning and execution due to the very dangerous condition of the burial chamber ceiling. A large portion had collapsed during the 1992 earthquake, and what remained – a ragged, hanging, inverted group of large and small stones set in mud – was liable to collapse at any time. Cintec used its unique WaterWall airbags to support the ceiling temporarily without provoking further stone fall, before beginning work on final anchoring processes which are now halfway to completion. These ongoing projects offered insight into the nature of the pyramids' structural deterioration.

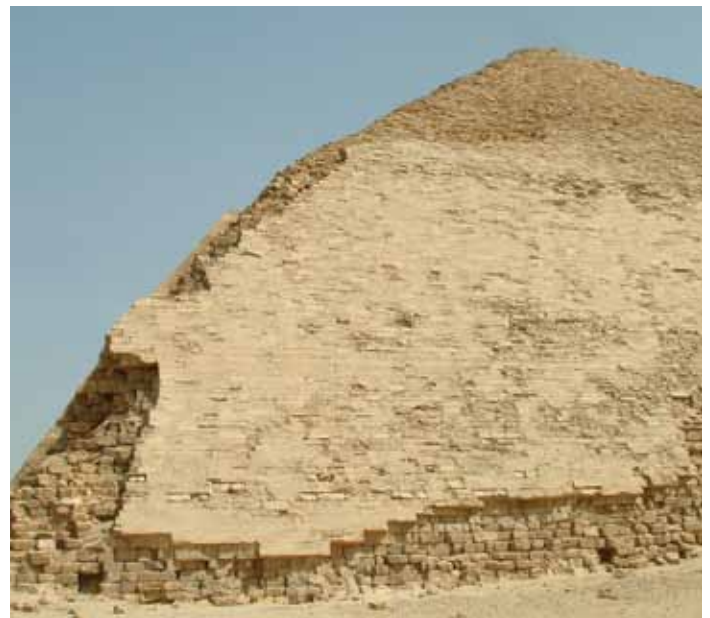
On one of the author's visits to the Step Pyramid, he was asked for an opinion on securing the remaining outer cladding of the Bent Pyramid (*Figure 2*), another construction by Pharaoh Sneferu, located 40 kilometers south of Cairo. This pyramid's top section sits at a slightly different angle to the main body, giving the structure its "bent" appearance.

Figure 2: The Bent Pyramid.

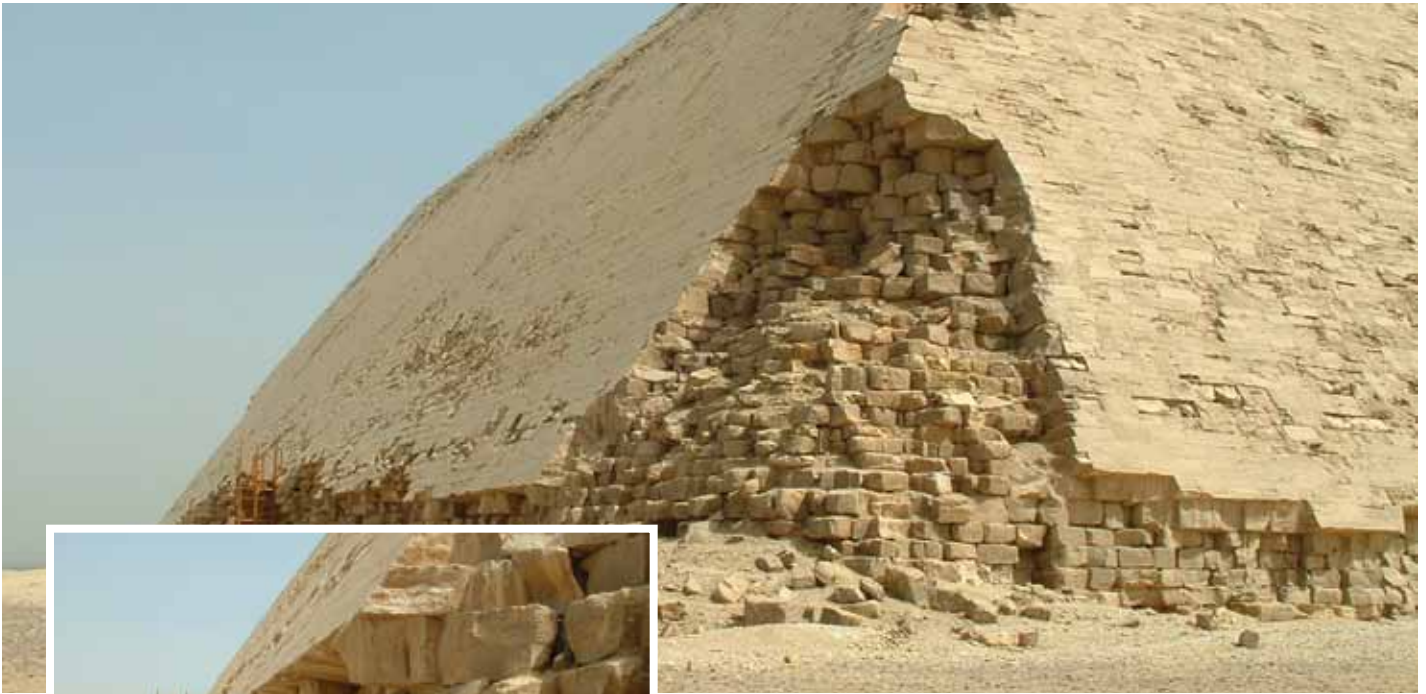
Before any structural restoration work could be considered, the exact nature of the pyramid's defects had to be established so that the correct intervention could be carried out. From a visual inspection, the structure showed distress along all of its extremities (*Figures 3 and 4*). What were the clues? The pyramid did not appear to have

any foundation movement. All of the missing cladding occurred at interfaces or changes of direction at the angles and between the ground and the cladding.

It is the author's belief that in the case of the Bent Pyramid – in fact, in the case of all pyramids – the outer casing has been affected by thermal movement. The Bent Pyramid is the only one with any degree of stone casing still attached, making the mechanism of failure apparent. The distress at all of the perimeter edges suggests that the outer casing has expanded from the center outwards, and movement has taken place on all of the extremities.

Figure 3: Major cladding damage at one corner of the Bent Pyramid.

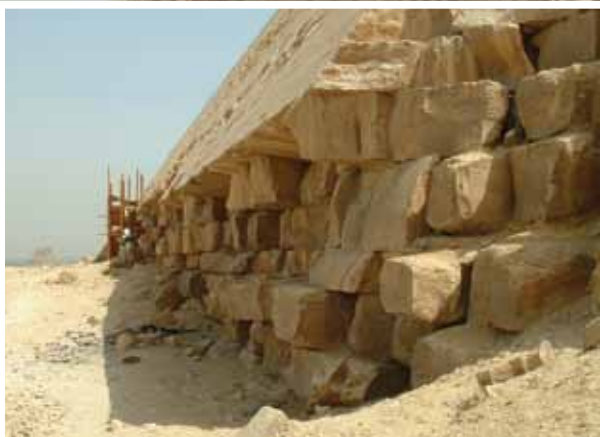
Figure 4: Limestone blocks cantilever out, where cladding below is no longer present, and eventually fail.

During the day, the temperature rises to 40°C (104°F) across the face of the outer casing, then at night cools to 3°C (37°F) because of the lack of cover and exposure to the prevailing winds. This gives an average daily temperature fluctuation of 37°C (67°F). The photographs of the Bent Pyramid show how thermal expansion has caused the blocks to move to the edges, where they have detached. It also shows how individual stones, unsupported, can cantilever and snap off and subsequently fall to the ground.

Limestone has a coefficient of thermal expansion of 8×10^{-6} , proportional to the change of temperature and to the original dimensions. Applying this yields $(8 \times 10^{-6}) \times (37^\circ\text{C}) \times (100\text{m}) = 30\text{mm}$ (1¼ inches) of movement per 100-meter (328-foot) run in all directions, although this is also dependent on the size of the gaps between adjacent stones. All movement from the thermal expansion of the casing would be taken up initially in the joints, but would also cause dust and stone particles to detach from the stones, filling the voids and gaps between them. This would reduce the amount of contraction possible at night, along with the stones' natural propensity not to return to their original dimensions and position, and so the cycle would start again. Multiply this endless movement by the number of days that the pyramid has been erected and you have the reason why all the outer casing has moved to the extremities, where it has buckled or displaced against blocks moving in the opposite direction and then fallen off. It may then have been picked up by opportunists and removed from the site.
