FULL METAL JACKET

Part 1: Evacuation

By D. Matthew Stuart, P.E., S.E., F. ASCE, F. SEI, SECB, MgtEng
and Richard H. Antoine III, P.E., S.E.

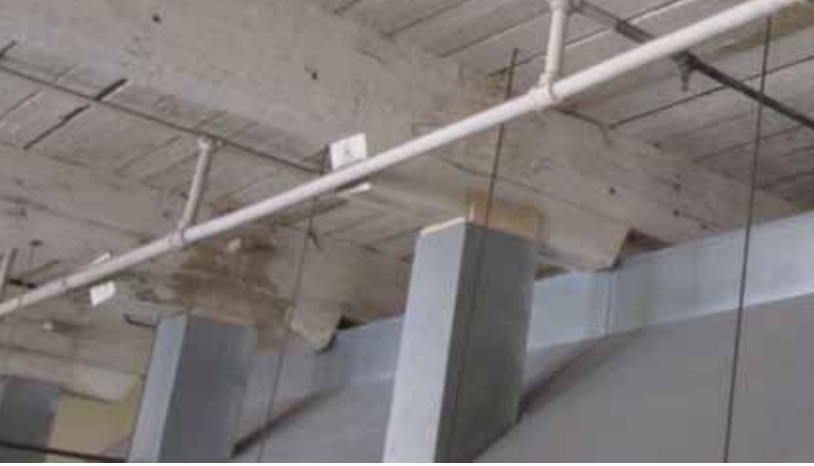
Figure 1.

heavy timber beams spaced at approximately 8 feet on center that spanned perpendicular to the longitudinal axis of the building. The beams were supported by timber columns located at the approximate midpoint of the transverse dimension of the facility, for a maximum clear span of approximately 22 feet. Wood decking spanned between beams, which interrupted the columns at each floor; however, the beams were spliced with a keyed scarf joint with beveled cuts at the centerline of the columns. In addition, a timber corbel or pillow beam was located below the beam and on top of the column below. This connection is illustrated in *Figure 1*.

Although it could not be confirmed visually, it was assumed that mortise and tenon joints had been used between the lower column and the corbel, the corbel and the beam splice, and the beam and the column above. This method of construction was used on all of the framed floors and roof; however, at the first floor, the beams were interrupted by the basement column, which extend up to the top of the first floor, where there was a connection to the bottom of the column above. There did not appear to be a connection between the first floor beams and the face of the columns, but the beams were supported by full-height 3x12 timber plates that were through-bolted to the sides of the columns directly beneath the beams. The first floor of the building included a concrete slab that was cast on top of the timber floor decking; however, at the other floors, it could not be confirmed if a similar concrete topping had been placed due to the presence of the existing floor finishes.

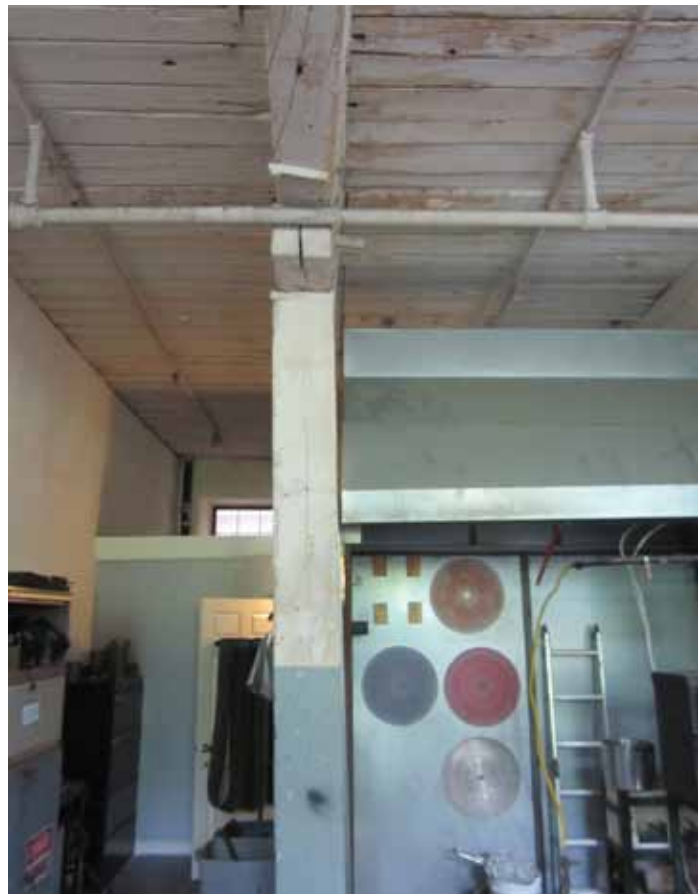
Figure 3.

The deleterious structural conditions included two primary issues. The first condition included extensive previous insect infestation damage observed in the basement at several of the timber columns, beams and decking. The second condition involved visible vertical settlement of several of the columns due to what appeared to be almost a complete loss of section at the base of the columns in the basement (Figure 2). It was unclear whether the loss of section was due to insect damage, deterioration due to exposure of the base of the column below the slab on grade to moisture, or both. The non-uniform vertical deflection of the columns had also resulted in the horizontal rotation and out-of-plane movement of the corbel and beams that were supported by the top of the column just below the second floor (Figure 3).

The extent of section loss at the bases of several of the timber columns below the basement slab on grade was extensive, and in some cases appeared to have resulted in little to no end bearing of the column on top of the footing. At these same locations, it appeared that the 3x12 side plates that were through-bolted on each side of the columns were supporting not only the first floor beams, but also the building column above. The bases of the 3x12s rested on the slab on grade immediately adjacent to the edge of the hole in the slab that had been previously occupied by the deteriorated building column base. In addition, these same 3x12s exhibited significant insect damage and moisture-related deterioration. This condition appeared to be very precarious and in danger of immediate collapse.

The evaluation team immediately notified the building owner that the structure was not safe for occupancy and should be evacuated. The owner obtained a second opinion from another local structural engineering firm, which agreed with the assessment and encouraged the owner to evacuate the building immediately due to the unsafe condition of the structure. As a result, the owner contacted the local building officials, who assisted in evacuating the building of all third- and fourth-floor residents, as well as the first-floor tenants.
