# CONDITION ASSESSMENT and Repair

## An Existing Composite Concrete Slab and Steel Beam Framed Parking Structure Part 2

By D. Matthew Stuart, P.E., S.E., F. ASCE, SECB

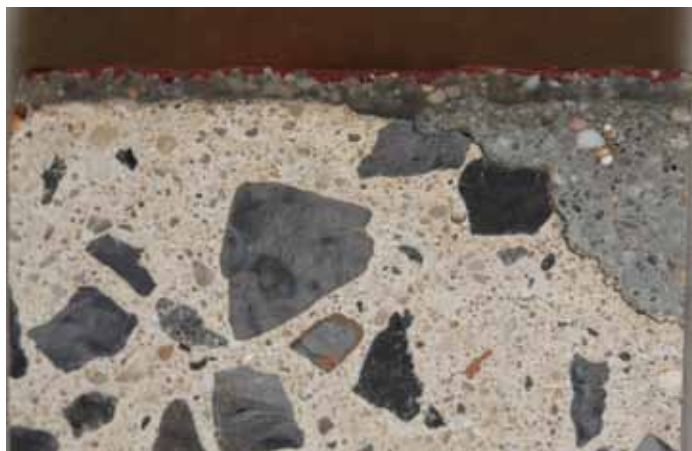
Image from Petrographic Analysis.

With the exception of some atypical features noted in the report, in general, the results of the petrographic analysis of the six core samples indicated that the concrete appeared to be of good quality. It was not clear, however, why entrained air content was not detected in core sample #1. Normally, concrete contains anywhere from 1% to 2% entrapped air; a value above 3% is indicative of the use of an air entrainment admixture. This admixture is typically recommended in concrete that will be exposed to exterior conditions because it greatly improves the ability of the concrete to resist damage that can result from freeze-thaw cycles.
