Keep Your Strands Dry Corrosion Protection of Unbonded Post-Tensioning Monostrand Tendons

By Gerard C. Feldmann, P.E.

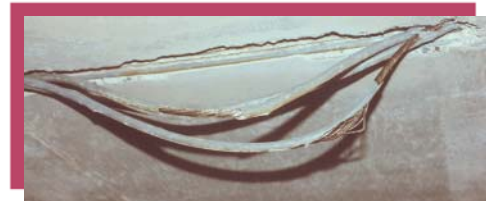
Figure 1: Tendon failure due to corrosion at anchorage

give minimum corrosion protection guidelines for typical installations and modifications for "Aggressive Environments". The corrosion protection of the older monostrand systems was vulnerable at or near the anchorages. Corrosion related failures sometimes allowed the strand to loop out of the slab at high/low spots with little cover, as shown in *Figure 1*. Additional corrosion protection guidelines regarding minimum concrete cover is provided by ACI 318.

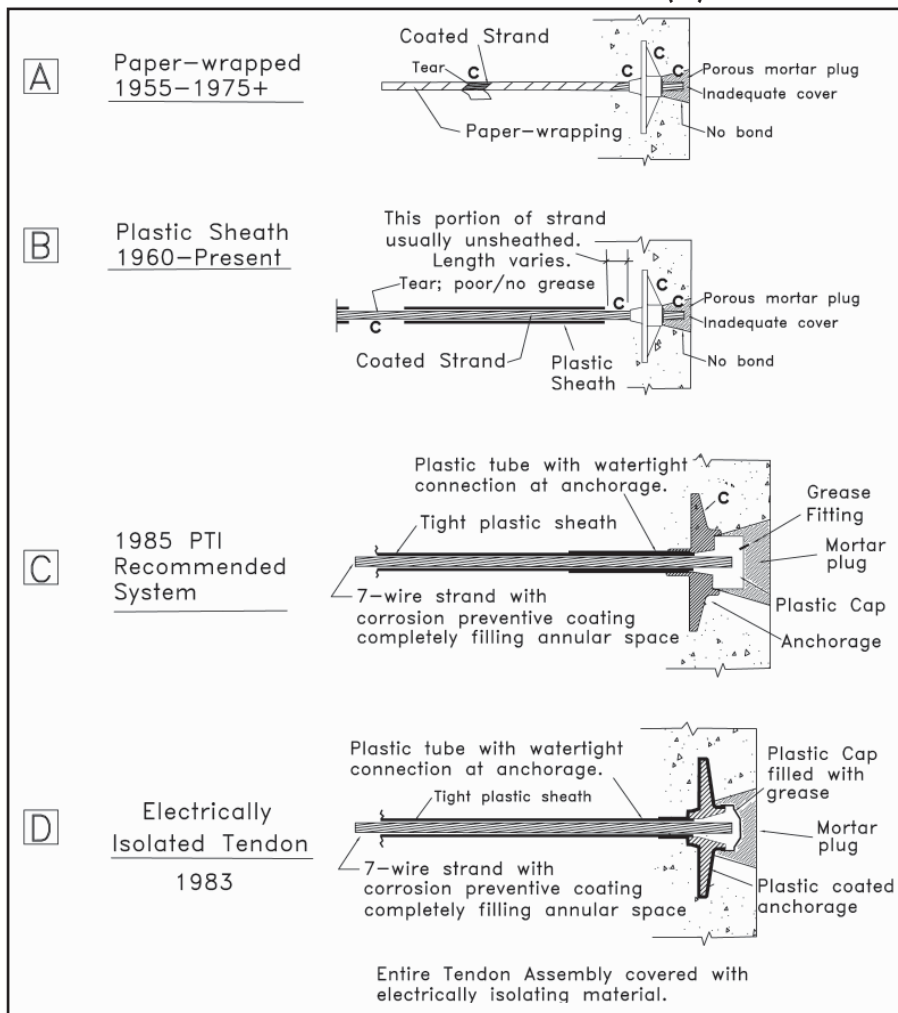
Unbonded Strand Tendon Corrosion Protection Evolution and Usual Location for Corrosion (C)

The evolution of corrosion protection is shown in *Figure 2*. The early systems had sheathing composed of spirally wrapped paper. Plastic sheathing was developed to give the unbonded systems better protection during and after construction. The early plastic sheathing was either a push-through or heat-sealed type, which had an annular space that allowed water to travel if the sheathing or anchorage was compromised. The current extruded plastic sheathing, usually made of polyethylene, is much tighter, leaving very little or no air space in the system.

Figure 2: Evolution of unbonded monostrand corrosion protection

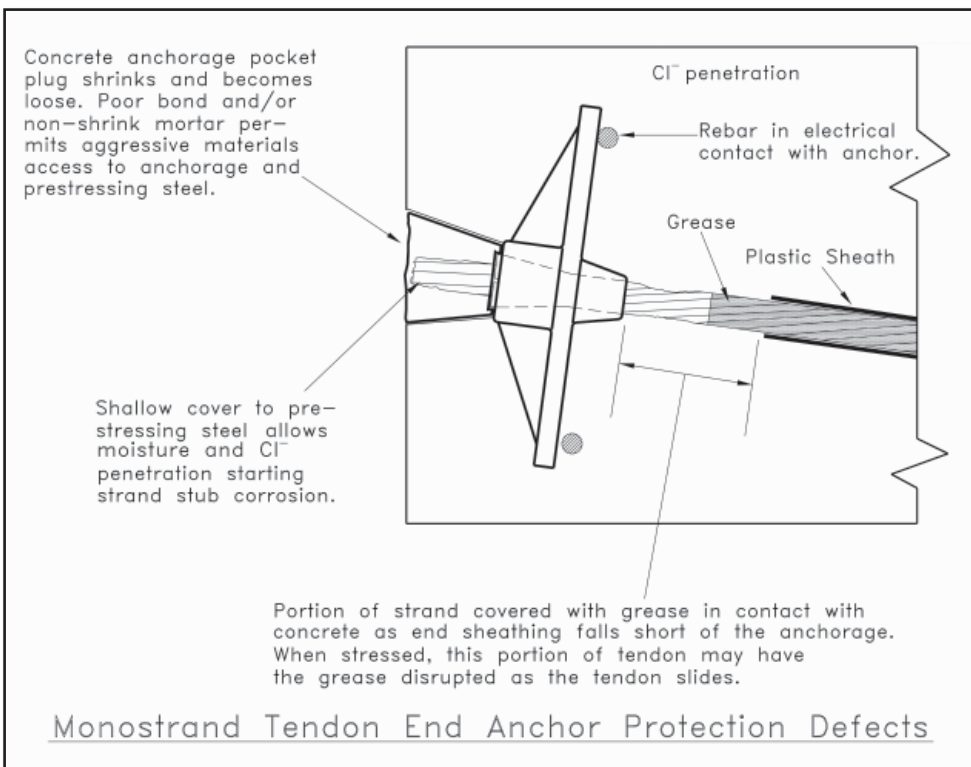
Figure 4: Typical corrosion locations on non-encapsulated monostrands

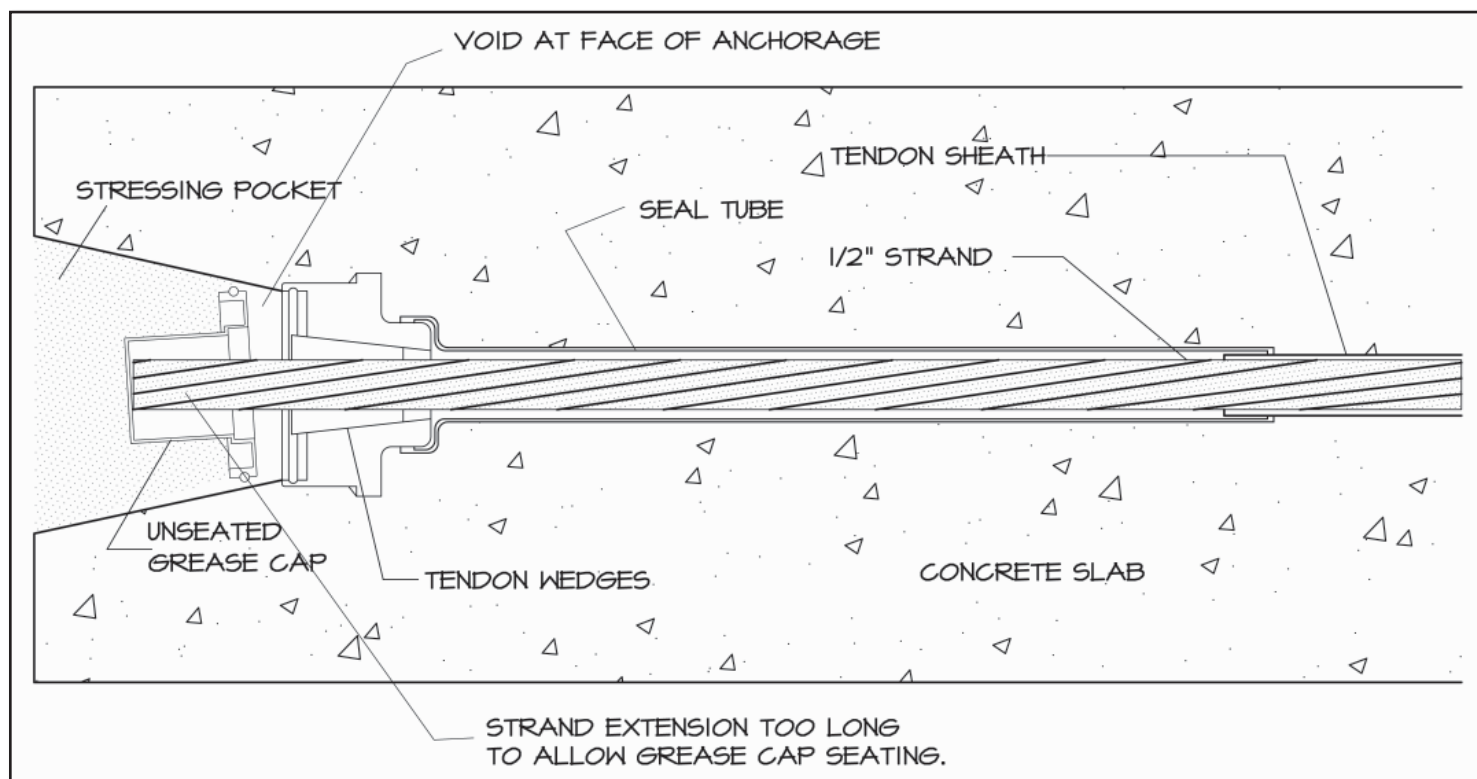
Problem 4: The last mistake was a result of the improperly cut strand extensions and the loose grease caps, which meant the stressing pockets could not be filled properly. The ability to pack the stressing pockets with a loose grease pocket left voids at the face of the anchorage, as shown in *Figure 5*, creating another weak link. In fact, in some areas where the stressing pockets were hidden by expansion joints or architectural protrusions, they were left unfilled or filled with fiberglass mesh and stucco. What you can't see can really hurt you, especially the owner's bottom line. Needless to say, millions of dollars have and will be spent to correct the situation. All of it could have been prevented with very little extra cost.

Figure 5: Improperly cut strand extension with resulting mortar void

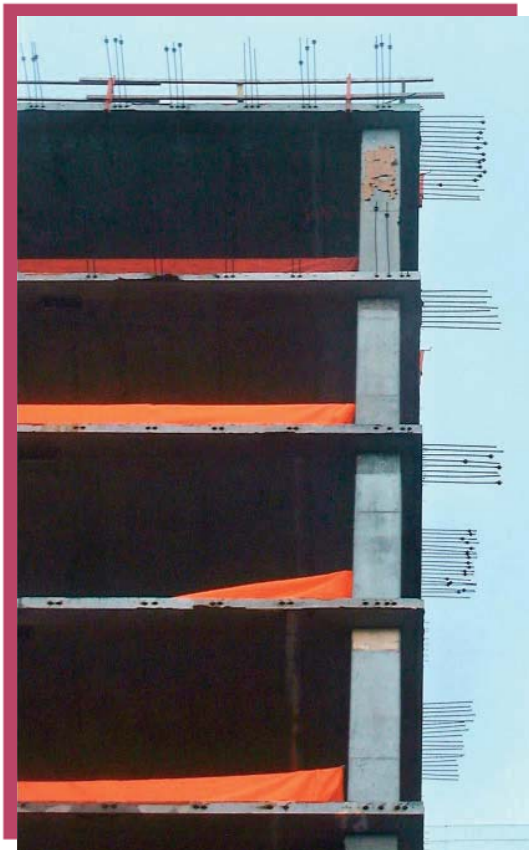
within 7 days. Additionally, the stressing pocket should be filled with mortar within 10 days following strand cutting. The long delay allowed wind-driven rain to enter the system. In fact, a hurricane occurred during construction, driving water into the structure. If water is driven into the sheathing, it will not leave. It will sit and initiate corrosion until the strand is consumed in the chemical reaction. *Figure 6* is from another structure, but the condition to the referenced building is similar. Here, all of the stressing pockets have been left open in a ten-story building for many weeks, leaving lots of opportunity for moisture to access the anchorage and strands.

Figure 6: Long term exposure of strand/ anchorages to elements
