# Structural Rehabilitation

### Repair of Corrosion Protection for Cables

A Case Study

By Paul A. Gossen, P.E., F.ASCE

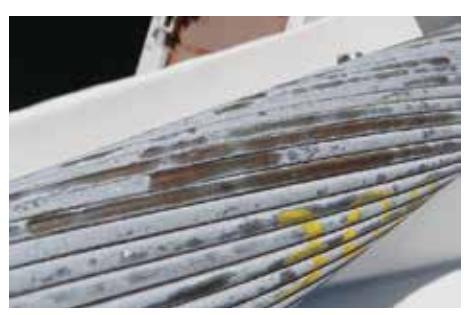
Figure 4. Depleted zinc coating on cable.

A close examination of the surface of the cable showed no rust stains or bulging, but the zinc coating was delaminating in little flakes on the exposed surfaces of the outer wires (Figure 4, page 25). The area of the wires, where the coating had delaminated, turned brown, indicating the onset of corrosion. There was no observed cratering or pitting from corrosion. Based on these findings, the consultant recommended using a cold galvanizing process that called for a recoating of the cables with a zinc-rich compound. A detailed preparation procedure and specification were drafted. It specified that the cables were wire-brushed with a soft wire wheel, with the brushing applied in the same lay, the twist direction of the wires, to avoid creating any scarring that could cause stress risers. The cables then were to be cleaned by air blasting and wiped to remove any dust. The surface had to be free of any contaminants that could diminish the bond of the zinc compound. The specification called for a coating thickness of 2.5 to 3.5 mils with 95% metal zinc content after drying.

What could have caused the flaking of the coating on the outer wires? As mentioned earlier, the wires had a Class C coating in which the zinc is electrolytically deposited on the wires. In the electrolytic process, zinc is bonded to the steel through adhesion. The flaking of the coating from the wires suggests a bond failure between the zinc and the steel. We rarely see this problem in Class A coating, which is the hot- dipped galvanization protection. During the Class A process, a steel zinc alloy layer forms that bonds firmly to the steel. Only steel with a phosphorus content higher than 0.03% has the tendency to flake.

The answer of the delamination may lie in the fabrication process of the wires. When drawn through a mandrel to obtain the high strength, the wires are lubricated. This lubrication needs to be fully removed for wires that are electrolytically coated so that a strong bond between the steel and the zinc is obtained. It takes more than a solvent to remove the lubricant. A solvent only dilutes the lubricant but does not remove it fully. In the Class A coating process, the wires are also cleaned, but any remnant lubricant burns off in the zinc bath.

The execution of the treatment followed in 2010. The stay cables on one side of the roof were treated first because both promenades could not be closed off due to fire escape considerations. The limited loading capacity of the promenade slab did not allow using large equipment with the required reach to cover the full length of the cables. As an alternative, scaffold towers that reached the top of the masts were erected. Tarps wrapped these towers to protect the work from rain and wind during the coating process. A concern with using a coating was the sealing of all surfaces. No coating is 100% waterproof over time, particularly cables composed of round wires. Even though there may be fill materials, such as grease or mischmetal to fill the voids between the wires of the inner construction, there can still be areas in which moisture may accumulate. Thus, pinholes in the coating were deliberately included to allow the venting of the inner structure of the cable.

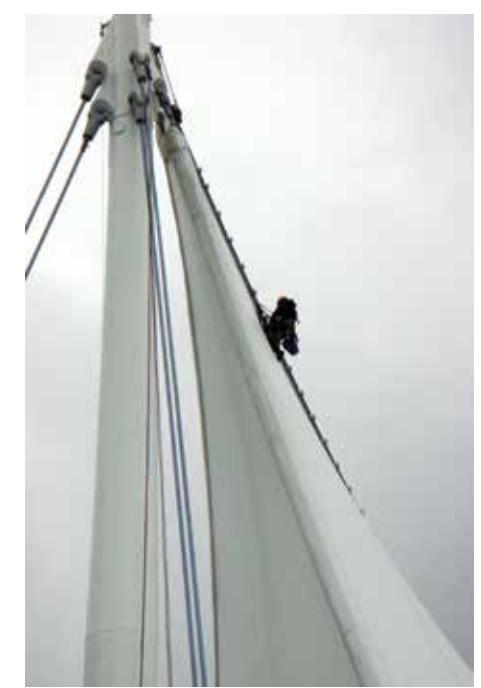
the promenade's floor and span across the convention center. For the inspection, the owner engaged Pacific Ropes, a specialty firm that is equipped and experienced in inspecting cables. They accessed the ridge cables by climbing up the stay cables (Figure 5). The inspection was conducted by taking pictures of the ridge cables for evaluation. The pictures revealed that the same condition existed as previously observed on the stay cables. Again, a recoating with a zinc rich compound was chosen as a remedial treatment.

Figure 5. Inspection of ridge cable.

The recoating of the ridge cables is scheduled for this year. The recoating process will be more difficult and tedious due to the difficult access to these cables. Also, the stainless steel loops that anchor the fabric clamps will have to be unbolted to reach the covered area for treatment. Care will have to be taken not to damage the fabric.

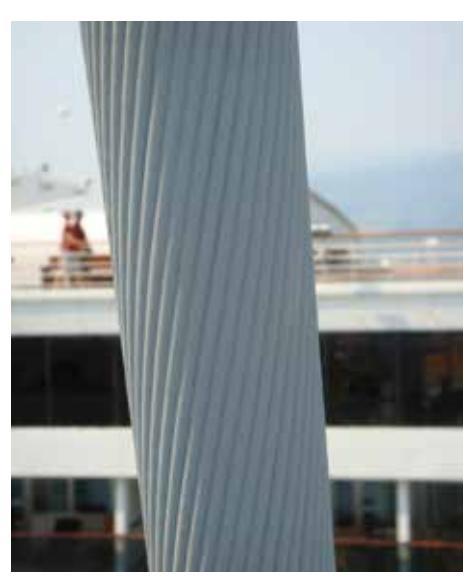
Figure 6. Applied coating after 6 years.

Inspections of the coating of the stay cables that were coated in 2010 showed it to be in excellent condition (Figure 6). A coating with a cold galvanizing compound is not as durable as a coating of the wires by hot dipping or even electrolytic depositing, but it is a viable alternative to replacing the cables.

It is understood that the cables need to be monitored and that their recoating in the future may be necessary.
