# The Polynesian Cultural Center Renovation

## A Hawaiian Journey

By James M. Williams, P.E., C.E., S.E., AIA, LEED AP

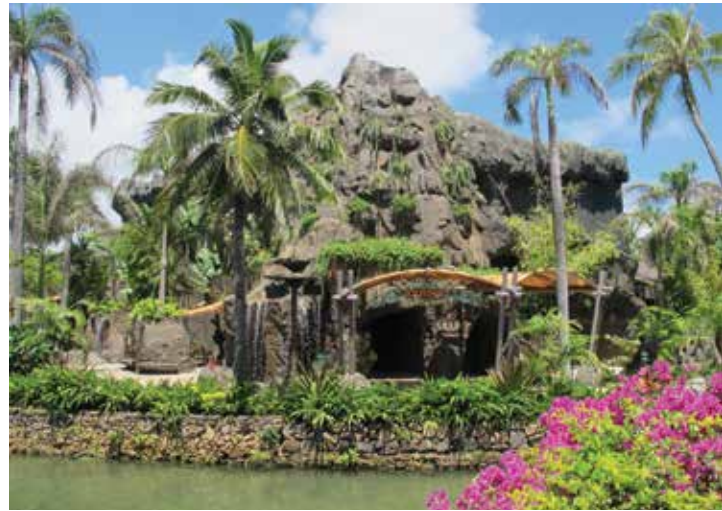
After performing calculations, it was discovered that the rigid frames were overstressed by 34% per code. The original design wind speed was 80 mph (which was used historically and was based on an evaluation of a 1968 study which did not include hurricane data). The 1985 UBC specified a wind speed of 110 mph. The current IBC specifies a wind speed of 105 mph. Because the building has an occupant load greater than 300, the importance factor is 1.15, which requires increasing the design wind pressures even more. The design wind pressure was 33 psf; the actual wind pressure varies from approximately 41 psf to 43 psf. When the gravity dead loads are combined with lateral wind loads, the rigid frames are overstressed 156%. Also, the actual seismic base shear is 4 times greater than initially designed for and exceeds the base shear due to the design wind load.

The beams were strengthened using external post-tensioning to increase the load carrying capacity of the roof to comply with code and to install a new catwalk system. Because of the slender nature of the bents, additional web stiffeners and bracing had to be installed along the webs and bottom flanges. The CMU walls were braced, grouted solid, new connections made, and the effective wall heights were reduced, allowing the reinforced CMU walls to act as shear walls and help the bents resist potential lateral loads.
