NORTHRIDGE 25 YEARS LATER

Nonductile Concrete Frames

By Keith D. Palmer, Ph.D., S.E., P.E.

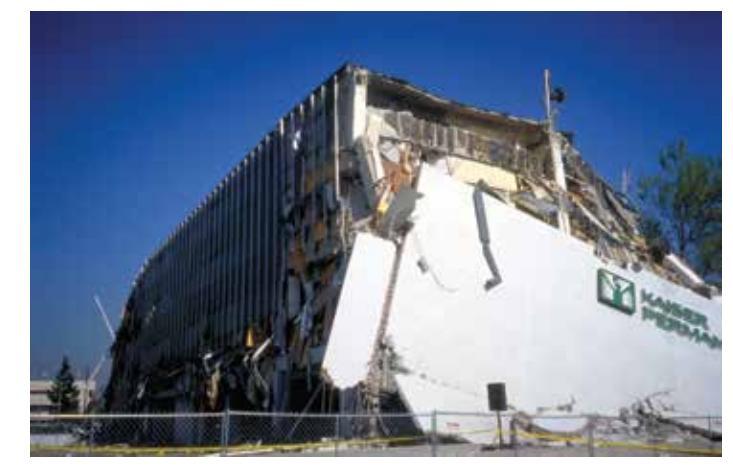
Figure 1. Kaiser Permanente. Source: NISEE-PEER, University of California, Berkeley.

Several buildings and parking garages saw partial or total collapse, including the Kaiser Permanente Office Building (Figure 1) in Northridge and two garages at the Northridge Fashion Center. The Kaiser collapse was attributed to inadequate confinement in the columns and shotcrete shear walls inadequately attached to the frame. The Northridge parking garages were relatively new structures (circa 1988) but were constructed of precast double and inverted tees. Failure was attributed to large diaphragm movements causing the failure of gravity columns that lacked proper confinement. Additionally, large out-of-plane displacements of the perimeter frames occurred causing the precast beams to unseat. Collector failures were also observed in the topping slabs of precast decks in the vicinity of shear walls.

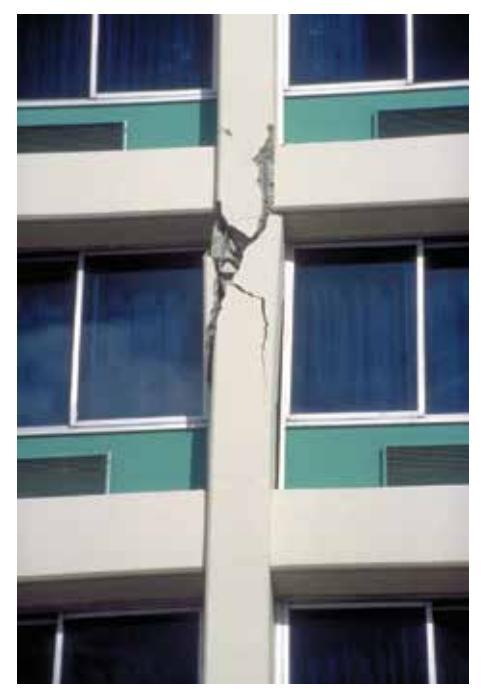
Pre-1980 frame buildings typically fared worse than their shear wall counterparts. The Holiday Inn in Van Nuys was a sevenstory concrete frame structure built in 1966. The frames consisted of exterior columnspandrels and interior flat slabs. Minor structural damage occurred during the San Fernando earthquake but was repaired using epoxy injection and patches. The building was red-tagged following the Northridge event and required temporary shoring for fear of collapse. The major damage mainly consisted of column shear failure below the fifth floor due to lack of ties (*Figure 2*),

Figure 2. Holiday Inn, Van Nuys. Source: NISEE-PEER, University of California, Berkeley.

which led to significant spalling and buckling of the longitudinal reinforcement. The building was later retrofitted with concrete shear walls.
