CONDITION ASSESSMENT and Repair

An Existing Composite Concrete Slab and Steel Beam Framed Parking Structure – Part 3

By D. Matthew Stuart, P.E., S.E., F. ASCE, SECB

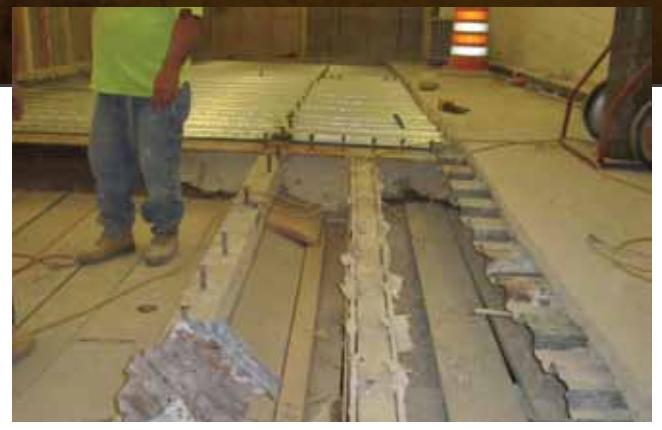
Ramp Renovation in Progress.

6) Non-technical concerns included phasing the renovation work as required to maintain normal operation of the garage, and phasing the repair work such that the property manager could fund the project over a number of years. The construction phasing and sequencing assumed that work at the entrance and exit ramps could only be done during weekend hours. In addition, all work would be done during the summer months when the occupancy rate of the garage was at its lowest. Work in the loading dock area had to be phased such that no more than half of the facility would be closed at any one time. To facilitate the construction phasing, the plans segregated areas of repair and altered the normal traffic patterns accordingly. The available annual funding of the \$3 million project required that it be spread out over a period of not less than five years. To facilitate this, the repair bid quantities were categorized by type and area of the garage, so that the submitted bids could be funded based on an established order of priority.

The renovation work for this project started during the summer of 2011 and is expected to extend until 2015. The initial work included the temporary shoring of a number of areas that exhibited such extensive metal deck deterioration that there was an immediate concern for the structural load-carrying capacity of the affected slab spans. The renovation that continues into 2012 includes the full-depth repair of the most significantly deteriorated and temporarily shored areas

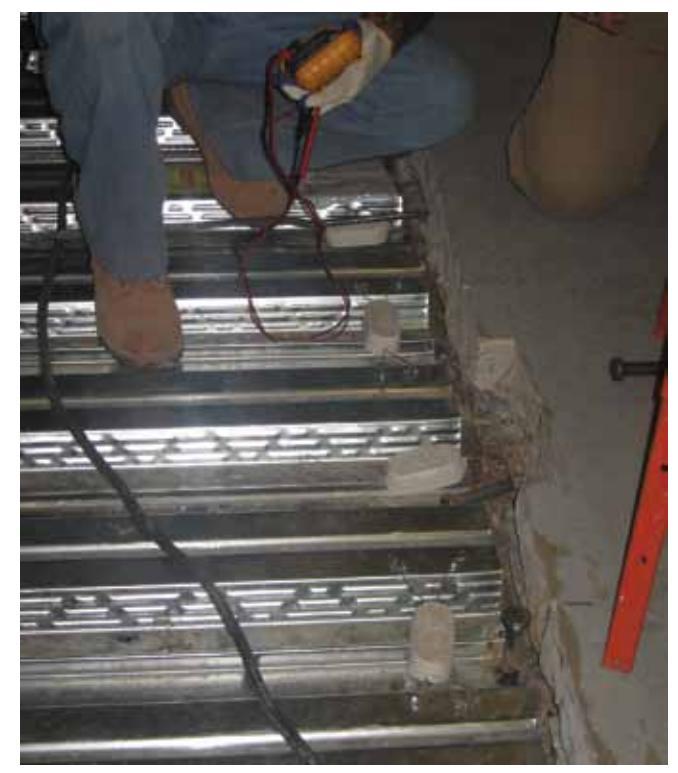
Installation of Internal Sacrificial Anode.

In order to prevent this phenomenon, the slab repairs included the use of a sacrificial, passive galvanic protection system to protect both the internal slab reinforcement and

the metal deck from further corrosion. A passive galvanic protection system is different from an active or cathodic system, in which an impressed electrical current is provided from an external power source. A passive system protects the existing reinforcement and metal deck from further corrosion through the following process.

When two dissimilar metals are coupled together in an electrolyte, the metal with the higher potential for corrosion (i.e., more negative electrochemical potential) will corrode before the more noble metal. By placing a sacrificial zinc anode in the slab repair, corrosion of the anode will occur while an electrical current prevents corrosion activity at either the reinforcing or the deck due to the direct connection of electrical lead wires from these elements to the anode. The service life of this system ranges from 15 to 20 years, at which point it will be necessary to replace the anodes in order to prevent further reinforcing and metal deck corrosion, and resulting concrete deterioration.

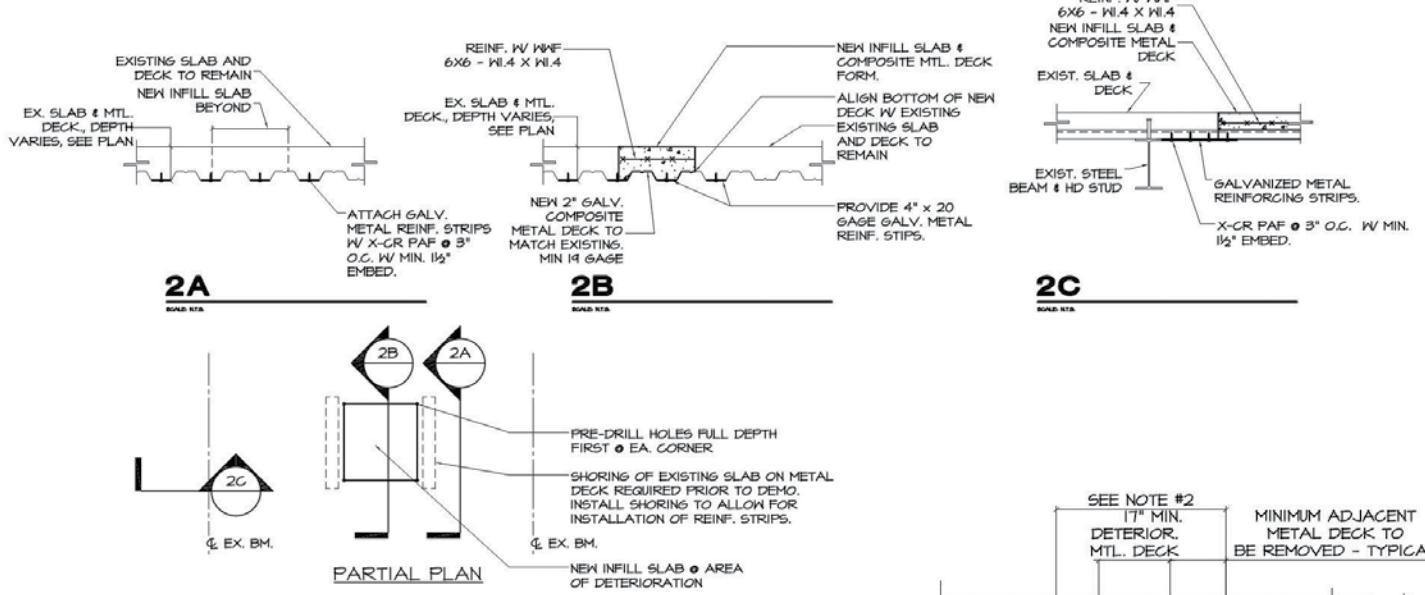
Isolated full depth repair detail.

- Due to the relatively shallow thickness (3¼ to 4½ inches) of the concrete slab over the 2-inch-deep composite deck, repairs of surface spalls and subsurface delaminations would need to involve the complete demolition and replacement of the deteriorated slab and metal deck. However, at the loading dock slab (6-inch slab over 2-inch metal deck), there were situations where it was possible to accomplish shallow (2-inch maximum) repairs involving conventional saw cutting, mechanical demolition and placement of an infill topping.

- 2) The nature of the flexural capacity of the existing composite deck dictated that the majority of the full-depth repairs extend from supporting beam to supporting beam at most areas of concrete deterioration, in order to avoid a situation in which discontinuity of the metal deck would occur within a significant portion of the clear span of the existing slab. However, at a few isolated locations, a full-depth repair was possible that allowed for the replacement of the portion of lost composite deck with external, full-span soffit reinforcement as described in note 5 below.

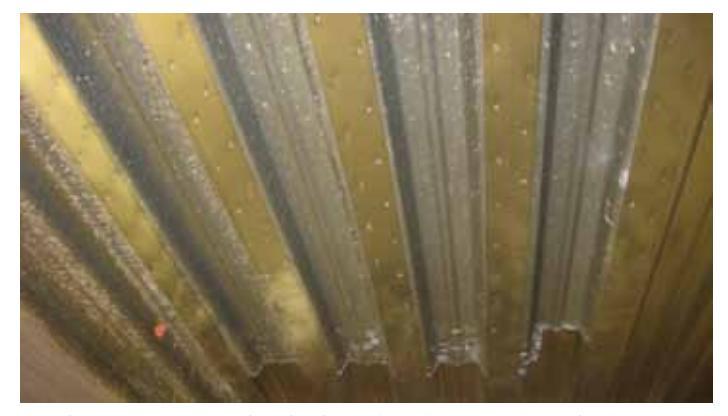
Reinforcing Strips on Underside of Metal Deck (External Sacrificial Strip Anodes Not Installed).

5) The alternate repair method for the metal deck presented the challenge of how best to replace the flexural capacity of the area of deck that had to be removed due to the resulting discontinuity of the deck, and how best to attach the new deck to the concrete above to ensure full composite action. Originally it appeared that carbon fiber reinforcement would be the best solution, but adhering the fabric strips to the bottom of a rust-stained concrete slab soffit was going to be problematic. In addition, there were issues with how best to lap and develop external fiber reinforcement with the remaining existing metal deck. The eventual solution was to employ galvanized sheet metal strips that could be attached to the concrete slab above using powder-actuated fasteners.

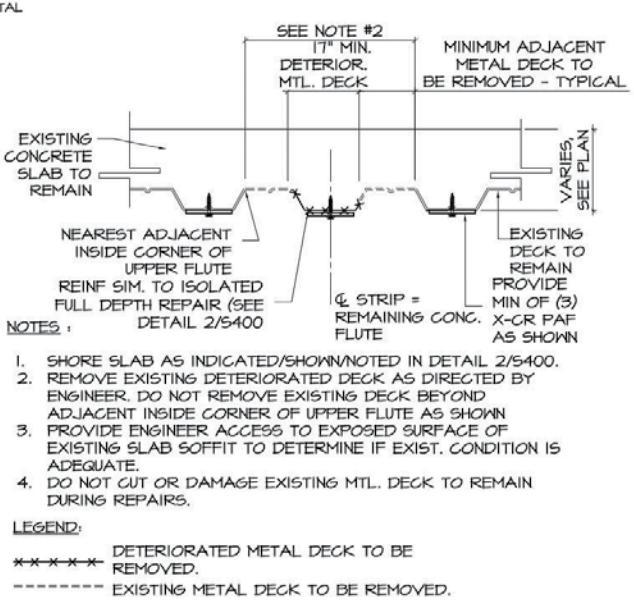
Isolated metal deck repair detail.

4) Because the true extent of concrete deterioration at the slab soffit could not be determined until the areas of corroded metal deck were removed during the renovation phase, it was necessary to develop the base bid repair details under

the assumption that the full depth of concrete slab would have to be demolished and replaced. Similar to the fulldepth surface repairs above, this also meant that the base bid repairs for the metal deck had to extend from supporting beam to supporting beam. However, in cases where the exposed concrete slab soffit had not actually deteriorated, an alternate detail allowed for just the remediation of the deck deterioration in lieu of a full-depth slab repair.

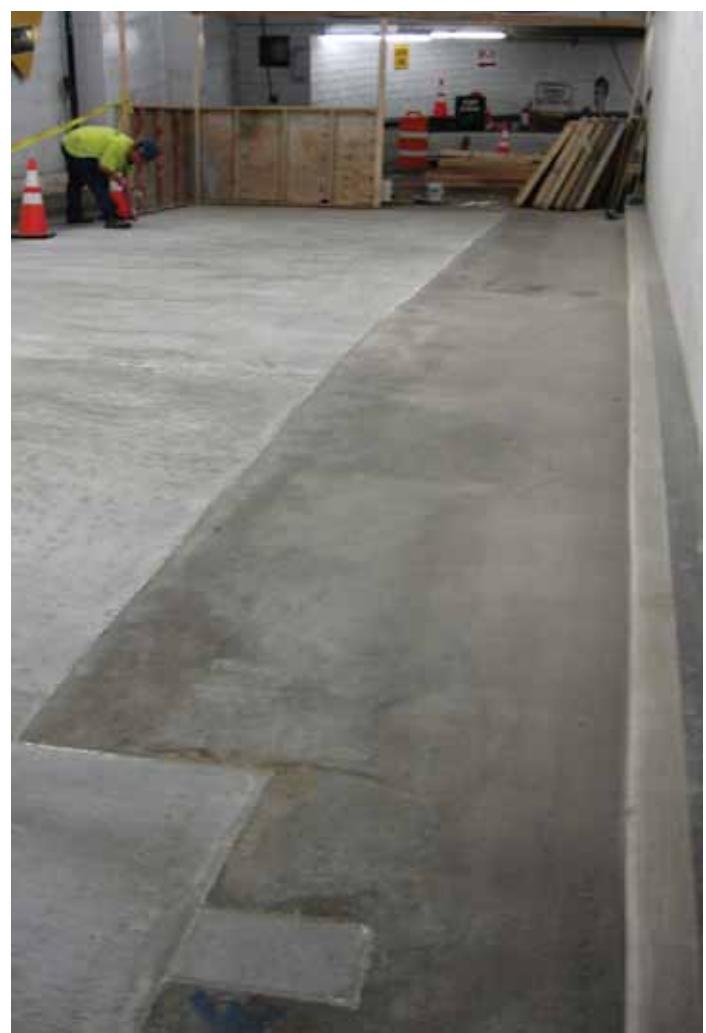
Completed Surface Repair.
