# How to “Right” the Yankee Craftsman Barn

## Cabled Tension System Returns Barn to Stable Vertical Position

By: Craig E. Barnes, PE, SE

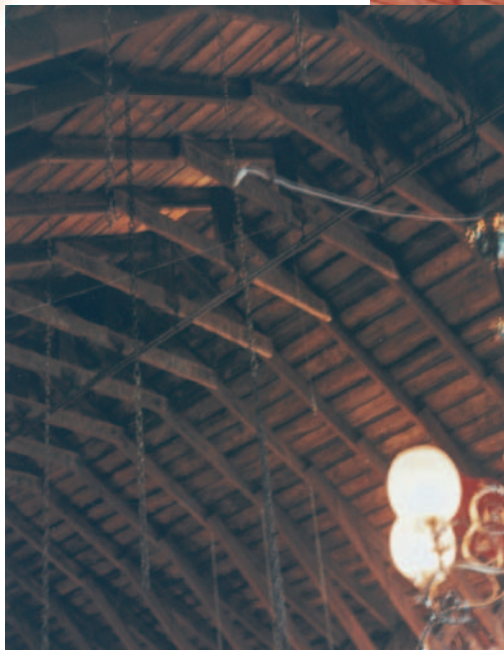
*Roof interior*

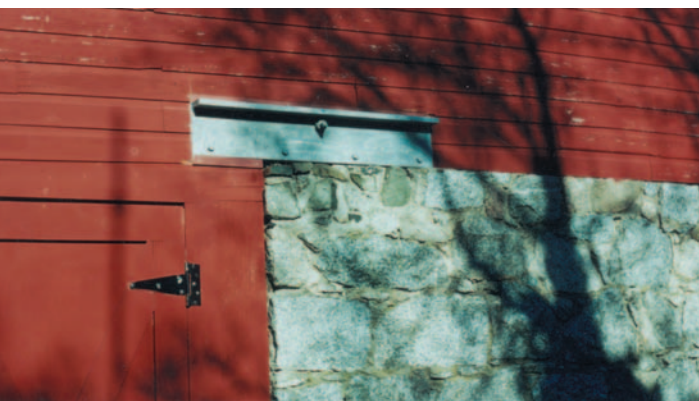
*Load distribution angle at first floor*

2. Loads from the cables would be distributed to the wood structure by the use of channels and angles.

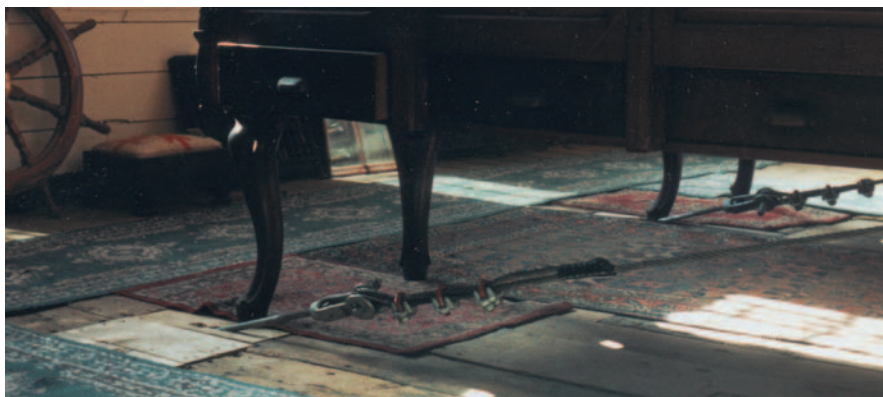
*Cables passing through floor*

1. It seemed reasonable to attempt the use of cables as the most efficient system to impart load to the structure. Cables by their very nature would impart load in one direction only. This could be done by bringing loads from the eave line diagonally back through the building. Cables were arranged to go from the eave line diagonally through the building to a line of stiffened elements of the first floor framing.

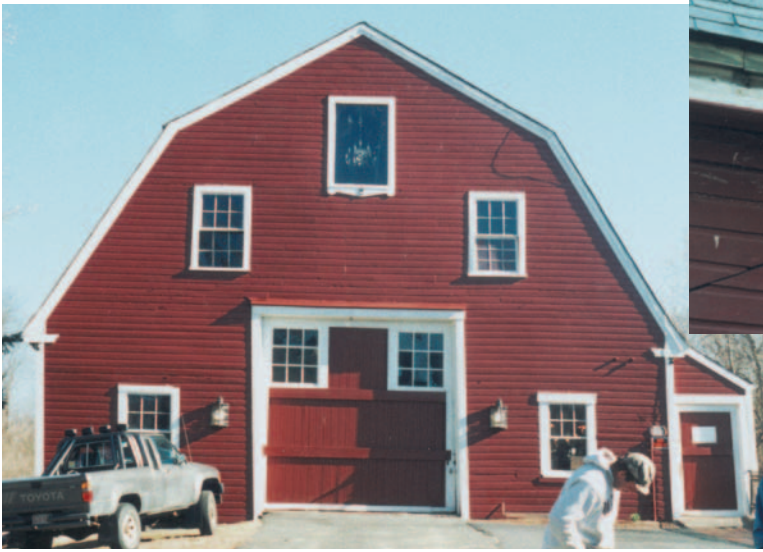
*Front elevation at completion of "righting"*

With everything in place, the tensioning started and the rest is history. Over a period of five years, the structure was "righted". Not unexpectedly, tensioning over time revealed the stiffness differences of the structure. This required slight adjustment to the sequence

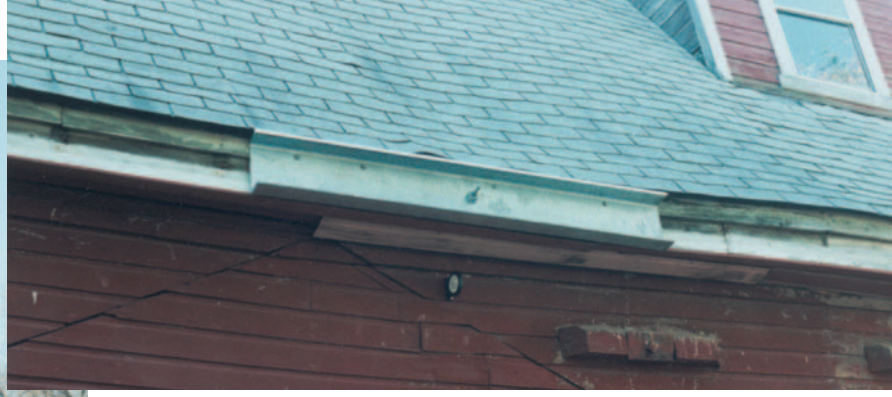
*Stiffening channel at Eave 1*

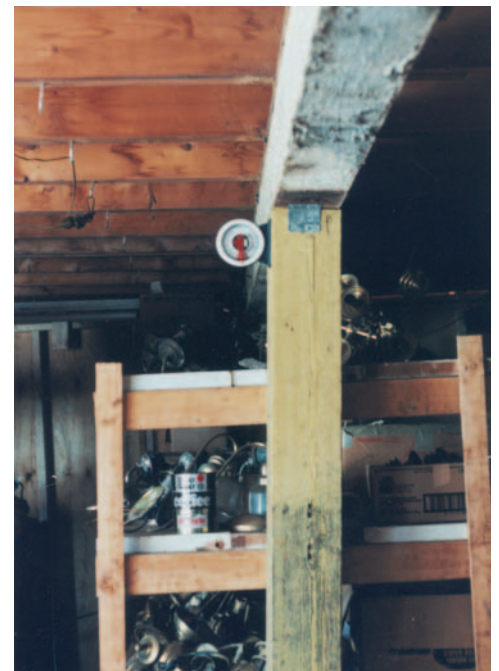
*Inclinometer on wood column*

5. In order to track the movement of the structure through the periodic tensioning process, measurement points were established by dropping plumb bobs through various locations of the building, tied into the first floor level at the base. We were fairly confident that, once reinforced, the first floor framed structure would be relatively stable and could act as a baseline. Measurements were established to be able to track the building movements both in the north-south and in the east-west direction, and to be able to track the deformation of the roof structure. Additionally, inclinometers were placed on posts within the structure beneath the first floor level to track column tilt. The inclinometers would be helpful in determining whether or not the concept of the first floor base being a permanent benchmark was indeed accurate.

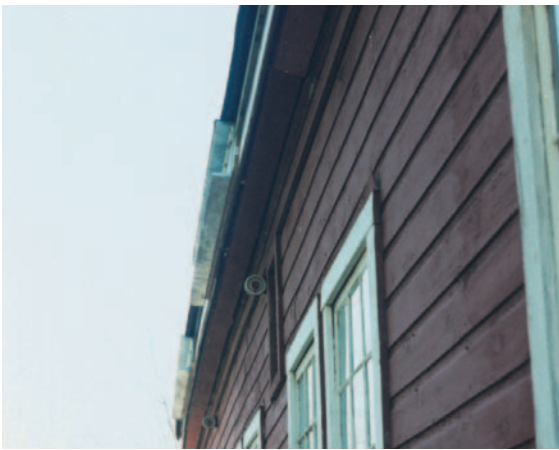
**Stiffening channel at Eave 2**
