By Steven E. Schaefer, P.E.

## Restoring the Sharon Woods Stone Arch Bridge

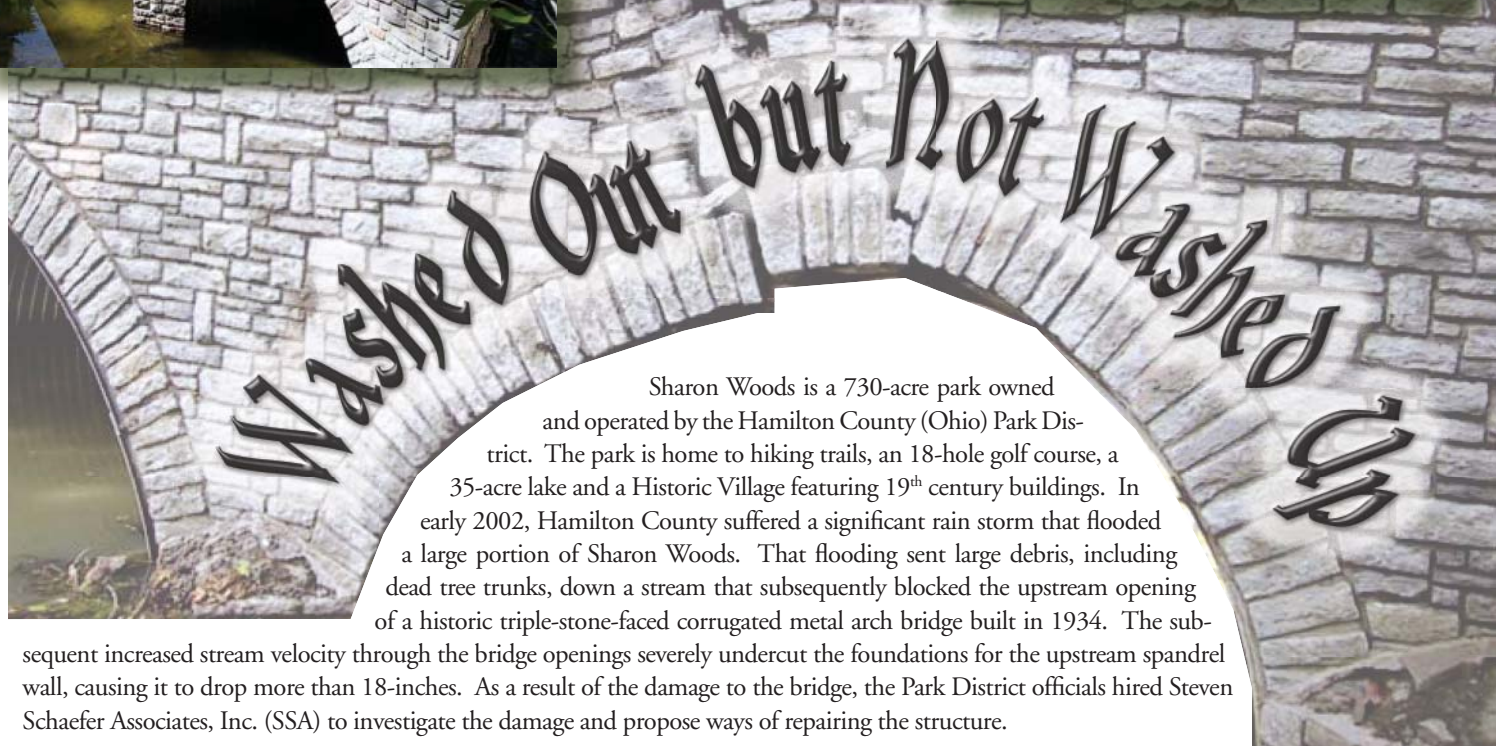
cifically the downstream spandrel wall, and reconstructing the rest of the bridge to match the original. “Prior to this unprecedented flash flood, the bridge was in good sound condition” notes Kevin Brill, Project Manager for the Park District, “but we had to make immediate remedial repairs to protect it from further damage while we were considering options to repair the bridge.” (See *Diagram 1* for details of the bracing)

The final plans called for demolishing all of the existing bridge except the downstream spandrel wall and the two abutments. A series of steel buttresses anchored to drilled concrete piers acted as temporary bracing for the down-

stream wall during construction. In addition, SSA required that all arch stones salvaged from the upstream wall be marked and stored to allow for reconstruction of the arches in the same configuration and location as the original. The remaining face stones were stored for reuse to keep the original patina on the exterior face of the bridge.

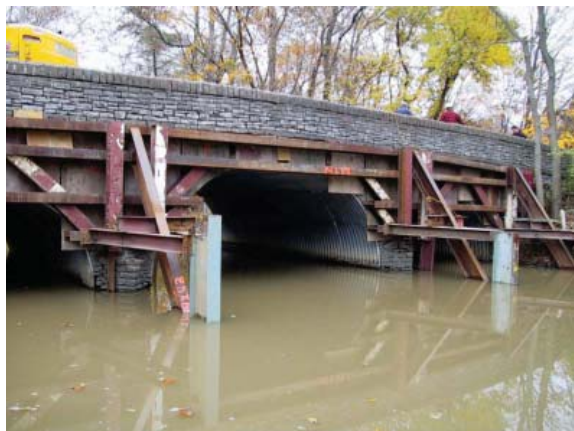
Prior to working on the foundation, the contractor needed an effective upstream dewatering operation to keep water levels low in the work areas. Sunesis Construction, the bridge contractor, could not have excavated for the grade beams without dewatering first. Sunesis devised a method for managing the stream water flow during the foundation excavations by digging and constructing a 15-foot deep well in the stream bed upstream of the bridge utilizing a circular steel multi-plate shoring system and backfilling with gravel. They diverted the stream flow to the well, and used a high capacity portable pump to pipe the water past the bridge to outlet downstream. Even with this, water contained

within the surrounding ground flowed out from under the abutments when the underpinning haunches were excavated, causing great difficulties for the men who were hand excavating this area.
