Portland Cement Cast Stone Veneers

An Overview of Practical Detailing Issues

By Dave MacGregor, P.E. and Edward Schwieter, P.E.

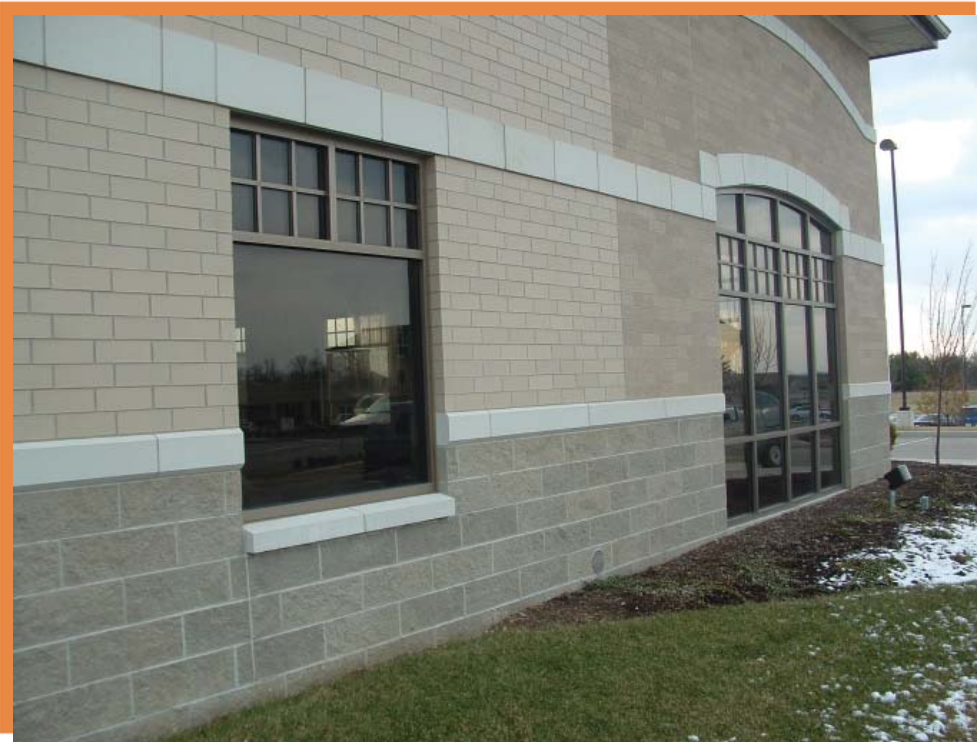
This building has a wainscot of six courses of 8 x 24-inch cast stone, 8-inch high accent bands at the top of the wainscot and near the top of the wall, and a 12-inch high accent band above the windows. A control joint was installed below the window after cracks appeared at a number of windows. It should be noted that nearly all of the head joints in the accent band over the window have hairline cracks, but they were not noticed by the Owner.

It is important to space vertical control joints in cast stone wainscots at distances no greater than 1.5 times the wainscot height (not the combined wainscot and brick veneer height), at window corners projecting into the wainscot, and at changes in the wainscot height. We have found that cracks in wainscots are noticeable because they tend to be fairly wide due to stress accumulation and because they are at the base of the building where they are easily seen. It is not necessary to extend closely spaced wainscot control joints into brick veneer, but all brick veneer control joints should be extended into the cast stone.
