Failure Trends

Studying Typical Patterns in Building Failures

By M. Kevin Parfitt, P.E.

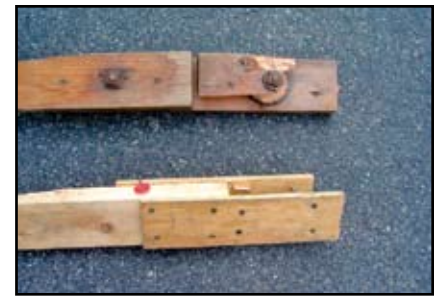
Figure 2: Comparison of original truss connection to improperly modified truss bottom chord and splice that utilized drywall screws.

ual trusses to accommodate space changes to the building due to the operational and occupancy needs of the owner. An example of this is shown in Figure 2, where an older truss had the bottom chord cut out and later spliced in order to accommodate what was believed to be the installation of some manufacturing equipment or a change in ceiling configuration. Note that the modified truss chord shown in the bottom of the photograph was improperly repaired using only short drywall screws and a plywood gusset plate. Compare the plywood connection to the much more robust original split-ring connector shown at the top of the photograph.

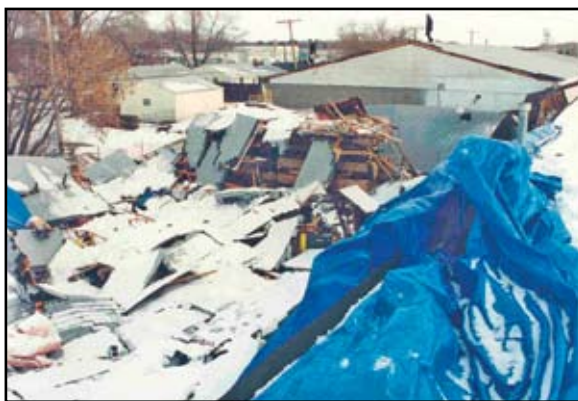
Figure 1: This building roof collapse resulted from a procedural failure in the construction and inspection of permanent bracing, despite the presence of manufacturer-installed red tags shown in the photograph on the right.

Many collapses related to this type of truss system are not from improper design, but from a lack of recognition and understanding concerning the importance of both permanent and erection bracing. Errors in the type, installation, and location of erection bracing, particularly for longer spans, is one of the most frequent causes of wood truss failures. One example is the collapse of a warehouse/manufacturing facility after a modest snow event in the northeast United States. As can be seen in the photograph in Figure 1, even though factory-installed red tags were attached to the metal plate wood trusses at the required permanent bracing locations, most of the bracing was never installed or was discontinuous.

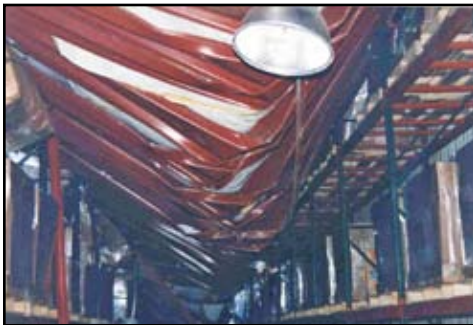
Figure 4: Rows of closely spaced Z purlins intended to carry the roof snow drift load rolled and buckled due to a lack of proper bracing as a result of a substantial number of missing purlin-to-roof connector clips

metal buildings, this is often accomplished by adding intermediate cold-formed Z purlins between the existing roof purlins. This solution is difficult to implement economically, since the Z purlins are highly dependent on the roof decking for proper bracing in order to develop the intended capacity. A typical condition of this type, which resulted in a partial roof collapse, consisted of purlins that were sized smaller in depth than the original ones in order to make it easier to install the new purlins between the existing support framing and the existing roof decking and insulation blanket; however, these same purlins were not attached to the roof decking and were only nominally braced to the original purlins.

erector left them out entirely on many purlins, resulting in an irregular pattern of bracing every second or third purlin or intermittent bracing along the length of the purlin, depending on the location. This condition was the primary contributor to the roof collapse, which is shown in Figure 4.
