# REPAIR OF A LEANING □ TIMBER STEEPLE - AMEN!

By Daniel Proper, P.E. and Melissa O'Leary, EIT

The Presbyterian Church of Catskill NY was constructed in the early 1840s. The building consists of a timber framed structure with a rubble foundation. In the early 1900s, the building was significantly modified with the addition of a 54-foot timber framed steeple and a Greek revival porch. Since that time, very little modifications have been performed on the church, beyond general maintenance (Figure 1).

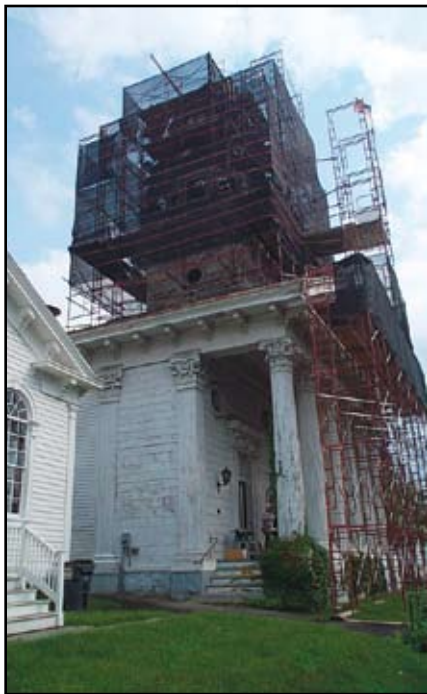
Figure 1: Front façade of church, steeple surrounded with scaffolding.

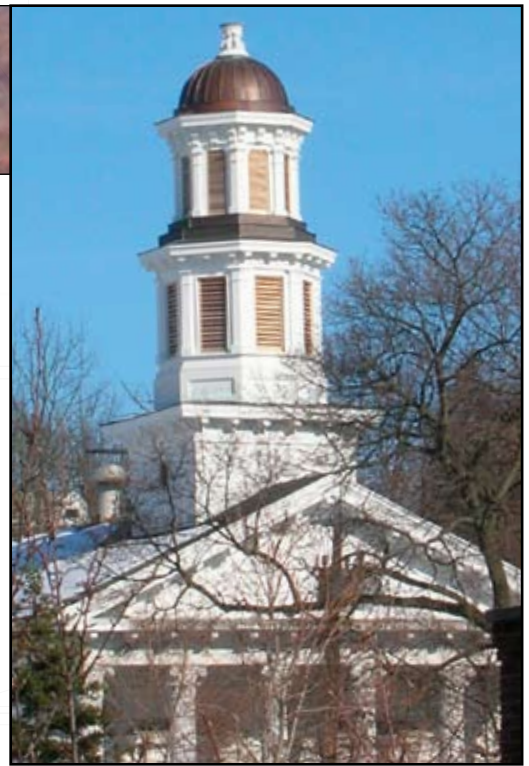
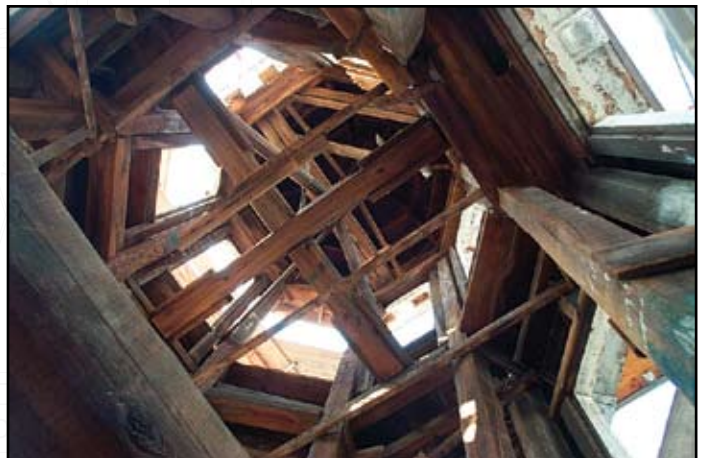
configuration of the steeple and its supporting members, starting from the top and following the load path down to the foundation. Access to the steeple was obtained from exterior scaffolding, which was erected to aid in the inspection process as well as allow repair and replacement of the exterior decorative trim (Figure 2).

Figure 2: View of steeple framing looking up from level 3, prior to reinforcement.

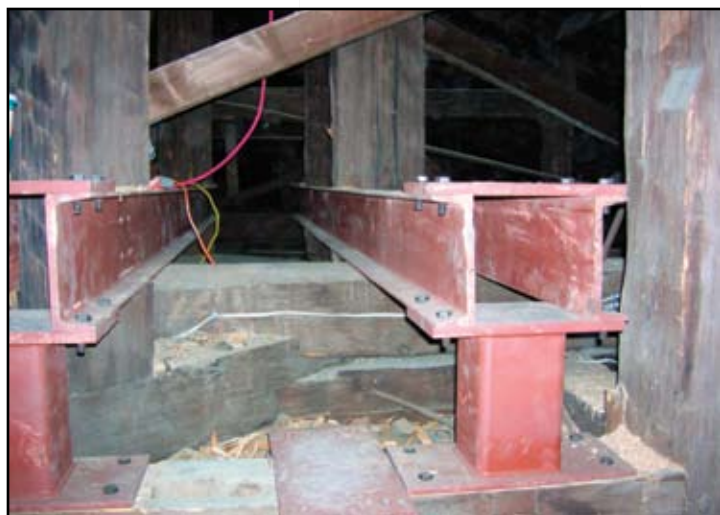
Figure 3: New transverse steel channels bearing on bottom chord of gable trusses, and sandwiching the bottom support columns of the steeple, final bolting not installed.

The sagging transverse beams at the attic level were abandoned in place and circumvented with steel channels, C8x18.75. The channels ran perpendicular to the main gable trusses in sets of two and bore on the bottom chord of the trusses. The channels, in turn, sandwiched the timber base columns of the steeple and were connected using thru bolts. To allow for adequate clearance, HSS stub columns were used to properly position the channels on top of the bottom chord (Figure 3).

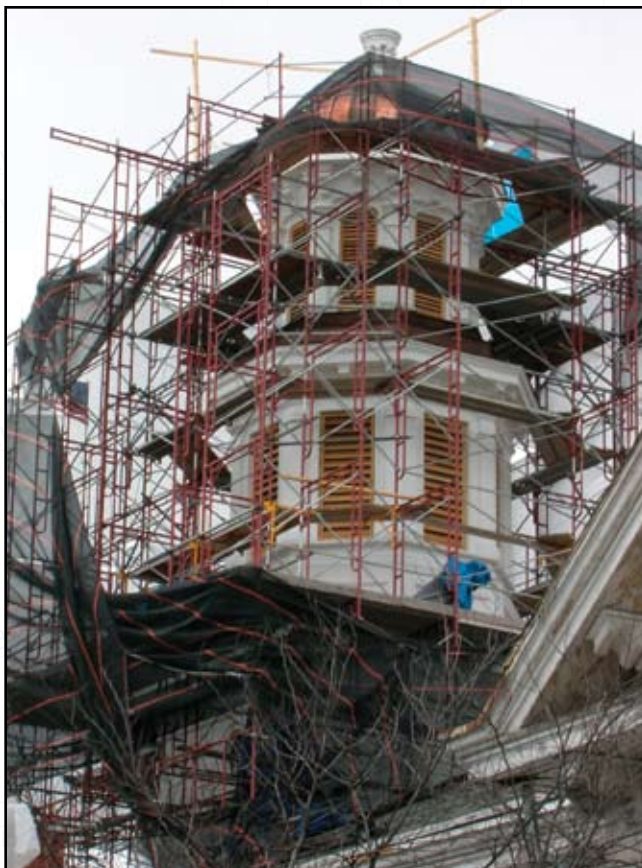
Figure 4: Section view thru centerline of steeple showing tension rod cross bracing, which was installed on four sides of steeple.

The bracing pattern was broken up into 5 panels of varying height (Figure 4). The nodal points coincided with the existing timber compression rings, consisting of 4-inch x 8-inch cross beams. However, two additional rings were added to reduce the slenderness ratio of the support columns. In addition, the added rings reduced the height to width ratio of the tension rods and aided in overcoming construction clearance concerns. The timber rings were reinforced with  $\frac{3}{16}$ -inch strapping anchored to the cross beams with  $\frac{1}{4}$ -inch lag bolts.

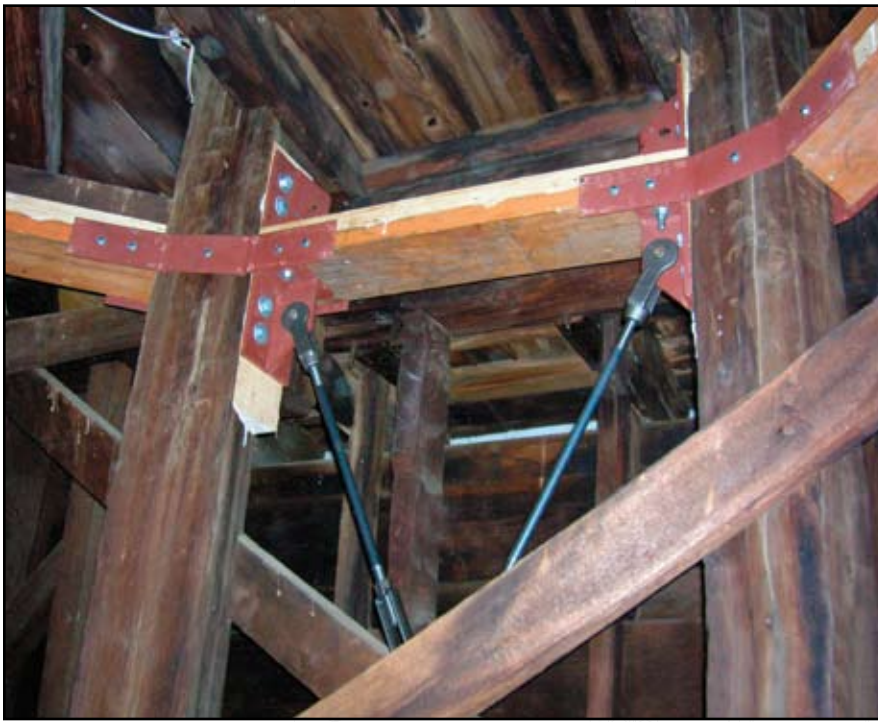
*Cross bracing installed at level 2, upper rods not installed.*
