11 Waverly Place, New York City

The Versatility of Structural Steel Allows for an Innovative Restoration Alternative

By Nissim Agassi, P.E., Scott Kamen, AIA, and Denise Keaveney
Co-authored by Ophir Agassi

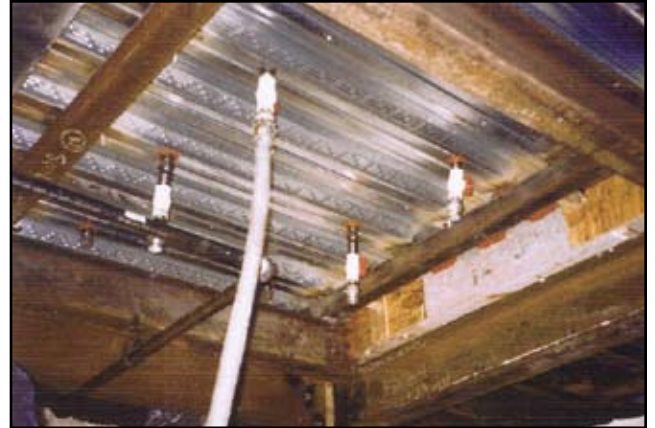
The space between the existing cinder concrete slab and a new metal deck is being grouted. The new deck with injection ports was installed on new sister beams, custom fitted and sealed.

Like the existing girders, the existing steel filler beams, supporting the roof slab, were left in place and not repaired at all. Instead, new sister beams were installed in each bay and were fitted with welded steel shelf angles. The angles supported a temporary metal deck placed against the bottom of the existing roof slab. This temporary deck served two functions: as a collapse protection platform during construction and as a stage on which the existing cinder concrete slab was to be demolished. Once the deteriorated roof slab was demolished, the temporary deck was removed and a new permanent metal deck was installed on top of the sister beams, avoiding 3 inches of concrete dead load in the new roof.

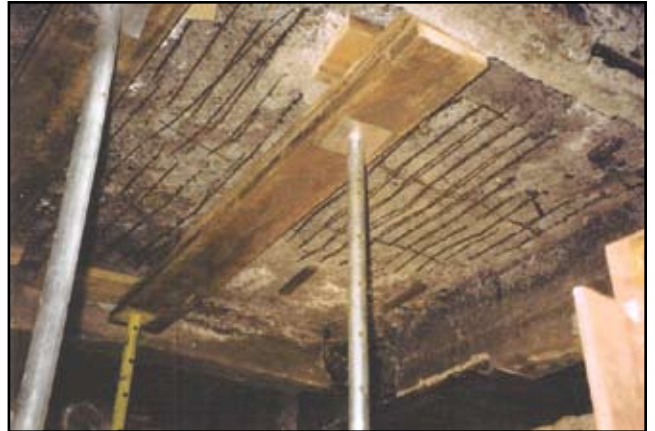
Temporary shoring of the near collapsing cinder concrete slab.

probe were widespread. Water damage over the years had caused severe corrosion of the structural steel and reinforcing bars, and non-reversible deterioration of the cinder concrete slab over the entire roof area. When coring of the deteriorated slab was attempted, it simply crumbled, indicating little strength to support itself and other rooftop loading.

The first response to these discoveries was to address the safety of the building occupants. The flimsy 1-inch stucco ceiling that was hanging from the deteriorated roof slab was the only barrier between the falling concrete debris and the occupants of the 12th floor. This was truly a disaster waiting to happen. With the owner's complete cooperation, the entire 12th floor and the penthouse were vacated to avoid tragedy. To protect the occupants of the 11th floor, the owner, at the designers' recommendation, engaged Brisk Waterproofing Company to remove the stucco ceiling and temporarily shore the deteriorated roof slab as each 12th floor apartment became vacant.

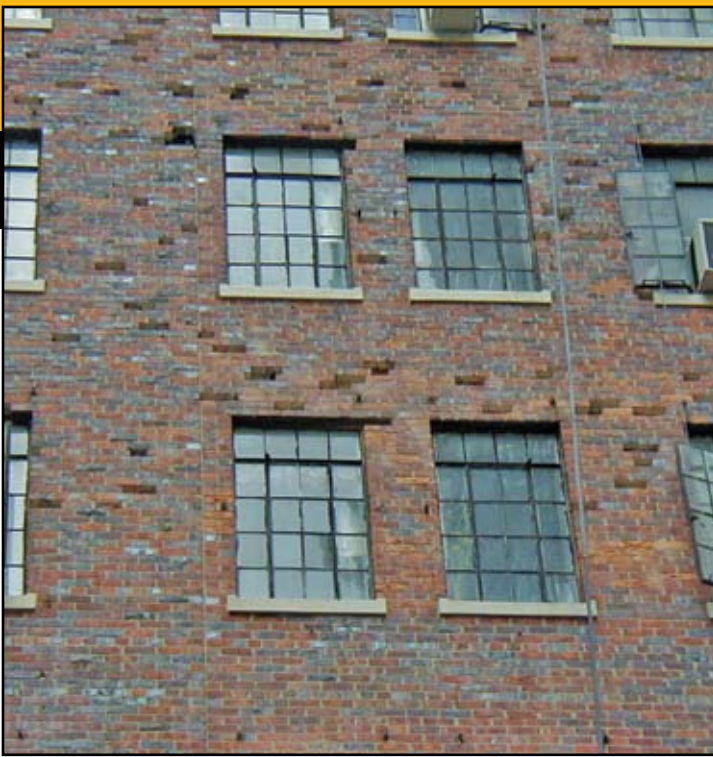
“Toothing” out of the exfoliated salmon (orange) face brick.

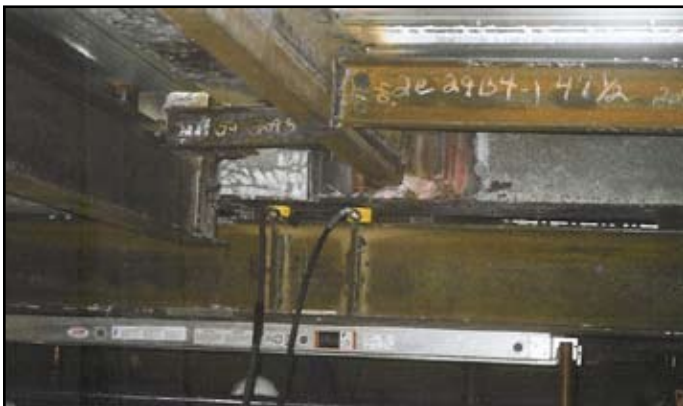
The existing concrete encased girder (top) being jacked against the new (lower) girder. Two calibrated jacks were used at each jacking location to permit the installation of a permanent bearing plate between them.

would undergo relatively large deflections but function suitably as a stage against which the existing girders could be jacked and partially relieved of their load. The roof slab stiffness would be maintained by the coupled system of the existing and new girders acting in unison. Jacking and “freezing” the deformed position between the existing and new girders at specific jacking points, and locking-in a predetermined force through the insertion of calibrated bearing plates, served to permanently relieve the existing corroded girders of their excessive load and transfer this necessary load to the new support girders.

The unique jacking system had to be worked out in detail, and required careful calibration of forces and deflections at each jacking location coupled with proper sequencing. A simultaneous jacking of all interconnected girders was necessary to ensure that induced deflections did not cause permitted loads to be exceeded in any girder.

In the end, the approach of jacking and relieving the loads from the existing girders permanently increased the overall load-carrying capacity of the roof structural system, and entirely eliminated the need to reinforce the corroded steel girders.

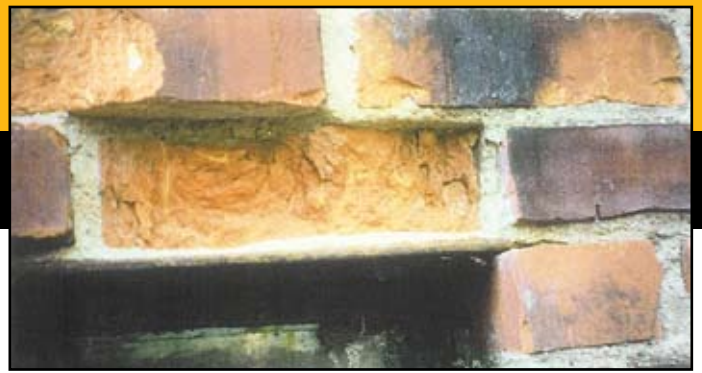
Close up of a typical exfoliated salmon face brick.

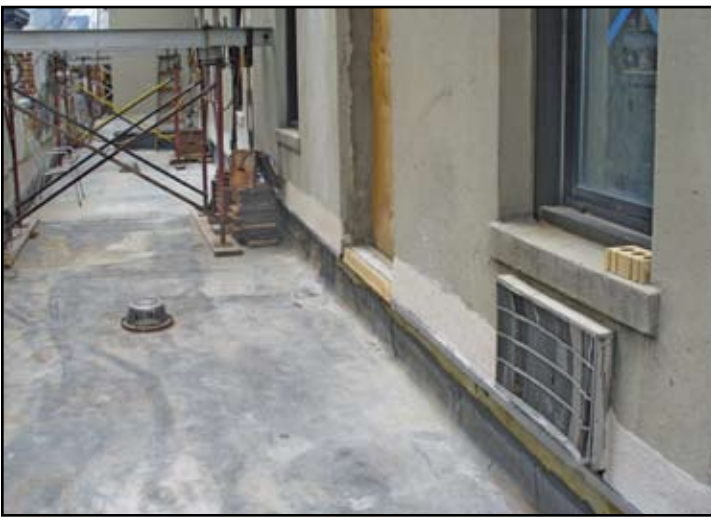
Temporary loose rubber roofing & flashing were installed & new drains added.

While the process of demolition and replacement of the roof slab took place from above, the need for tenting was entirely eliminated and the building was kept watertight by a temporary loosely-laid rubber membrane that utilized new permanent drains previously installed at the main roof. The temporary rubber roofing system was rolled open in the morning and closed at the end of each workday.

This membrane was installed in sections immediately following the removal of the existing roofing and cinder fill, and remained in place until the new permanent waterproofing system could be installed.

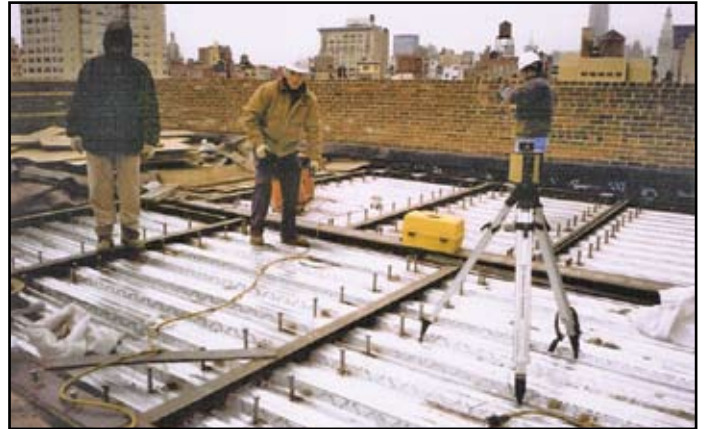
The new permanent metal deck and existing steel before pumping new concrete. The existing steel was cleaned and left in place. After removal of the existing slab, the temporary deck was removed and a new permanent deck (shown) was installed on new sister beams that are below the lines of the shear studs.

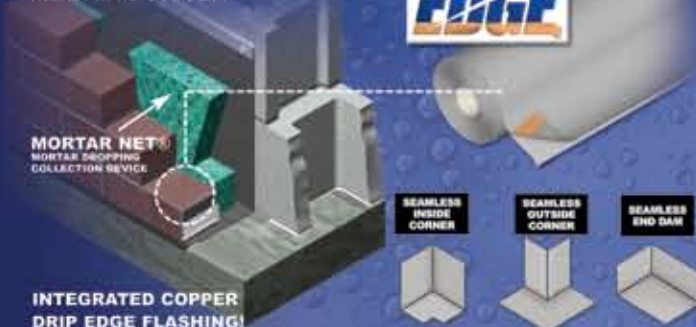
HOHMANN & BARNARD'S FLEX-FLASH® EDGE FLASHING SYSTEM

INTEGRATED COPPER DRIP EDGE FLASHING

MEMBRANE FLASHING MATERIALS ARE TYPICALLY TOO RESILIENT TO BEND INTO A LASTING DRIP EDGE WHEN PROJECTING BEYOND THE FACE OF THE WALL. H&B SOLVES THIS PROBLEM BY EMBEDDING A NARROW COPPER STRIP INTO THE EDGE OF FLEX-FLASH FLASHING. FLEX-FLASH® EDGE CAN THEN BE EASILY FORMED ON SITE INTO A TYPICAL 3/8" - 1/2" DRIP EDGE THAT WILL ENDURE.
