FAITHFUL PRESERVATION – ANOTHER 100 YEARS

OLD FAITHFUL INN RENOVATION – YELLOWSTONE NATIONAL PARK

By Thomas Beaudette, P.E. and Janna Moser, P.E.

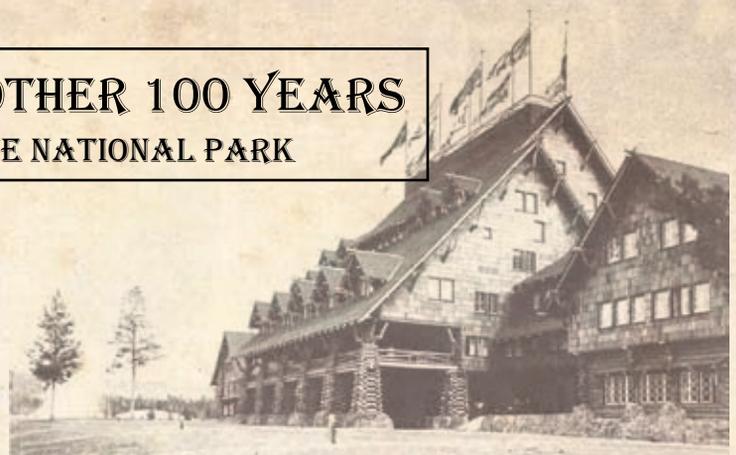
View from the northwest – undated, circa 1904. Courtesy of NPS Archives and A&E Architects.

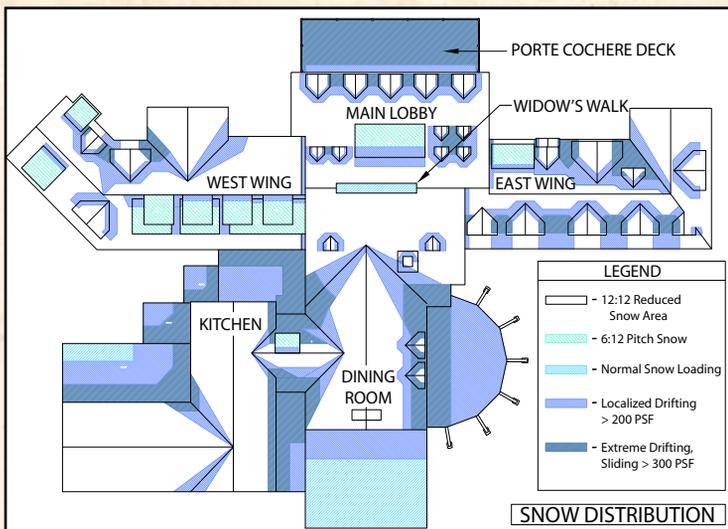
Roof snow load contours used for structural analysis.

The NPS-adopted design code for this project is the 2001 *International Building Code* (IBC). The basic design snow load (p_f) for the roof is reduced for the 12:12 pitch, however, intersecting roofs of the wings, dining room, main dining room, and kitchen create many valleys and drifting areas. Further accentuating snow accumulation is Reamer's original design concept of clustering small gable and shed dormers on the north side of the main lobby roof and east and west wings. The immediately adjacent dormers funnel snow to concentrate, back-up, and exert very large forces on the dormer roofs. The east wing dormers have been ripped from the main roof several times over the Inn's history.

Sliding snow from the steep pitched roofs causes serious snow accumulation on adjacent flat roof additions in the employee dining area, the Bear Pit Lounge, and the entry porte-cochere. These areas are designated for design snow loads in excess of 300 psf. All roofs have supplemental sheathing applied, and dormers were reattached throughout. The lobby and dining room roofs have new steel beams installed within existing structure depth, providing challenging constraints and unique details along with interesting working conditions at 12:12 pitches and extreme weather situations.

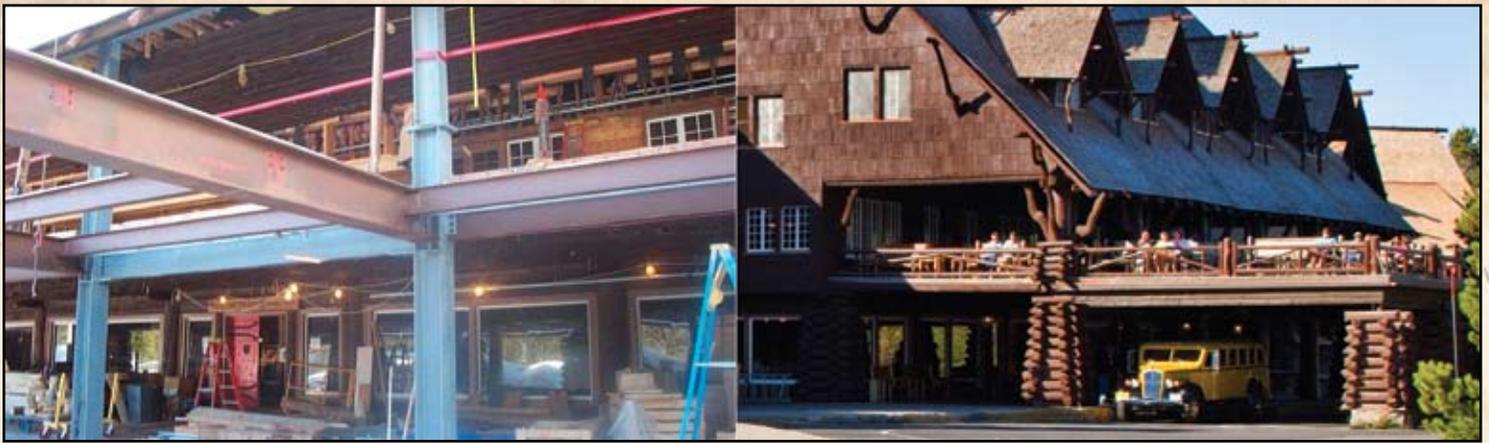
Before and after photo of north side steel framing ultimately covered with logwork. Courtesy of JK Lawrence Photography and A&E Architects.

The existing gnarled knee braces are woefully inadequate to resist the high seismic loads. A combination of methods was implemented to solve this inadequacy. First, the roof and floor diaphragms were upgraded with additional structural sheathing. Second, the log walls were replaced in areas previously noted, and all walls were reinforced with structural pinning. Next, wood sheathed shear walls were added in strategic locations. Finally, in certain areas, structural steel moment frames were installed and buried in log beams and columns to withstand the more extreme lateral loads.

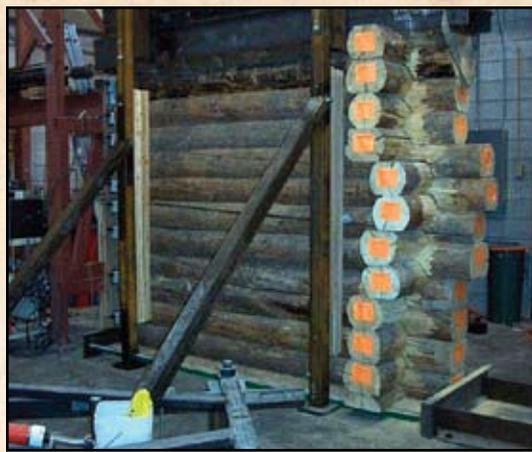
In-Plane log wall shear test at Montana State University.

Load testing was done at Montana State University to analyze the lateral capabilities of existing and upgraded log wall interfaces. Supplemental pinning was strategically installed to hide their presence by placements out of typical viewing lines, as well as artistic disguise to make the pins appear to be knots. At upper levels, existing interior framed walls designated as shear walls were retrofitted with light gage steel braces. The reason for this retrofit is to preserve certain architectural details like jamb thicknesses. The tall end walls of the lobby were significantly stiffened with a combination of Laminated Veneer Lumber (LVL) studs, steel T-beams, and structural plywood for both in-plane and out-of-plane lateral forces.
