# A COLD NIGHT IN GEORGIA

Renovation of the First Baptist Church of Atlanta

By Nebil Sedki, P.E.

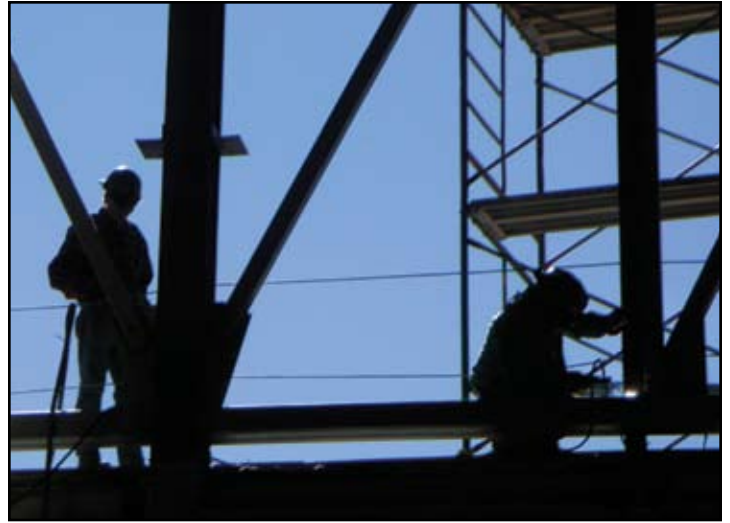
Close-up of the members of the new truss.

The difference between the low roof and high roof is 17 feet 2 inches. Instead of adding transfer girders to remove the columns, the design team introduced a truss between the two roofs, using the existing posts as the vertical web members. Then the design team added diagonal members between the vertical posts and a top and bottom chord, which were two steel tubes – one at each side of the vertical posts.

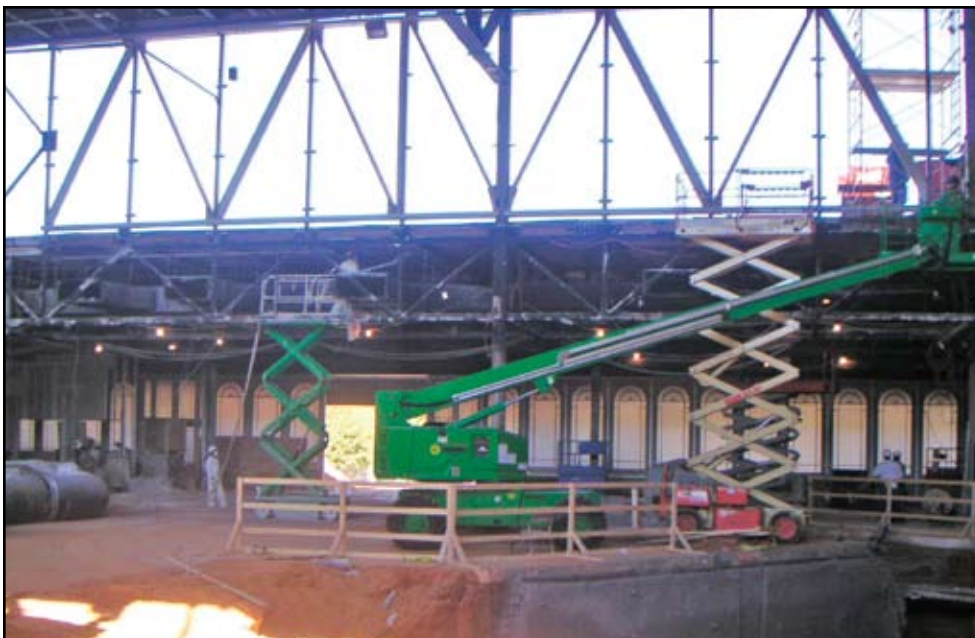
The new truss that was added between the low roof and the high roof, using the existing post as part of the truss.

This approach avoided causing major disruption of the existing finishes. The load was transferred to one column 30 feet away from the existing column; however, there was no place to locate a column at the other end without creating the same problem. Since the first column was supported by two columns 7 feet 6 inches away from the other trusses, the first truss was used to cantilever out to pick up the other trusses.

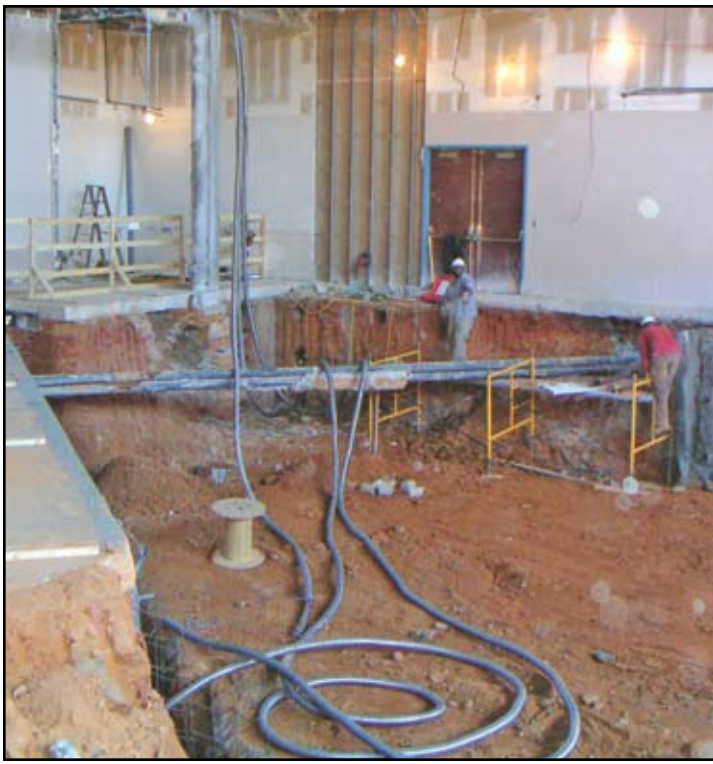
*The excavation of the orchestra pit.*

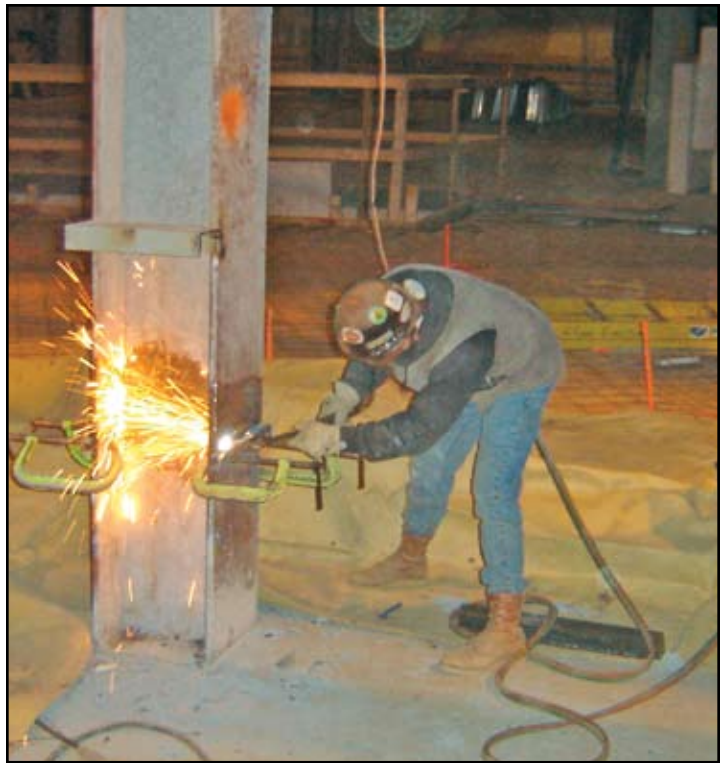
*The actual cutting of the load-bearing columns, one carrying over 320,000 pounds.*

The first step was to saw cut the column to be removed just above the ground floor. Then the crew started to jack up the steel beam from the new truss until there was daylight at the saw cut location.

And when they saw this daylight (actually nightlight), the crowd roared – the load had transferred to the truss. Shims were then added between the beams and the truss, and everything was left “as is” for 48 hours to make sure that all of the connections were working and everything had been done correctly. Then the column was removed.

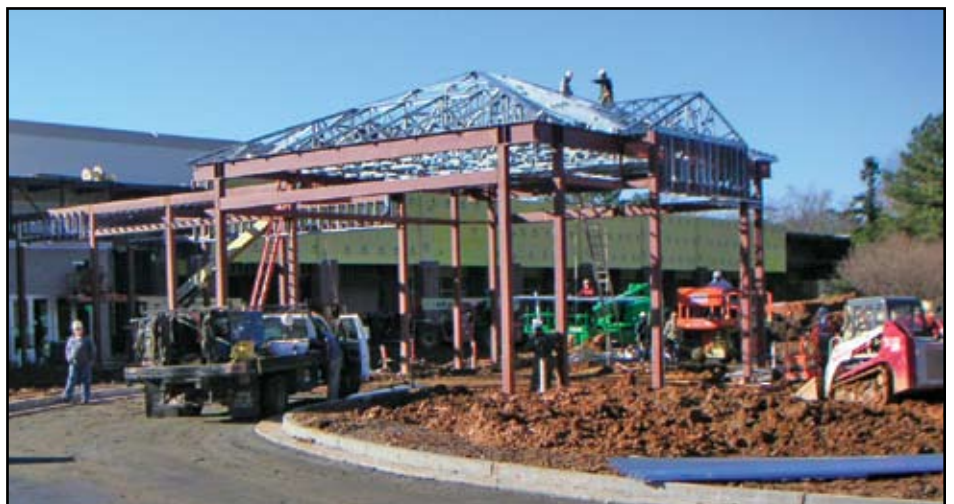
*The Port-o-Cochere in progress.*
