# Historic Renovation of the PROVO TABERNACLE

By Jeff Miller, S.E., Jesse Malan, S.E., and Julee Attig, CPSM

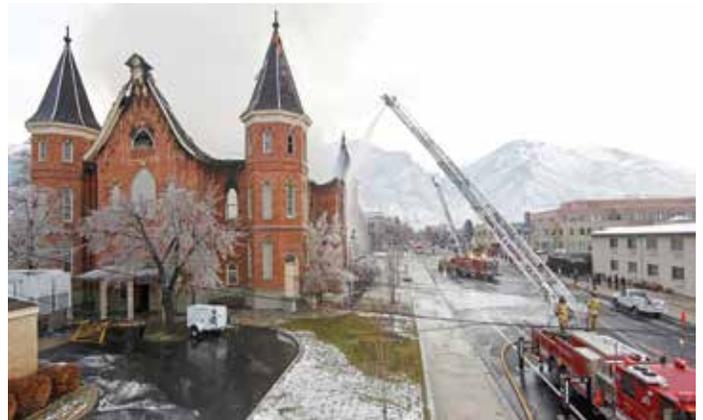
*Figure 1. Crews respond to Tabernacle fire.*

A four-alarm fire destroyed the building (*Figure 1*) in December 2010. The exterior was almost all that remained of the Tabernacle. Rather than demolish the structure, the owner enlisted a team of architects, engineers, builders, and historians to assist with an unprecedented reconstruction and restoration project. Reaveley Engineers + Associates (RE+A) was the structural engineering consultant.

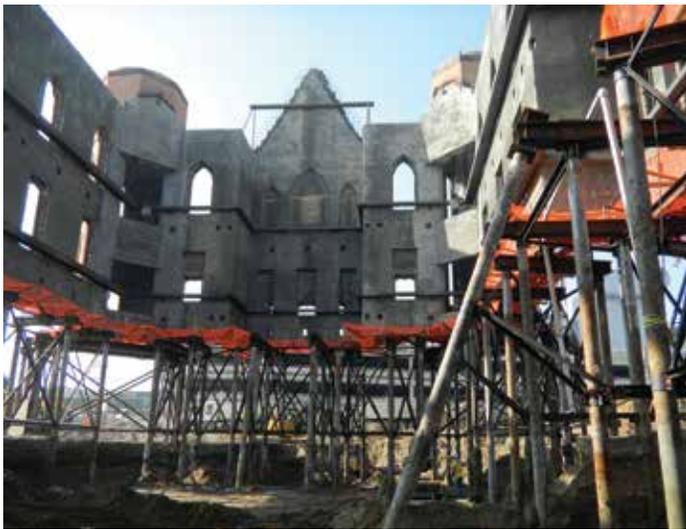
Figure 2. Shotcrete placed on interior face of the brick.

The original brick walls are anchored to new reinforced concrete shear walls by placing shotcrete against the interior surface of the brick (Figure 2). Two of the five interior wythes of brick (approximately 8 inches) were removed, and that space was replaced with shotcrete. Essentially, no floor space was lost. The remaining three wythes of brick were permanently anchored to the new shotcrete walls by installing 14-inch to 16-inch-long steel helical anchors into the brick.

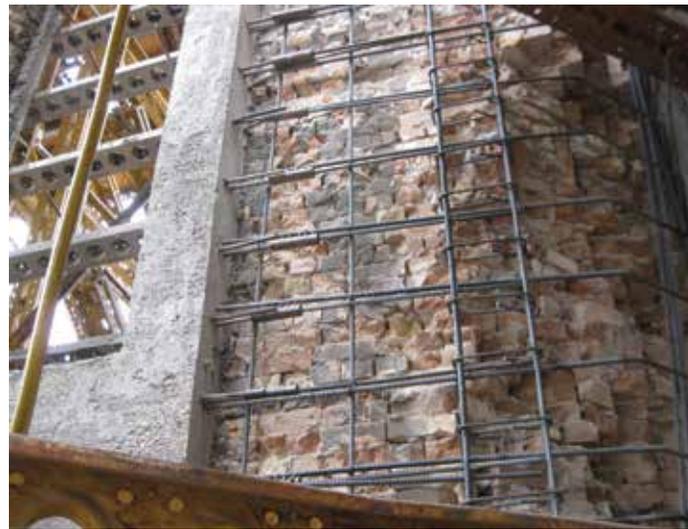
Figure 3. Care was taken with shotcrete placement around reinforcing steel.

Because of the reduced thickness, the quantity of reinforcing steel within the walls was greater than normal. Extra care was taken by the contractor to place the shotcrete in the walls while preventing voids behind and between the reinforcing steel. Enhanced inspections were conducted to maintain quality control of the shotcrete placement (Figure 3).

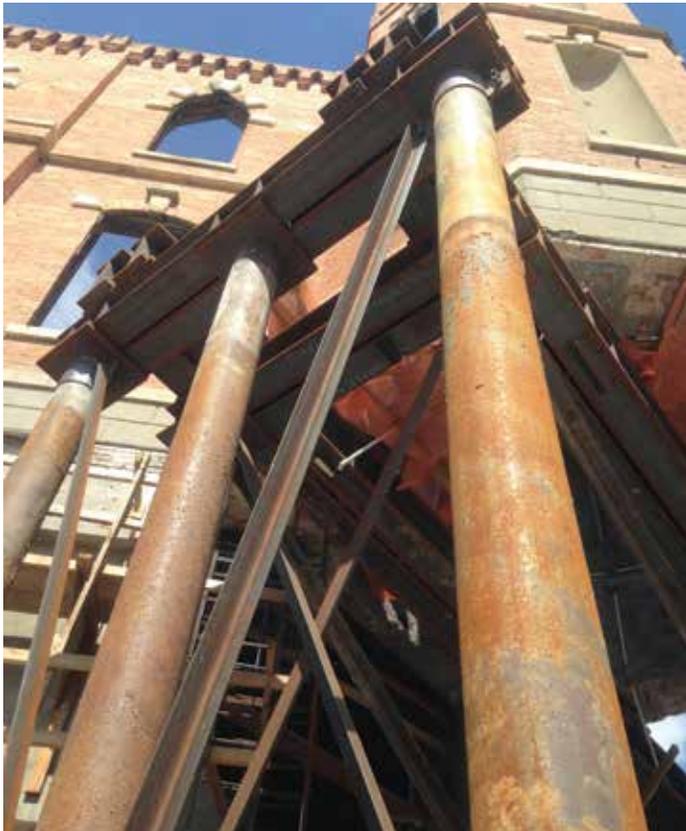
Figure 4. Steel needle beams connected to micro-piles.

A series of eight-inch diameter micro-piles were drilled into the ground, on each side of the walls, to a depth of about 90 feet. Some of the piles were battered to resist the temporary lateral loads on the shored walls during construction. Openings were then excavated through the rubble-stone foundation walls just below the brick and shotcrete walls. These openings were aligned between pairs of micro-piles. Steel needle beams were placed through the foundation wall openings and connected to the micro-piles (Figure 4, page 40).

Hydraulic jacks were placed between the needle beams and concrete bearing lugs formed into the bottom of the shotcrete walls. The jacks

were then loaded to transfer the weight of the walls above onto the needle beams and shoring system. The contractor closely monitored the elevation of the walls during this load transfer to ensure only very slight changes in the elevation.

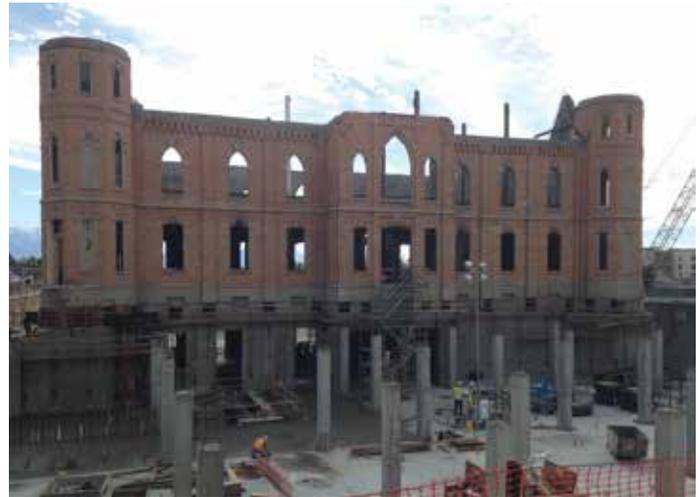
Figure 5. Block-outs in foundation walls.

After the new mat footing had been completed, new reinforced concrete foundation walls were constructed between the mat footing and the bottom of the brick walls. Block-outs were formed in the foundation walls around each of the shoring needle beams (Figure 5).

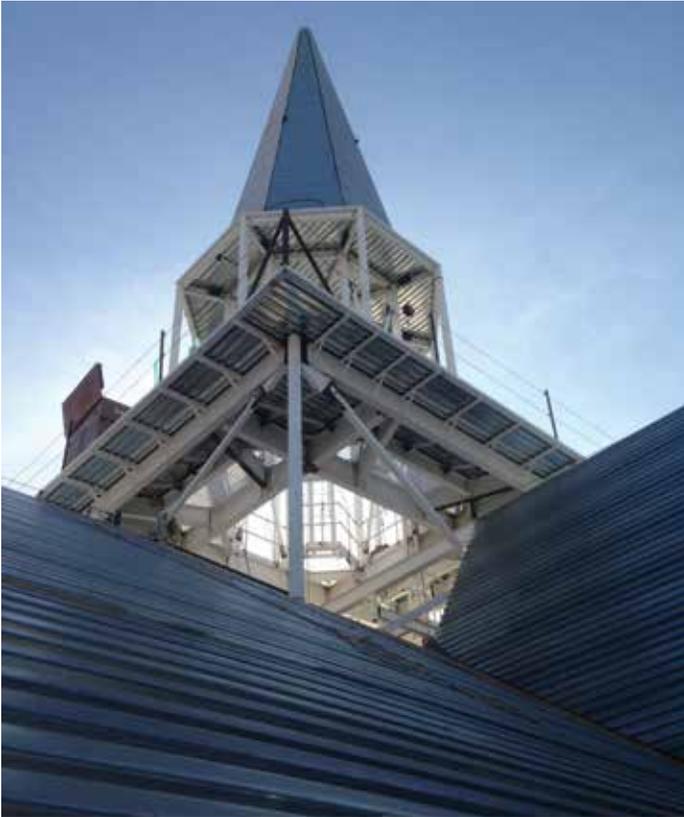
Figure 6. Restoration of center tower.

The structure was designed to support the weight and overturning forces imposed by a new center tower matching the pre-1917 original.

The restoration of this key architectural feature was of particular import to the owner (Figure 6).

Preserving and stabilizing the original brick walls was an initial focus. Also of intense interest was restoring the original central tower. In 1917, the tower was removed because its weight caused excessive deflections in the roof members. The new tower is laterally supported by steel braced frames which transfer forces to the shotcrete shear walls through the roof diaphragm and supplemental bracing. Natural light streaming through windows around the tower illuminate an art glass ceiling in the main upper lobby located directly below the tower.

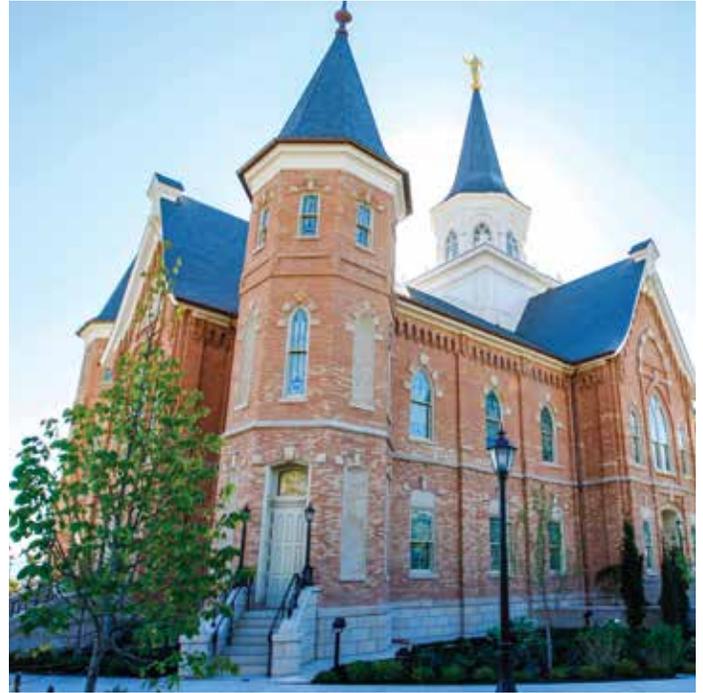
Figure 7. Wood-framed roofs at the four building corners.

Another significant architectural feature of the original Tabernacle was the wood-framed roofs of the octagonal stair towers at the four building corners (Figure 7). One stair was partially burned and damaged by the fire while the other three only suffered minor smoke damage. The tower roofs were each removed as a single piece, and the one damaged tower was rehabilitated and rebuilt to its original configuration. The original straight wood sheathing on the tower roofs was overlaid with new wood structural panel sheathing to stiffen and strengthen the roof structures. Connections between the base of the tower roofs and the walls below were improved to resist the required wind and earthquake loads.
