Treating Historic Masonry *Very Gently* at Drayton Hall

By Craig M. Bennett, Jr., P.E.

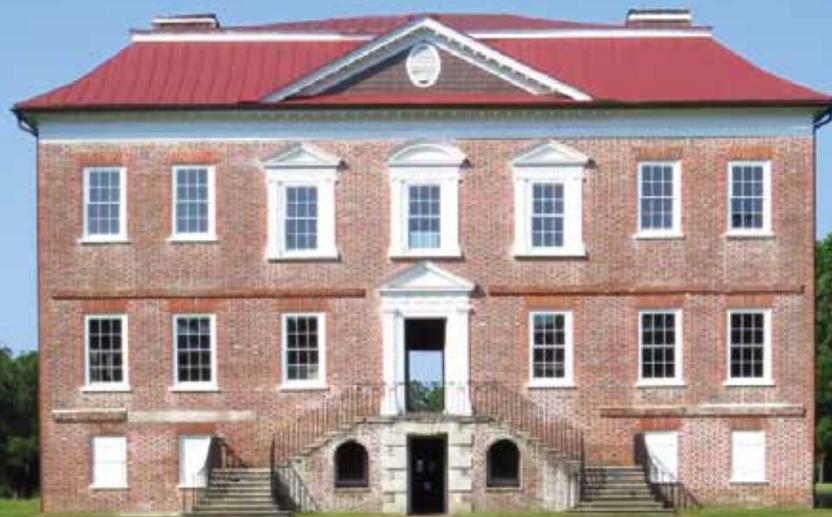
Figure 1. Drayton Hall.

Drayton Hall is considered one of the finest, if not the finest, example of Palladian architecture in America (Figure 1). This 1740s plantation house sits on the banks of the Ashley River, near Charleston, South Carolina. It is owned by the National Trust for Historic Preservation and is maintained in roughly the same condition in which it was received from the Drayton family in the 1970s.

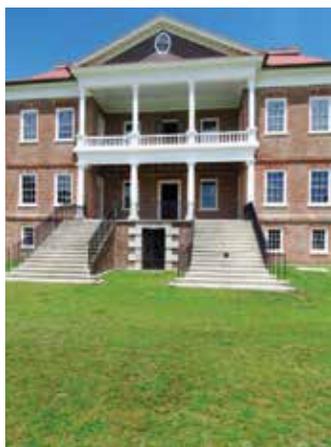
Figure 2. West Portico.

These two initial studies had several interesting findings. The study of the portico showed that the columns were segmental columns of whitewashed limestone masonry. At the second floor, those columns supported brownstone lintels which themselves

supported timber joists carrying a timber deck with a stone and concrete walking surface.

As with most historic structures, work on Drayton Hall began with careful study. The design team was first asked to study the west, or land side, portico of the building (Figure 2) and to determine how serious a problem the deteriorating 1920s concrete supporting the first floor of the portico was. Following that study, the team did a general structural study of the whole building, focusing strongly on the effects of visitorship on the structure.

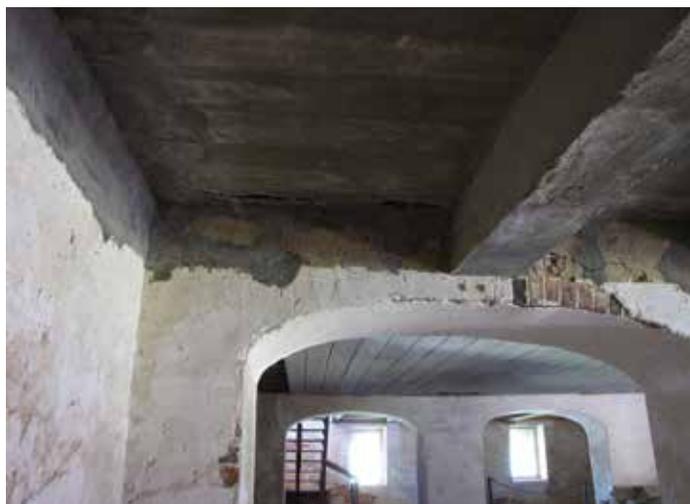
The first floor was much more interesting. The original timber structure had been replaced because of deterioration, once in timber and a second time, in the early 20th century, with a concrete beam and slab system supporting the brownstone and Portland stone pavers. Unfortunately, some of the concrete beams landed directly in the middle of the relatively flat 1740s brick masonry arches (Figure 3). To make matters worse, the early 20th-century reinforcing was corroding and destroying those same masonry arches.

Figure 3. 20th Century concrete damaging 1740s arches.

With the decision made that the 1920s concrete had to be removed, the question became, “What are the problems associated with doing so?” Further study of the portico indicated that the concrete slab, and even the beams, had been poured tight up under the stone columns. When determining how that could have been done without lifting the columns, it was ultimately concluded that the team did not want to know the answer to that question. Construction was significantly more risky in the early 20th century than it is today, and yet it had been done.

The decision—lift from the bottom, remove the concrete, rebuild the masonry, then insert a timber frame and deck to support a well-hidden modern drainage mat under the limestone and brownstone deck.

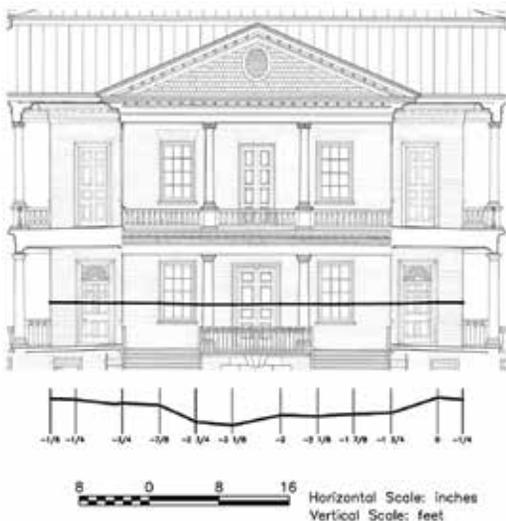
The study of the portico turned up a couple of other things that were relatively interesting. First, the brick piers that supported the arches appeared to have settled. Tracing the elevation of an original mortar joint on the wall above at the first floor showed that the columns beneath had settled just over 3 inches (Figure 4). This unquestionably indicated the need for both foundation investigation and load calculation.

Figure 4. Tracing a mortar joint to determine settlement.

out only half the width of a brick, or two inches, all the way around. Calculation of the loading on the soil indicated that the bearing stress was roughly 6300 pounds per square foot, in an area normally designed for about 1500 psf. And that was just the dead load! Adding full live load resulted in bearing stresses up to about 9,000 psf. Typically this would seem to be a cause for immediate action. However, one must remember that the columns had been in this condition for roughly 270 years. The conclusion was that the settlement should be carefully monitored but that no immediate action need be taken.

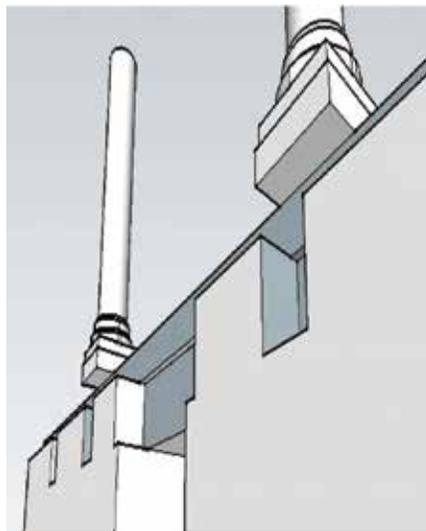
Figure 5. Questionable stability of the columns if the concrete were to be moved.

The task at hand was to determine a repair method. A simple 3D model of the structural system (Figure 5), without the concrete shown in place, indicated that removing the concrete would cause a tremendous stability issue. It was clear that the stone columns would have to be lifted, but lifting more than a couple of millimeters risked breaking the stone lintels above and destabilizing the second-floor columns as well. So how should one lift a house of stone cards (Figure 6)?

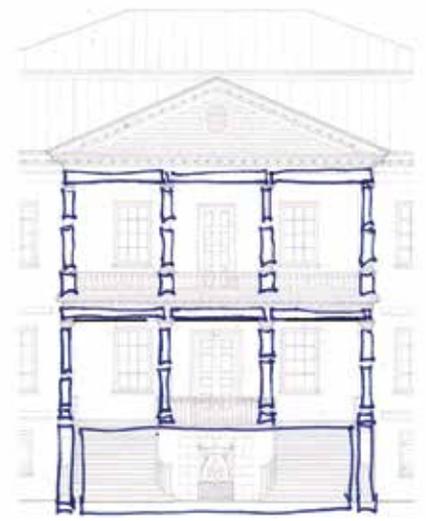
Figure 6. Segmental stone masonry – a potential house of cards.

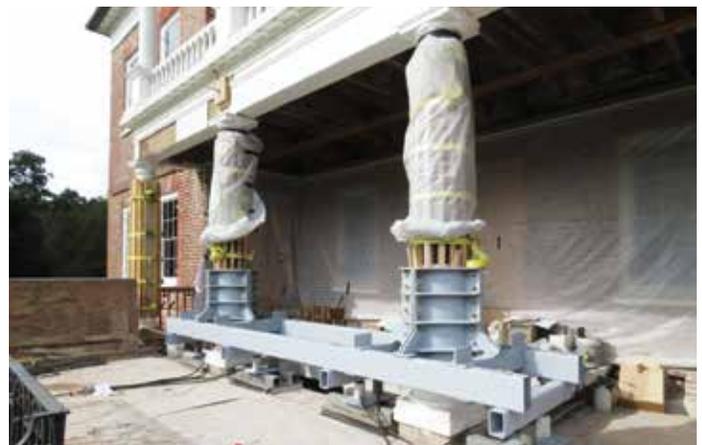
Figure 7. Lifting mechanism in place.

After reconstruction of the masonry wall on each side of the bases of the columns, the team was able to instrument the plinth blocks, then lift the columns, using the surrounding masonry (Figure 7, page 27) to get the load off of the masonry directly beneath the column bases. The first column was lifted 500 micrometers and the second only 200 micrometers. With the load off of the concrete, removal of the concrete beneath was easy, and reconstruction of the masonry under the bases proceeded (Figure 8).

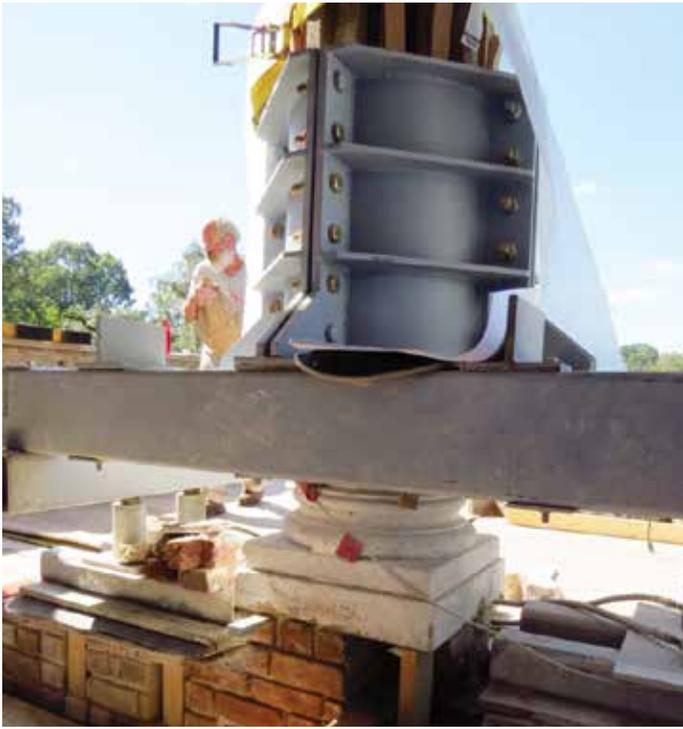
Figure 8. Freshly rebuilt masonry under a column base.

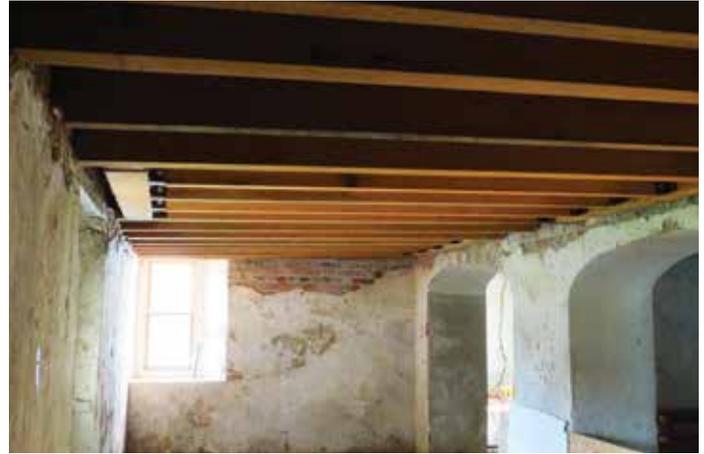
Figure 9. Timber joists taking loads to the sides of masonry arches.

The masons were able to build joist pockets into the masonry wall and line them with copper boots to receive the ends of the timber joists (Figure 9). The timber deck soon followed, as did all of the layers up to the stone pavers (Figure 10). The columns were lowered onto the cured masonry beneath their bases. The portico was ready for another hundred years.

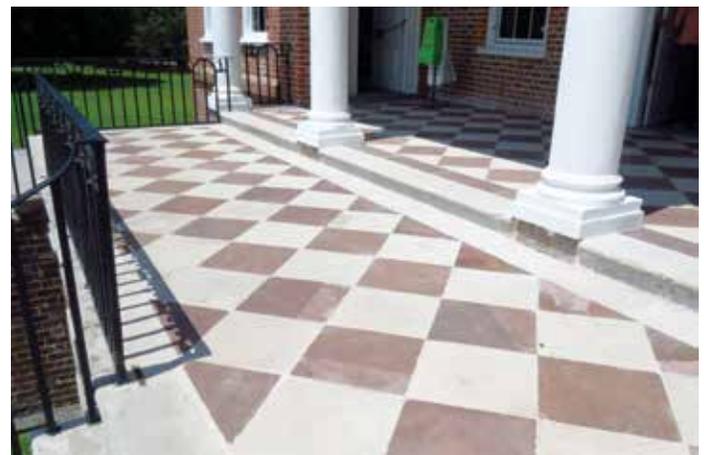
Figure 10. Rebuilt Portico floor.

- Remove the concrete under the columns and replace it with masonry;
- Lower the stone column back onto the rebuilt masonry; and,
- Install the timber joists, the deck, a waterproofing layer, a drainage mat and copper drains, a setting bed, a slip system, another setting bed, and finally the brownstone and Portland stone pavers.
