STRUCTURAL FAILURES

Failure of Imagination

By Stan Caldwell, P.E., SECB

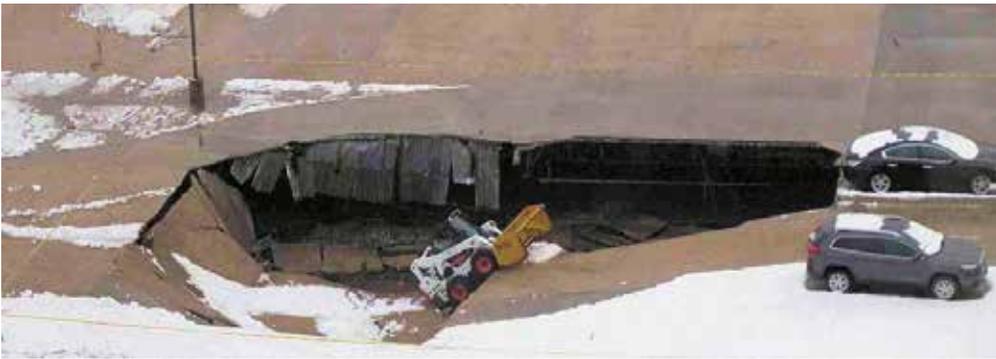
Failure caused by compacted snow pile, Secaucus, NJ.

A 3-level garage with 600 parking spaces serves the Harmon Plaza office tower, the Clarion Empire Meadowlands Hotel, and the Osprey Cove apartments. A Bobcat utility vehicle was plowing the top deck of the garage following a snowfall of 4 inches or less. The weight of the Bobcat was not a problem, nor was the weight of the accumulated snow. However, compacted snow weighs about 20 pcf, and 30 pcf or more if wet.

The snow had been pushed into a compacted pile. At 7:00 am, with the pile more than 4 feet high, the top deck of the garage collapsed under the combined weight of the snow pile and the Bobcat. The resulting opening swallowed the Bobcat and one vehicle parked below was crushed. No one was injured except the Bobcat driver, who had a mild concussion. On weekdays, the garage would have been filled with vehicles and people.

In Secaucus, the garage probably did not need to be plowed. The light snow likely would have melted within a day or two. If snow removal was necessary, it should have been done in a manner that avoided creating compacted piles.

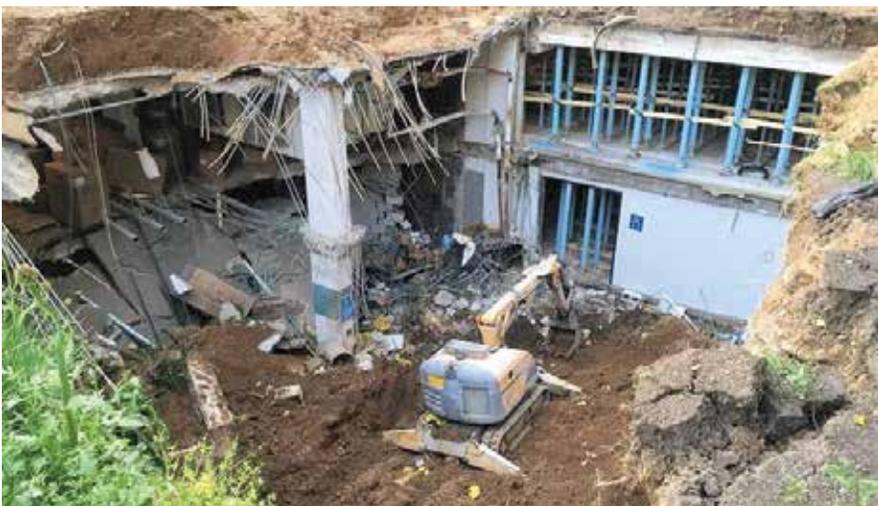
A 3-level garage serves the iconic Watergate mixed-use complex. Now more than 50 years old, the complex was undergoing a comprehensive restoration. A landscaping contractor placed soil and debris on the top deck of the parking

Garage collapse, Washington, D.C.

garage. Soil weighs about 75 pcf if dry, and up to 125 pcf if wet. Thus, only one foot of soil might cause failure.

At 10:00 am, the top deck of the garage collapsed beneath the soil and debris. Everything on the two levels below was crushed in a pancake failure. Two people were injured, one critically, and about 35 vehicles were destroyed.

In Washington and Dallas, the owners and the landscaping contractors should have

contacted structural engineers for approval before the placement of any soil or debris, even temporarily, on the top decks of the garages. In Houston, an above-grade security fence or rail at the perimeter of the underground garage footprint would have kept heavy trucks off of the top deck.

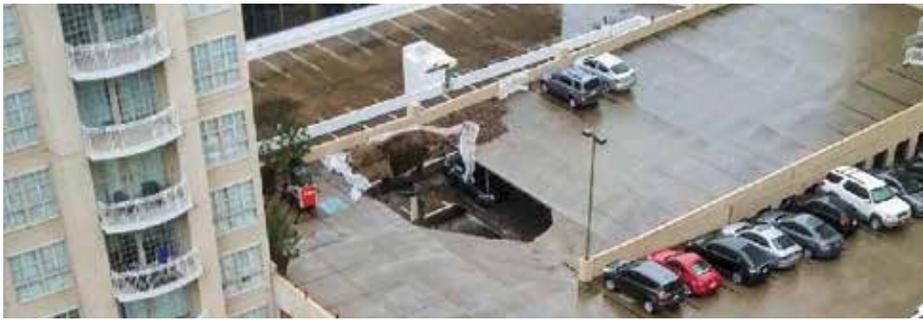
Pancake failure, Dallas, TX.

A 7-level garage with 800 parking spaces serves the upscale Renaissance on Turtle Creek condominiums. The pool and amenities deck at the top of the garage were being renovated, and the contractor piled soil and miscellaneous debris at the toe of a ramp near one corner of the top deck of the garage. A video taken just a few hours before the collapse shows that the pile was about 3 feet high and was covered with plastic sheeting.

During a rainstorm, water flowed down the ramp and partially saturated the pile. At 5:00 pm, the top deck of the garage collapsed beneath the pile. Everything on the six levels below was crushed in a pancake failure. Amazingly, no one was injured. Numerous vehicles were destroyed, and about 250 vehicles and their contents remained inaccessible to their owners for 58 days. The garage remained closed for several months until reconstruction was completed.

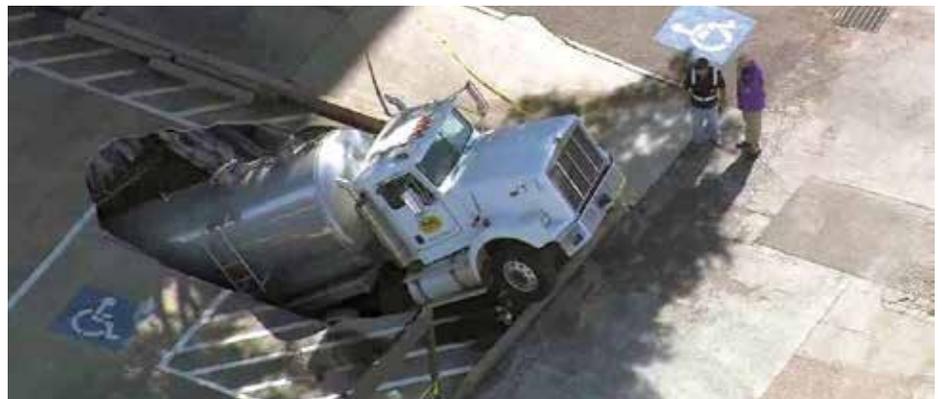
An underground garage with an at-grade top deck serves adjacent office buildings on Town & Country Boulevard in Houston. The garage had been flooded during a period of record rainfall. A tanker truck was summoned to the site to pump out the water. The entrance to the top deck was blocked by a clearance bar proclaiming “MAXIMUM WEIGHT 4,000 LBS”, so the truck driver backed his tanker over the curb and onto the deck a few feet to the right of the entrance.

The tanker has a capacity of 5,800 gallons. That amounts to 48,400 pounds of water, not including the weight of the truck. As the tanker filled with water, the top deck

eventually failed under the weight of the rear wheels. Fortunately, no one was injured.

Deck failure, Houston, TX.
