# STRUCTURAL PRACTICES

## Balcony Issues in High-Rise Buildings

By Dan Eschenasy, P.E., F.SEI, SECB

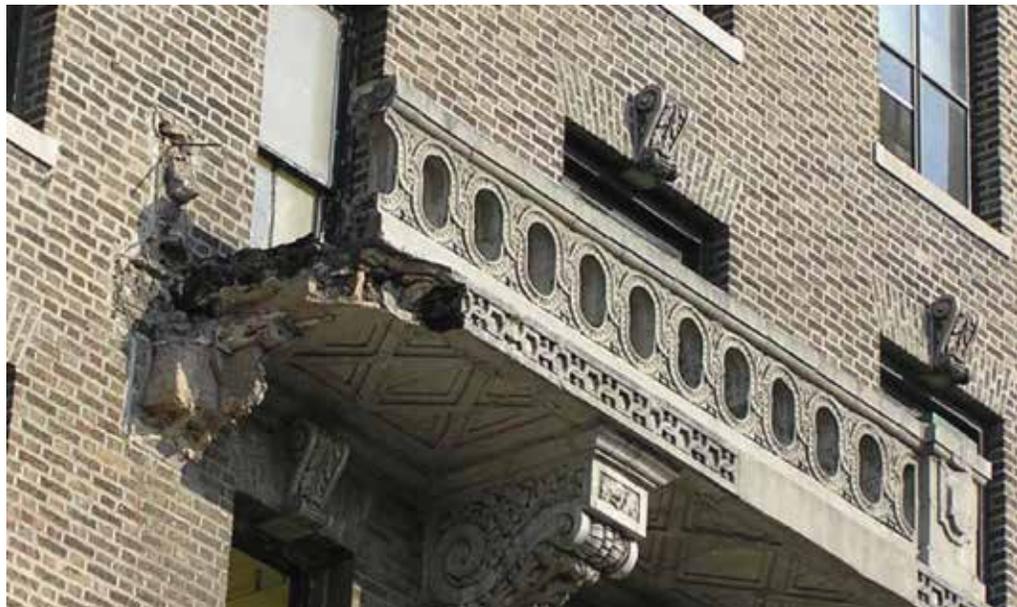
In the early decades of the last century, it was not uncommon to decorate façades with decorative terracotta Juliet balconies (i.e., balconets). They were only meant to give the visual illusion of a balcony and their width did not allow any use by tenants. In many cases, the terracotta balusters of these balconets had cracked or became loose and had to be repaired or removed. A serious accident occurred in 2008 when a significant portion of such a balconet collapsed (*Figure 1*), as the corrosion of the embedded steel outriggers caused the cracking of the terracotta floor. That building façade had been subject to a recent periodic inspection, but the prescribed repair consisted only of patching cracks in the terracotta. Similar terracotta problems led some building owners to remove the balconets, to the desperation of architectural preservationists.

Figure 1. Collapse terracotta balconet.

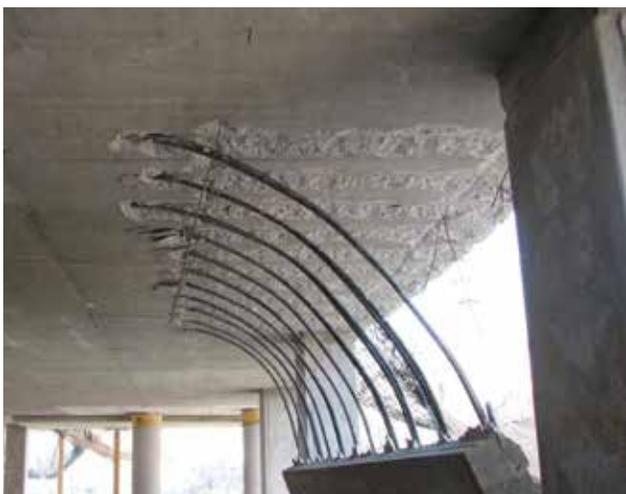
A balcony is a non-redundant structure; design or construction errors cannot hide as the cantilever does not have the advantage afforded by multiple load paths nor the added capacity allowed by stress redistribution. Some published reports on balcony failures elsewhere mentioned overloading. However, in the cases investigated, the author determined that the failure of the concrete structure was mostly due to improper placement of the reinforcing (*Figure 2*).

Figure 2. Balcony collapse after shore removal.

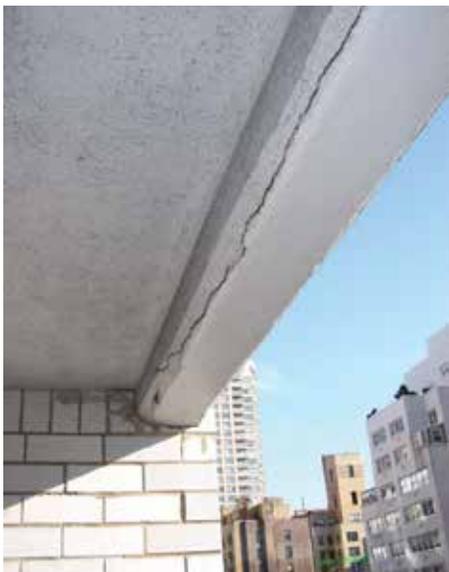
Figure 3. Crack along balcony edge.

The NYC periodic façade inspection law has included some condition assessments of balconies since its promulgation in 1980. The reports, prepared in conjunction with periodic inspections, provide useful information on the ways concrete balconies deteriorate. The symptoms of failures described are typical for weather exposed concrete (concrete spalling, cracking, rust of reinforcement, and related consequences). The condition is most likely made worse by the exposure of both faces to weather. Because they may allow rainwater accumulation or stagnation, balconies are more likely to deteriorate when compared with the vertical surfaces of the façade of the same building. Architectural coverings and even carpets may influence the rate of decay. The deterioration is more prevalent along the outside edges of the balcony (Figure 3).

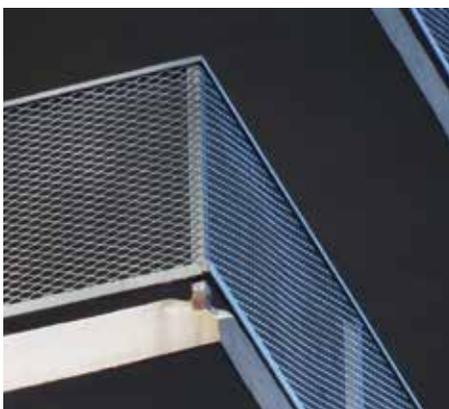
Figure 4. Concrete spall at corner post.

Probably the most common surface failure is the spalling that occurs to the outside corner due to corrosion of the railing post (Figure 4). Galvanic corrosion may occur even at the base of aluminum posts when they are in contact with steel reinforcing bars. Patching cracked concrete can provide relief for five to ten years, but ultimately the corroded reinforcement and the deteriorated concrete have to be replaced (Figure 5). While the engineering principles of the repair/replacement of concrete are simple, the execution is sometimes very expensive due to the difficulty of working from hanging scaffolds. By now, most of the balconies erected in the 1960s have had their edges repaired or reconstructed.

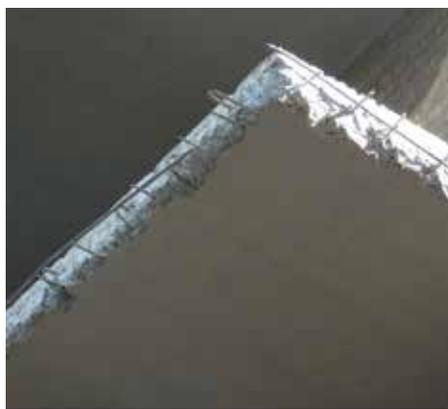
Figure 5. Edge balcony during repair.

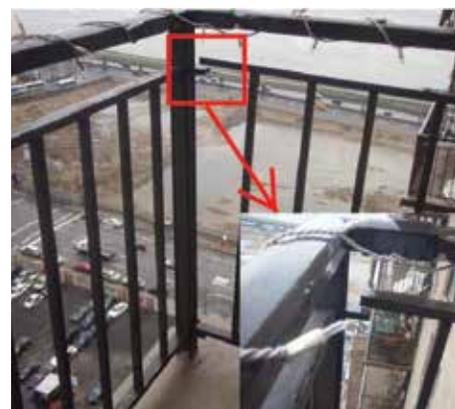
In 2010, a young man fell from a 24<sup>th</sup>-floor balcony. The department's investigation determined that the fall had occurred through the opening created by the failure of the metal panel underneath the handrail. It was found that the original installation for balcony railings met the code strength requirements, but it was flawed as it did not restrain an upward movement of the panel. As a result of the lack of restraint, some minor upward pull on the panel (under minor loads, not necessarily specified in the code) could bend the panel into a potentially dangerous position that could become permanent. The inspectors observed several permanently deformed panels at other floors (Figure 6).

The collapse was possible only because of a flaw in the design – lack of vertical restraint at the panel ends. Calculations demonstrated that, if the restraint was present, the collapse would not have occurred.

Figure 6. Panel not permanently secured.

Following the accident, a citywide search identified six other high-rise apartment buildings with balconies having the same insufficient panel connection details. These balconies were vacated until the repairs were performed. The 2014 New York City

Building Code contains an added requirement for the design of components; “a concentrated upward load of 50 pounds (0.22 kN) applied at the most critical location”. (2014 *New York City Building Code*, Section 1607.7.1.2). A separate analysis of several periodic façade inspection reports revealed that inspectors were mainly concerned with danger to pedestrians below and less with the structural reliability of the railings. The department notified the industry of the problem and ordered supplemental inspections specifically focused on the condition of railings of balconies, setbacks, and terraces. Common defects observed included: 1) rusted pickets, 2) displaced or detached rails, 3) guard rail assemblies easily displaced under a slight force, 4) open cracks around pitch-pockets of railing posts, 5) deterioration of end railing attachments to walls, and 6) loose connections. The safety of railings is strongly impacted by the deterioration or degradation of the concrete at the balcony's edge, as discussed above.

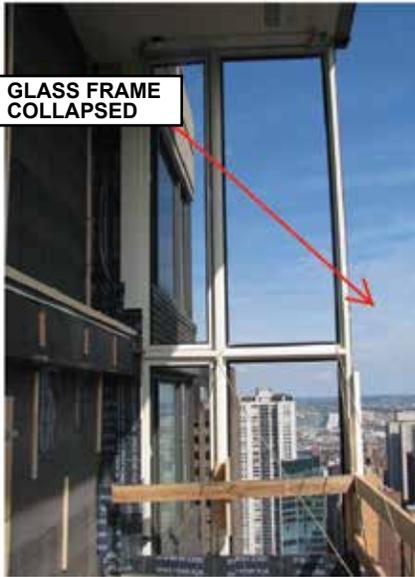
In 2010, a moderate intensity wind microburst collapsed a 10-foot by 30-foot full height glass enclosure on a 52<sup>nd</sup>-floor balcony (Figure 7). In its fall, the glass destroyed the skylight roof of a ground floor public

Figure 7. Glass blown away due to depressurization.

space. The collapse occurred when the interior space was depressurized by a window being opened inside the apartment. In another case, a wind-borne wicker chair, left unattached on a 45<sup>th</sup>-floor penthouse terrace, hit and broke a glass panel, injuring five pedestrians below. A 42-story building on Fifth Ave had repeated balcony railing breakage. The repair solution required a complete replacement of the glass and a change in the framing system. To improve the robustness of glass panels, the 2015 version of the *International Building Code* eliminates tempered glass by specifying: “Glass used in a handrail, guardrail or a guard section shall be laminated glass constructed of fully tempered or heat-strengthened glass.”
