MOUNTAIN “S” HOME

By James M. Williams, P.E., C.E., S.E., AIA, LEED AP

Stepping and twisting around its site, this “S” shaped, \$25 million mountain home provides 360-degrees of scenic views. Located above Park City, Utah, the Mountain “S” Home is a structural engineering Opus. Every design element of the home represents an engineering challenge. The Mountain “S” Home was a winner of the 2016 NCSEA Excellence in Structural Engineering Awards Program, category – New Buildings under \$10M.

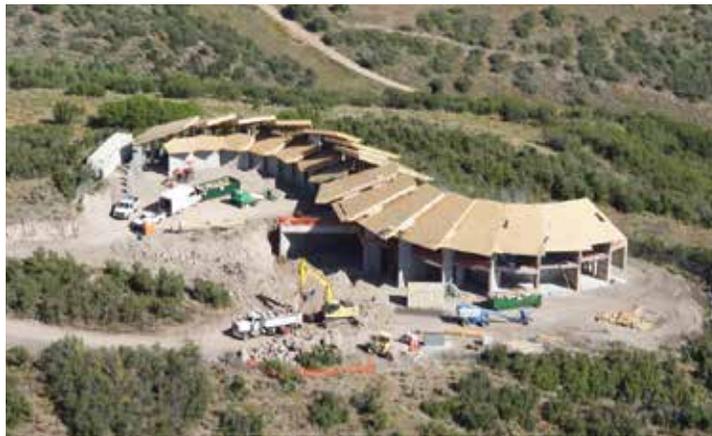
The “S” shaped home steps and twists around its mountain site. Although the home is curved, all of the structural members are straight.

Multiple radial grid systems were required to lay out the structure. Although the house is curved in multiple directions, all of the structural members are straight and repetitive. Often the best structures are the ones that can be simplified, and once simplified, repeated, thus reducing costs and speeding up construction. Such was the case for this project.

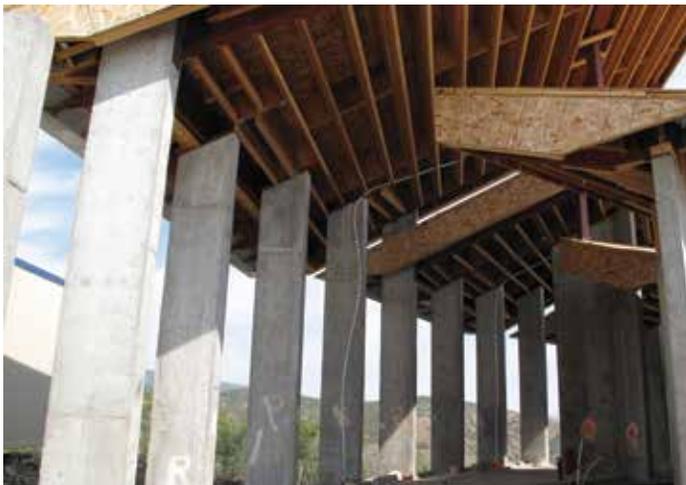
The lower cantilevered roofs span perpendicular to 6-inch-thick concrete walls, resulting in tension or compression loads of 80,190 pounds on each end of each wall.

In addition to the concrete piers which support most of the roofs, there are 9 staggered wall segments that range from 10 feet to 13 feet tall and are only 6 inches thick (a constraint also imposed by the architect). These thin wall segments support lower roofs which span perpendicular to the 6-inch-thick concrete segmented walls and which are staggered 2 feet, resulting in a tension or compression load of 80,000 pounds on each end of each wall. The connection required an embedment knife plate with (8) #8 dowels, 62 inches long. The 6-inch-thick pier has (10) #9 vertical bars in a 2-foot-wide jamb. This occurs in 24 locations. The 6-inch-thick segmented wall sections were required by the architect to allow for a thin stone veneer and glazing between the staggered walls. A superplasticizer was required along with several mockups and on-site testing. Initially, the architect wanted these walls to be only 4 inches thick. The engineer requested at least an 8-inch thickness but was only granted 6 inches maximum.

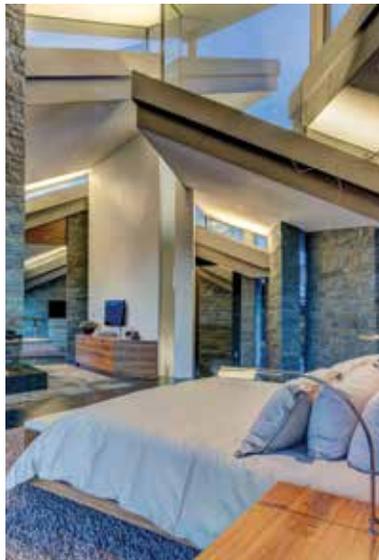
Roofs cantilever inside and outside, with clerestory glass between. The clerestory glazing sits between two independent roof structures.

The structure is suitable for its environment; it appears to be open, light, and airy. The home is located high in the mountains. The large exterior glass walls provide unobstructed views in all directions. All of the structural materials and members were readily available, and easy to work with. The winding hallways, tall interior walls, stepped roofs, and transom glass feels as if you are hiking through some canyon narrows as you pass through the house. Roofs cantilever inside and outside, with clerestory glass between.

The clerestory glazing sits between two independent roof structures, so cantilever deflections had to be limited. With the large expanses of glass, the structure is hardly noticeable. ■

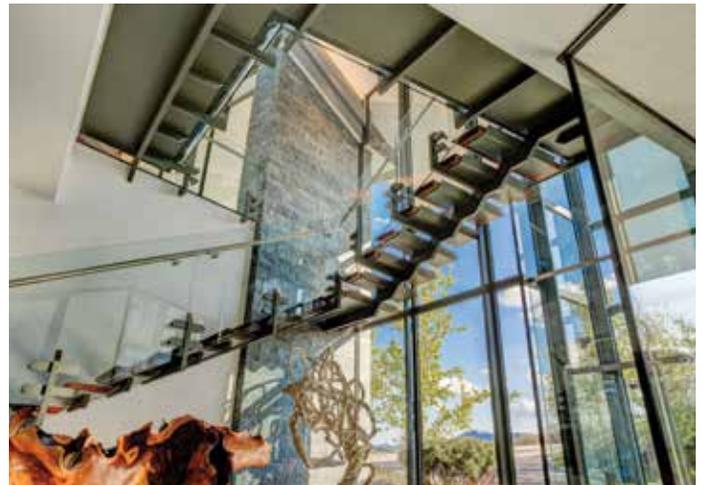
Stair treads are supported by a single “saw-tooth” stringer, cut from bar stock and then welded back together. Other treads cantilever off of a concrete wall.

The open-riser stairs are an architectural and structural design feature and focal point. The stairs have treads supported by steel plates which are supported on steel bars that are doweled into the wall and cantilever the full tread width. One of the stair runs extends past an exterior glass wall with no attachment and only one stepped-support stringer, constructed of segmented-stepped-steel bar stock welded together. There is additional plate steel around the stair opening to achieve a thin profile. Adjacent to the stairs is a glass elevator with minimal structure.
