STRUCTURAL TESTING

Testing Tension-Only Steel Anchor Rods Embedded in Reinforced Concrete Slabs

This article is derived from an Interim Report on *Testing of Tension-Only Steel Anchor Rods Embedded in Reinforced Concrete Slabs*, SEAOC Convention Proceedings, September 2013, San Diego, CA.

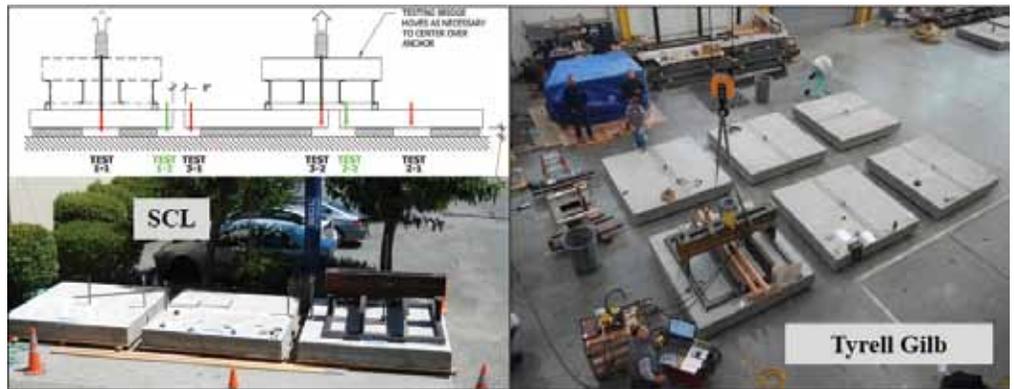
Figure 1: Test layouts at SCL and Tyrell Gilb laboratories.

Phase 1 (completed in June 2012) proposed a testing protocol for the extensive Phase 2 testing. To validate and/or refine the proposed testing protocol, Phase 1 concluded with the construction and testing of three full-scale experimental specimens featuring both center-of-slab and edge-of-slab details. Phase 1 experiments were performed at Scientific Construction Laboratories, Inc. (SCL) in Lafayette, California (Figure 1).

Phase 2 is currently in progress at Simpson Strong-Tie's Tyrell Gilb Research Laboratory in Stockton, California (Figure 1). Phase 2 features full-scale podium slab sections with varying levels

Phase 1 experiments at SCL validated the testing protocol using a high-capacity testing bridge previously developed by Simpson Strong-Tie. *Figure 1* depicts each 8-foot x 8-foot x 1-foot concrete specimen with anchors cast in the field and at the edge. The slabs were elevated off the ground to avoid any potential restraining effect on slab bending. Slabs were reinforced to prevent bending

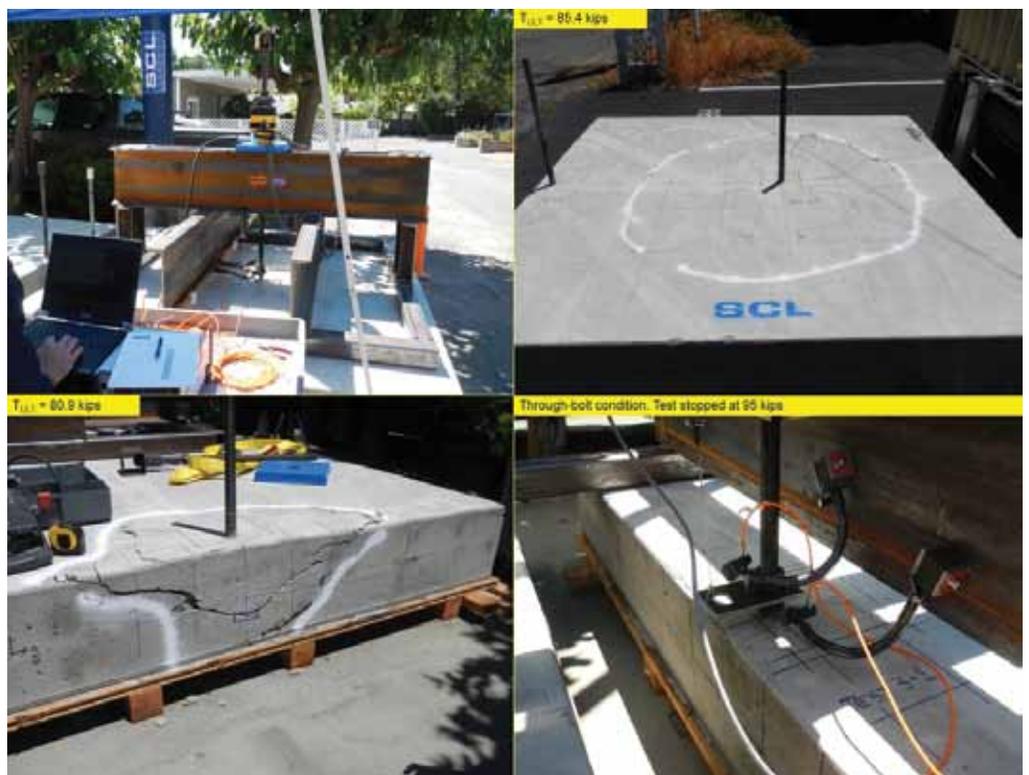
Figure 2: Phase 1 edge and field testing.

Figure 2 and *Table 1* show a summary of the Phase 1 experiments. A published testing report describes further details related to the setup and results. *Table 1* compares some model building design demands with currently available design capacities. The limited design capacity for concrete anchorage is immediately apparent once building height exceeds three stories.

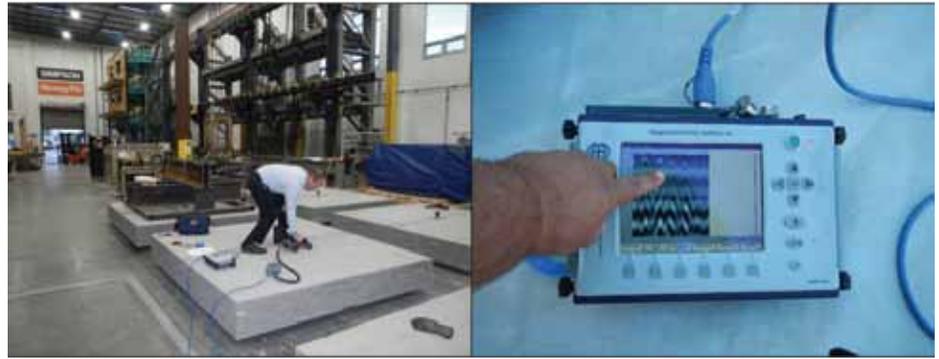
Figure 3: Non-destructive testing (NDT).

clearances and/or geometry. NDT was limited to pachometers and ground-penetrating radar (GPR) methods (Figure 3).

Based on NDT results, the research team confirmed that Structural Observation and/or Special Inspection prior to concrete placement will provide good conformance with designed anchorage detailing. To ensure consistent construction quality, engineers might consider requiring and/or incorporating photo-documentation of installed anchorage and reinforcing around the anchor. While unique, this level of inspection and confirmation is important given the critical nature of most anchorages of this type.

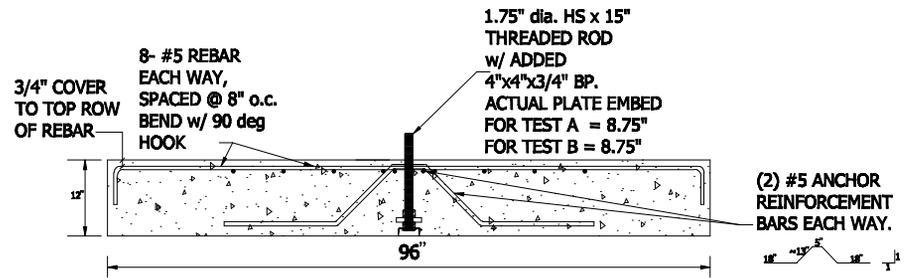
Figure 4: Cross-section of slab showing one-piece anchor reinforcement.

The initial Phase 2 experiments were run in pairs to test three main configurations: (1) anchors without additional anchor reinforcement; (2) anchors with one-piece inclined anchor reinforcement (Figure 4); and (3) anchors with two-piece inclined anchor reinforcement (Figure 5). For each of these

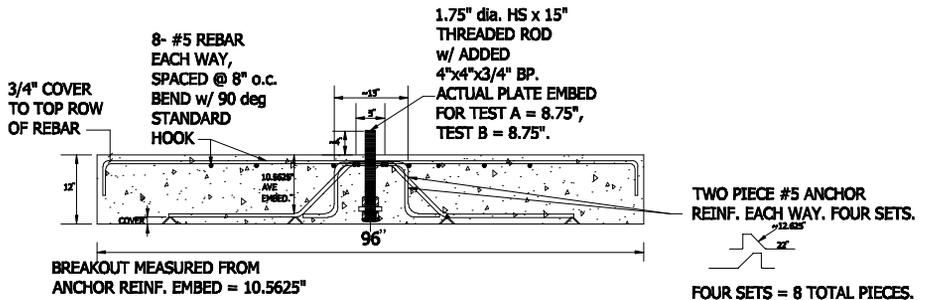
Figure 5: Cross-section of slab showing two-piece anchor reinforcement.

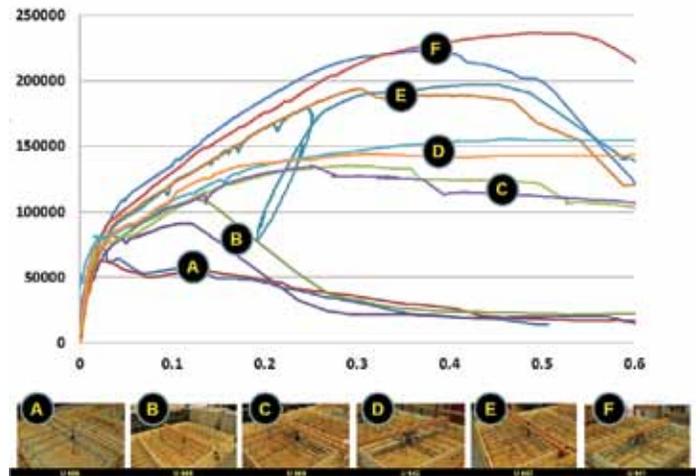
Figure 6: Initial Phase 2 test results. Pre-test photos courtesy of Testing Engineers, Inc. (TEI).

As shown in Table 2 and Figure 6, Phase 2 results indicate that under-reinforced concrete slabs will typically fail in flexure before a shear cone can develop. These results prove the adequacy of ACI 318-11 Appendix D considering a limitation on anchor capacity for locations where a plastic hinge can form as noted in D.3.3.2.

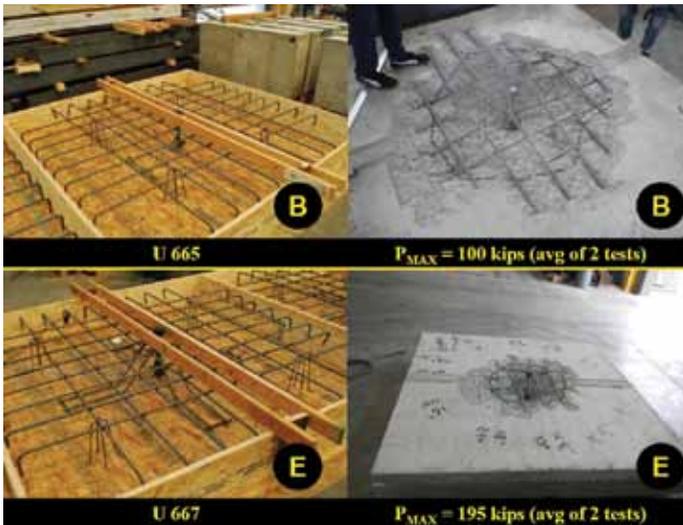
Figure 7: Test “B” and Test “E”. Pre-test photos courtesy of TEI.

Figure 7 shows failure surfaces and corresponding peak loads (average of two tests) for two different anchor reinforcement conditions. Test B has no supplemental anchor reinforcement; Test E has a one-piece inclined bar anchor reinforcement.

It is interesting that, in these sloping sides, the vertical component of the nominal yield strength was 105 kips. Figure 7 shows that the ultimate capacity of Test D is nearly the sum of this 105 kips and the Test B results. Predicting the average uncracked ultimate tension cone breakout force of Test B using ACI 318-11 equation (D-6) with $k_t=40$ (instead of 24; this removes reductions for cracks and reduction from average result to 5% fractile), and also properly considering the A_{NC}/A_{NCO} ratio in accordance with D.5.2.1 and D.5.2.8, yields a predicted strength of 83 kips. Combined with the 105 kips from the anchor reinforcing results in a predicted sum of 188 kips, which is also very close to the 195-kip average test result.

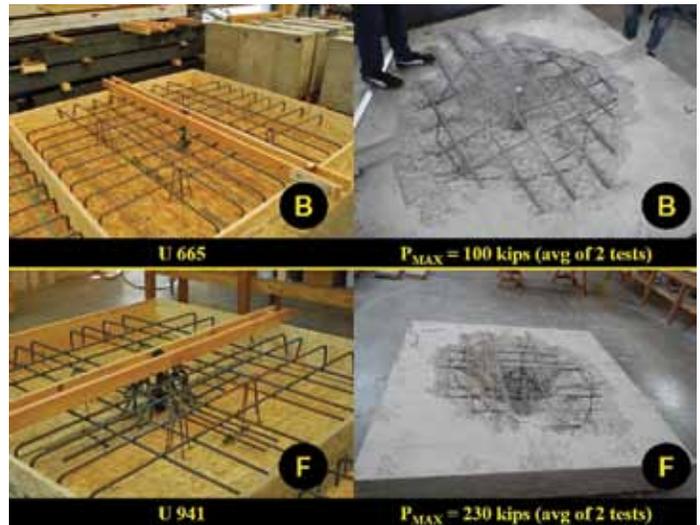
Figure 8: Test “B” and Test “F”. Pre-test photos courtesy of TEI.

Figure 8 also shows the failure cone and corresponding peak loads (average of two tests) for reinforced and unreinforced anchor

specimens. Test B has no supplemental anchor reinforcement; Test F has two-piece anchor reinforcement. With sufficient flexural reinforcement, a shear cone will develop as indicated in ACI 318-11 Appendix D. By adding anchorage reinforcement (bars dedicated to resist shear cone failure), the capacity of the anchor in tension can be significantly increased.
