HISTORIC STRUCTURES

Deconstructing Bridge 92297

From Destruction
Comes Knowledge

By Ryan Salmon, EIT and
Meghan Elliott, P.E., Associate AIA

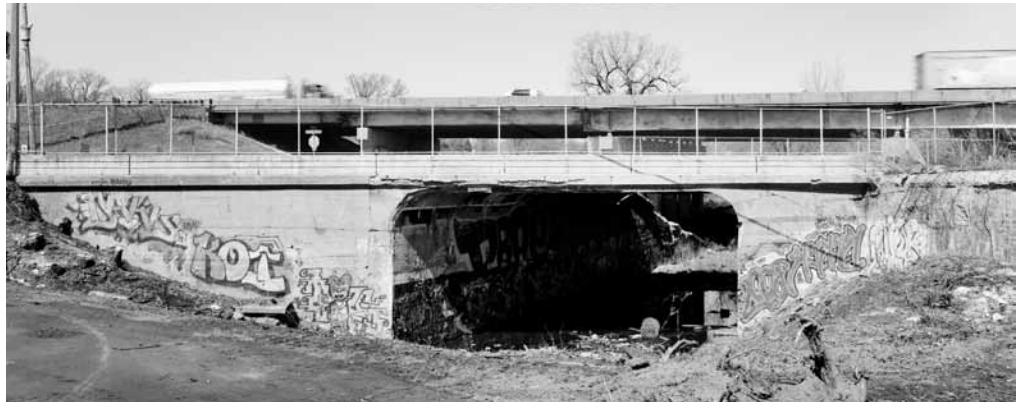
Figure 1: Bridge No. 92297 shortly before demolition. Photograph by Daniel R. Pratt, courtesy of MN Historical Society Archives.

Bridge No. 92297 was a monolithic, single-span, reinforced concrete flat slab deck with vertical abutments supported on reinforced concrete strip footings, constructed in 1912 (Figure 1). It was oriented on a 35-degree skew, measured 49 feet in total length, and had a clear span of 41 feet with a 60-foot-wide deck. Without any background about its history, the bridge would have appeared rather unremarkable. However, research on the bridge revealed that it was an innovative design for its time. Its documentation shed more light on the work of the bridge's designer, and also created a record available for future study.

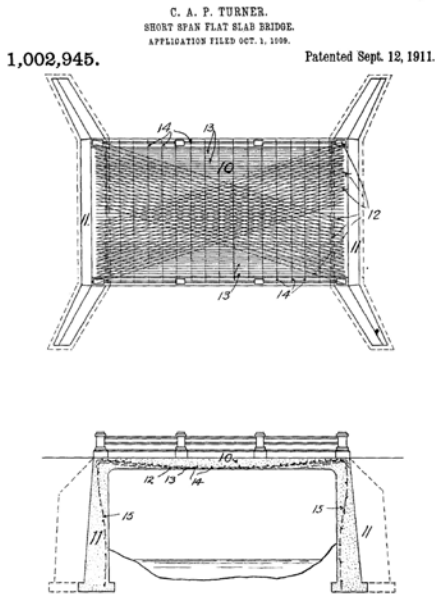
Figure 2: Excerpt of C.A.P. Turner's U.S. Patent 1,002,945: "Short-Span Flat-Slab Bridge," filed October 1, 1909. Although the deck reinforcement of Bridge No. 92297 did not resemble the design in this patent, the profile of the deck, abutments, and footings, as well as the abutment reinforcement bears a striking resemblance. Digitized by Google Patents.

In addition to implementing his system in buildings, Turner designed several reinforced concrete flat slab bridges, most as adaptations of his mushroom floor system. To date, all known flat slab bridges in the Twin Cities designed by Turner have been demolished. The bridge decks were often designed with four-way reinforcement similar to his floors, with longitudinal, transverse, and diagonal steel. With the exception of a tunnel originally located not far from the area studied for this project, Turner's published examples of flat slab bridges did not bear much resemblance to Bridge No. 92297 (Gasparini, et al., 2001; 12-27). However, Turner held a number of related patents for both floor systems and bridges, one of which bears a striking resemblance to Bridge No. 92297, particularly the configuration of the abutment reinforcement (Figure 2).

slab and abutment reinforcement correlated closely with the design illustrated in Turner's patent. Because of the geometry of the bridge span, the flat slab of Bridge No. 92297 more closely resembled a one-way structural system, rather than the four-way systems found in Turner's published designs.

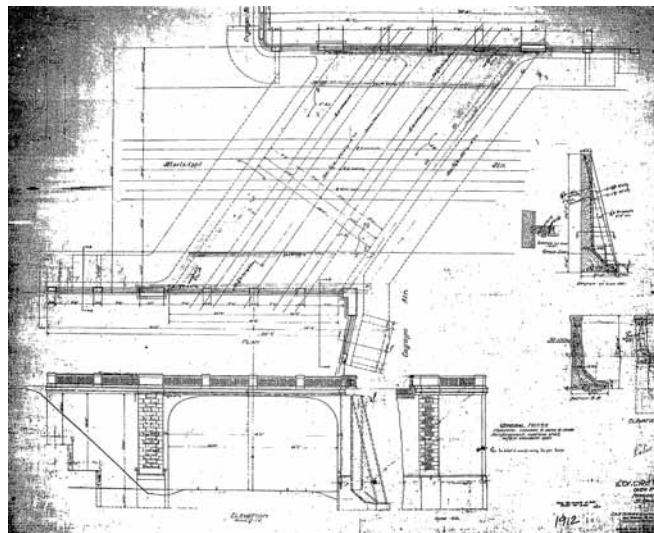
Figure 3: Original construction drawing of plan and elevation of Bridge No. 92297.

were of poor quality and only partially legible (*Figure 3*). Of the six sheets in the set, one was stamped with “CAP Turner Consulting Engineer” in the title block, while the “Chief Engineers Office” of the railroad was stamped on the remaining sheets. The date of the sheet stamped with Turner’s firm was illegible, but several of the sheets stamped by the railroad engineers were clearly dated to 1912. The correspondence between engineers indicates that plans were originally drawn for the bridge in 1908, and then were revised in 1912 because the earlier plans did not meet the standards of the 1907 city ordinance. Summit

Envirosolutions postulated that the drawing sheet stamped by Turner was part of the original 1908 set, and the remaining sheets were a revision of Turner’s design made by the railroad’s engineers.

Interpretation of the original drawings was also hampered by their poor legibility and a lack of corresponding notes or engineering calculations. This was compounded by the fact that changes had obviously been made to the bridge after its construction, such as the replacement of the railing and the installation of a new topping slab, which complicated efforts to differentiate original and more recently added features. Despite these difficulties, comparison with observed conditions, the original drawings, and Turner’s patent for a similar bridge design, led to the conclusion that the structural design of the bridge can be substantially attributed to C.A.P Turner.

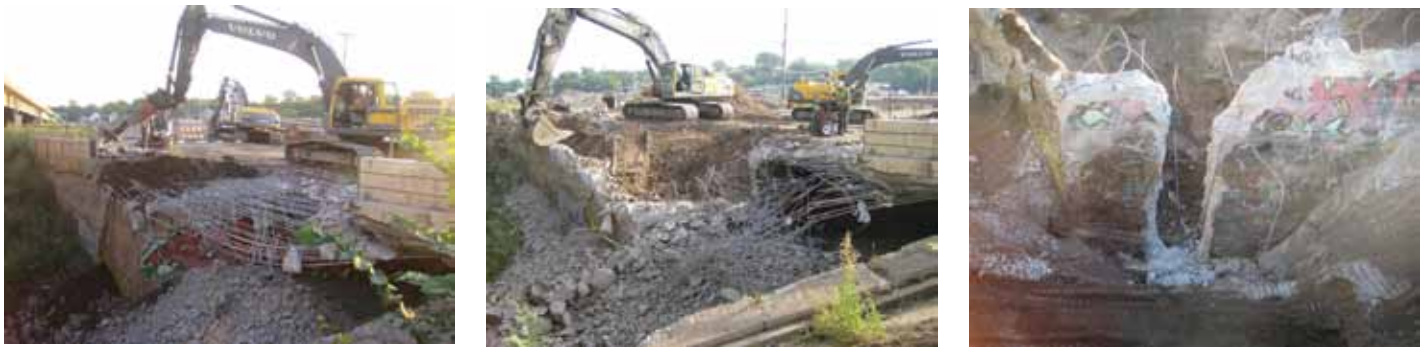
Figure 4: Careful demolition of the bridge revealed the reinforcement, facilitating its documentation in selected areas.

Deconstructing and documenting a historic bridge requires time, care and coordination that is not required with standard demolition and removal (*Figure 4*). Determining the configuration of reinforcement for comparison to the original construction drawings required investigative openings in areas that would expose representative samples of reinforcement in the bridge deck, abutments and footings. Maintaining stability of the bridge to allow for safe access after its partial demolition, as well as to expose sections of the abutments and footings, required an extensive amount of earthwork.

A two-stage demolition process accommodated the documentation process. Backhoes equipped with hydraulic jackhammers removed concrete in selected areas of the bridge to expose reinforcement. Fill placed below the bridge stabilized the abutment walls during the exposure and removal of the deck. Two full-depth openings in the bridge deck – one near the middle, and another along the edge and the adjoining transition into the top of the abutment – facilitated its documentation before complete demolition. Next came excavating soil on both sides of the abutment to the top of the footing, then removing concrete from the selected area to

The plan and profile of reinforcement was generally congruent with the original construction drawings from 1912, with the exception of minor details and extra reinforcement along the fillet corner in the deck-to-abutment transition. The skewed geometry of Bridge No. 92297 was not well-suited to Turner’s patented short-span bridge design, but the two layers of slab reinforcement in the bridge were similar to the configuration of diagonal reinforcement in Turner’s patent. One layer of slab reinforcement was placed parallel to the span of the bridge, and the other layer was placed perpendicular to the abutment walls. Some transverse reinforcement was present, which correlated with the patent, but it was so widely spaced – over five feet on center – that its intended purpose was likely just to support the draped geometry of the two primary layers of slab reinforcement. The profile of the
