# The High Cost of Low Maintenance and Design Mistakes

By Narendra K. Gosain, Ph.D., P.E.

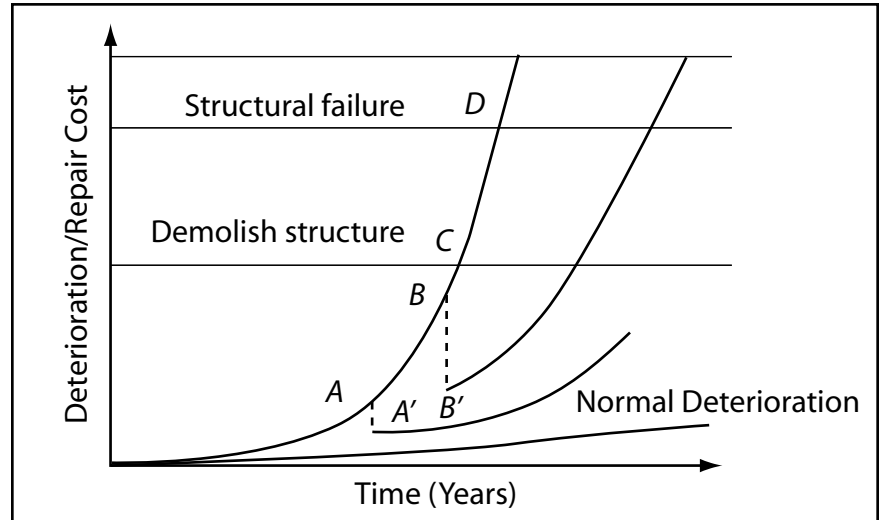
Figure 1: Structural Deterioration Model.

Cost of deferred maintenance is best described by Figure 1.<sup>3</sup> It is certain that all structures deteriorate over time, as indicated by the plot marked "Normal Deterioration." The curve marked ABCD is the plot that, shows that if the facility is not proactively taken care of, repair cost will escalate exponentially. If there is intervention at an early stage of its life at point A', then the deterioration cost will be much lower. If intervention is at a later stage at point B', the cost will be lower than that indicated by curve ABCD but higher than the curve for point A'.

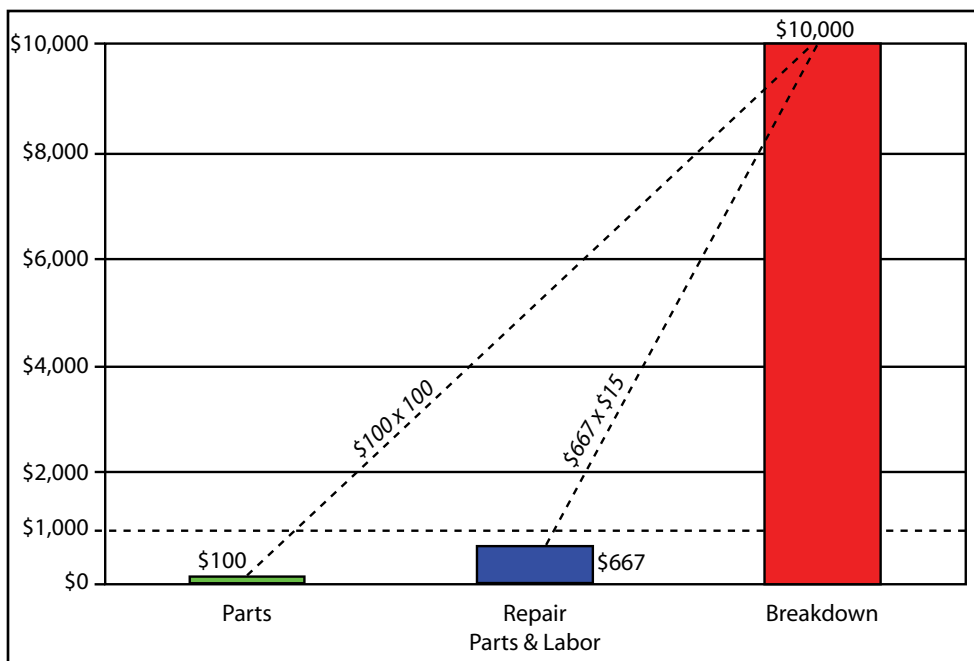
Figure 2: Geaslin's "Inverse Square Rule for Deferred Maintenance".

Keeping up maintenance over time does not seem to be a priority of business management. David Geaslin of the Geaslin Group<sup>4</sup> has taken on the challenge. He has found that time and cost to recover is huge compared to time and cost to avoid. He has developed a rule called *Inverse Square Rule for Deferred Maintenance*, which states that "If a part is known to be failing and the repair is deferred and allowed to remain in service until the next level of failure, the resultant expense will be the square of the failed part." (Figure 2) For example, if a missing bolt is found in a beam connection supporting a floor, and the cost to replace this is \$100 but not done in a timely manner, then the cost of fixing the entire connection due to consequent failure of other bolts due

to overstress and other related cost may be as much as  $\$100 \times 100 = \$10,000$ .

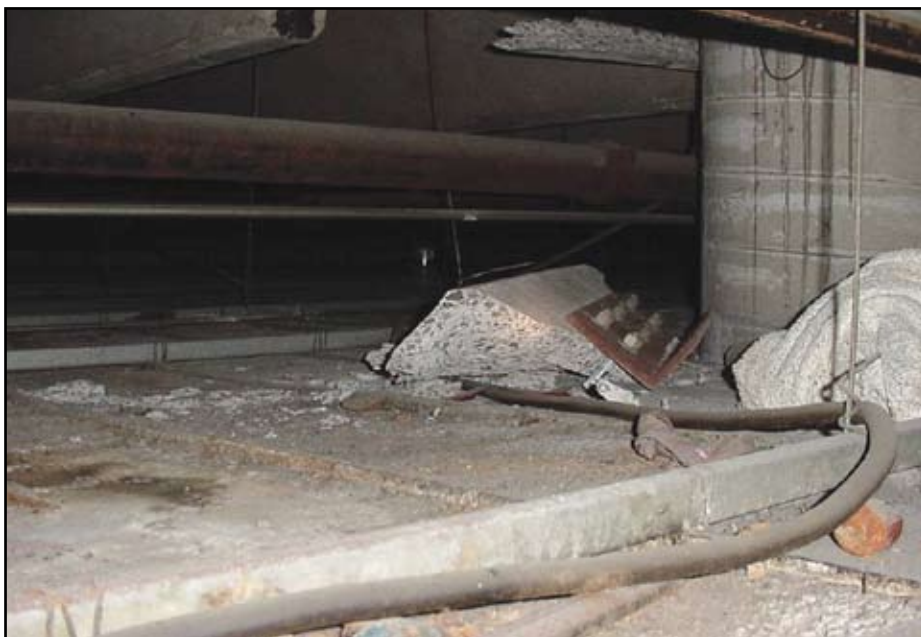
Figure 4: Failed and fallen steel angle bracket connection bolted to concrete.

A construction and design related failure occurred after many years in a **hotel ballroom floor made of precast double tees**. In the 1970s, a ballroom of a major hotel was constructed using precast double tees. The ballroom functioned satisfactorily for about 30 years until one day, while the wait staff were preparing for a major banquet, they noted a visible sag in the ballroom floor. Responding to a request for an urgent investigation of the reported sag, several pieces of concrete were found on the ceiling (Figure 4) and severe distress in the inverted T beam supporting the precast double tees with dapped ends. The entire floor was shored up immediately and investigation conducted. In the absence of construction drawings for this area, it was surmised that the all the precast double tee members were cast about 6 inches too short in that area. In order to use these members, a steel angle bracket was bolted to the inverted T beam by post installed expansion anchors to support the double tees.

In doing the analysis of the capacity of the as-built post installed anchor connection, the capacity was found to be only 25% of the required design capacity. This was due to the tremendous reduction in capacity due to the close spacing of the post installed anchors in the connection. Working with the contractor, a steel saddle support system was designed and installed. Post installed anchors are one of the most neglected areas of retrofit design. Fortunately, the inclusion of design requirements of post installed anchors is now included in the current ACI code.

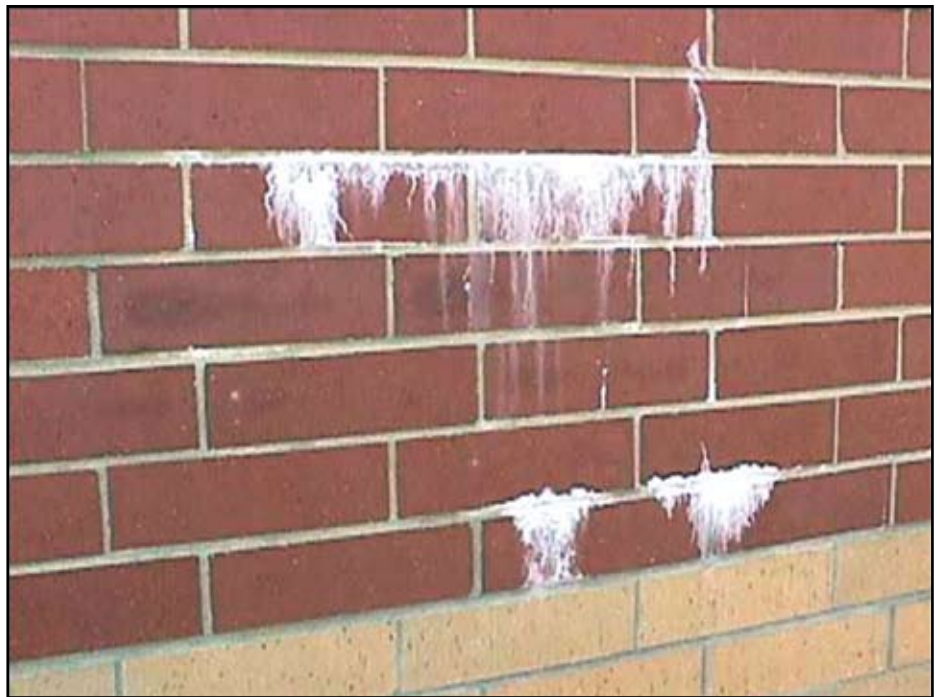
Another construction-related failure occurred in an **elementary school building masonry facade infiltrated with water**. Exterior wall construction of a two-story school building was comprised of a nominal 4-inch brick veneer with 2-inch of cavity and 8-inch thick concrete masonry wall back-up in the interior. Within 12 months of the construction of the school, the paint on the concrete masonry wall failed. It was repainted, but failed again within a few months. Moisture was evident at several locations in the exterior brick veneer wall that also had lime runs as seen in (Figure 5). Three bricks at the mortar joints were removed to investigate the condition of the cavity and the back side of the concrete masonry units. As the mortar was being cut, water started running out of the wall, and once the bricks were removed, it was found that water had filled the brick cores. No insulation was found in the cavity. Apparently, the moisture and freeze-thaw action in the cavity had turned the insulation into a paste, and the freeze-thaw action of the collected water in the core of the brick had also split the bricks. The problem of water intrusion was caused by the poor quality of the mortar and joints. To solve the problem, the brick veneer wall would have to be removed so that new insulation could be installed. The cost of doing this work was considered to be prohibitively expensive, and the school board decided not to do any repairs.

Figure 5: Lime runs in brick wall.
