# Blast Loading Retrofit of Unreinforced Masonry Walls

With Carbon Fiber Reinforced Polymer (CFRP) Fabrics

By Mo Ehsani, Ph.D., P.E., S.E. and Carlos Peña, M.S., P.E.

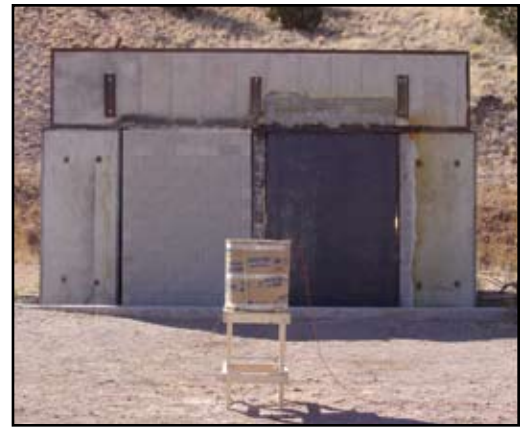
Figure 2: URM wall test specimens ready for blast test.

A blast source consisting of 240 pounds of explosive (equivalent to 200 pounds of TNT) was placed in a cylinder with aspect ratio (length/diameter) equal to 1.0, at a height of 3 feet and at a distance of 30 feet from the URM walls. This blast source was intended to reproduce the effects of a car bomb explosion occurring on a side street in front of the wall. *Figure 2* shows both test wall specimens and the blast source.

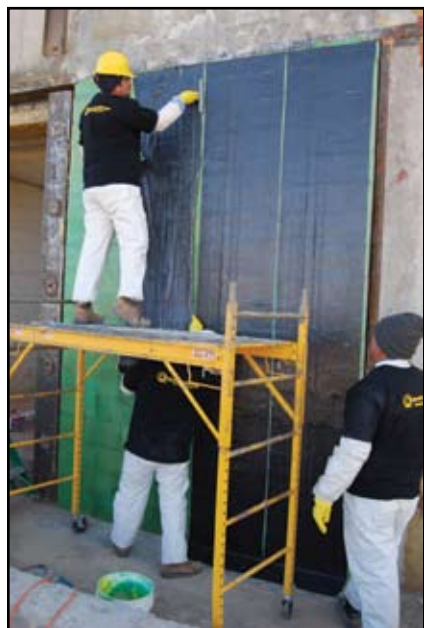
Figure 1: CFRP fabric installation on URM wall.

(CFRP), considering the following construction sequence: first, a layer of tack coat was applied to the wall surface. The purpose of the tack coat was to seal the wall surface, smooth out small imperfections and hold up the weight of the saturated CFRP strips; second, the CFRP strips were saturated in epoxy resin and placed on the tack coated surface. *Figure 1* shows the installation of the CFRP fabric over the tack coated surface.

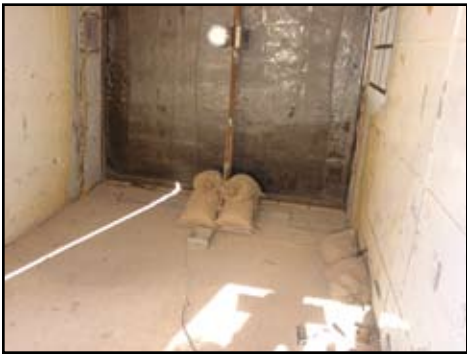
Figure 3: Instrumentation on the interior of the reaction building room.

Figure 3 (page 17) illustrates some of the instrumentation installed on the inside of the room. Visible in the figure is the laser gage mounted on the steel post, the interior pressure gage on the floor (inside the aluminum casing behind the laser stand) and the interior lateral high speed camera window on the left wall. Also visible in this figure is the interior bottom steel angle used as mechanical anchor for the CFRP fabric.

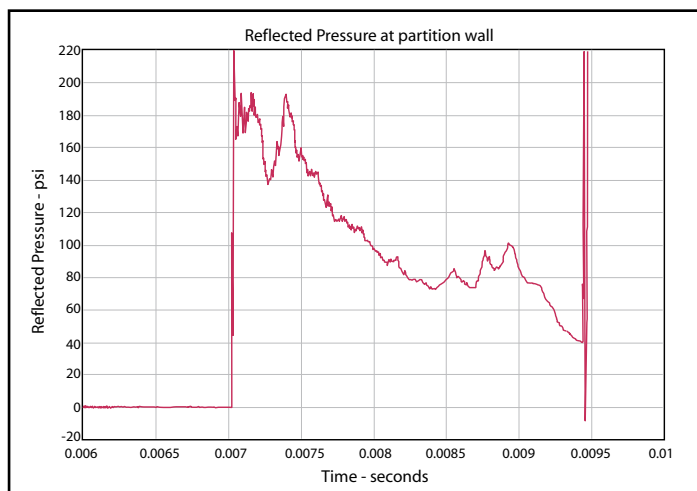
Figure 4: Reflective pressure time history.

- 1) Peak reflective pressure: The maximum value was measured at 192 psi, which was just 4% lower than the retrofit design value of 200 psi. Figure 4 shows the reflective pressure time history.
- 2) Peak lateral deformation: The maximum deformation was measured at approximately 9 inches. The deformation time history plot is given in Figure 5 (negative values indicate wall movement towards the inside of the room). From Figure 5, it can be observed that there is no elastic

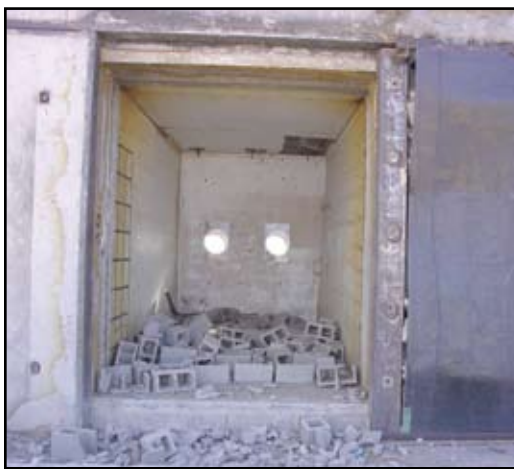
*Figure 7: Un-retrofitted and CFRP retrofitted URM walls after the blast test.*

As mentioned above, crushing failure of the masonry occurred as predicted by the structural calculations. Also, CFRP anchorage failure occurred on the top edge of the outside face of the wall due to insufficient development length. Under static conditions, a simply supported wall would have very little tensile force demands at the edges, so CFRP anchorage failure is usually not a concern. However, under dynamic conditions, the inertial forces of the disintegrated mass of crushed masonry forced the CFRP to act as a membrane, placing significant tensile demands on the edges. The use of a proper development length would have meant extending the CFRP beyond the steel angle anchoring system and into the parapet of reaction building, which was avoided to minimize residual CFRP fabric adhered to the building exterior. Figure 7 (see page 20) shows CFRP anchorage failure occurring at the upper left corner of the wall.

Figure 7 also shows the state of the retrofitted and un-retrofitted URM walls after the blast test. The un-retrofitted URM wall suffered catastrophic failure, with masonry debris scattered

It can be observed from *Figure 7* that the CFRP retrofitted wall remained standing, even though the masonry inside was practically reduced to debris. It can also be seen that all the debris was contained by the CFRP. The high speed camera video taken from the inside shows evidence that no masonry debris projectiles were present in the room enclosed by the retrofitted wall and that all the debris was contained by the CFRP fabric. The inside lateral video camera clearly captured the deformation behavior of the wall during the blast event, including the effects of the crushing failure of the masonry. The lateral exterior video camera illustrated the effect of the arrival of the shock wave on both URM walls.
