# Post-Tensioned Slabs on Ground

## Part 4: Existing Foundations

By Bryan Allred, S.E.

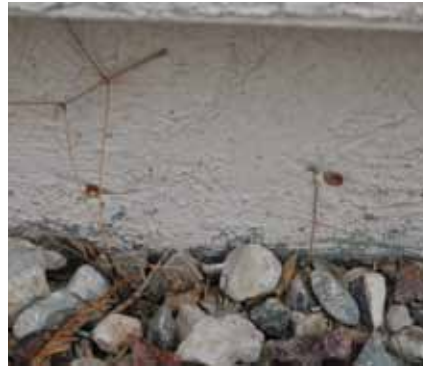
Figure 1: Rust Marks of Burned off Anchor Nails.

the house may provide the answer. Typical residential construction will only require stressing of the tendons from one anchor. The stressing anchor is typically connected to the form boards by two 20d nails that are approximately 4 inches apart. After the concrete is placed and cured, the form boards are removed with the 20d nails sticking out of the slab. The nails are subsequently burned off with the tendons tails to the face of the concrete (Figure 1). Over time, the exposed nail will rust and leave two small reddish marks on the edge of the foundation. If these rust marks are noted approximately 3 to 4 feet on center, it is a strong possibility the existing foundation is post-tensioned. In addition, the marks will indicate the anchor location and the approximate cover to the strand as it extends across the foundation. Since tendons are placed at mid-depth of the slab, the cover to the strand should provide a reasonable estimate of the slab thickness.

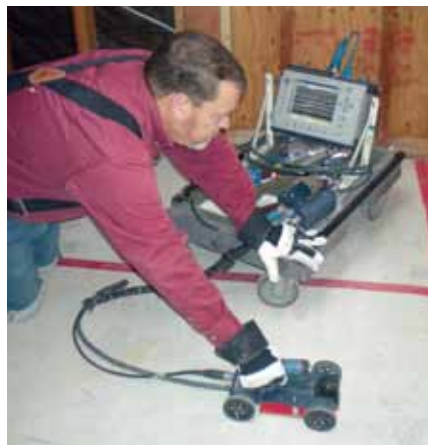
Figure 2: Scanning Slab to Locate Existing Strands.

There are several methods for locating strands that range from digital readouts of a concrete surface scan (Figure 2) to using a hand held metal detector and looking for spikes on the dial (Figure 3). The technician in Figure 2 scanned a room with rough dimensions of 20 feet by 20 feet in about an hour and was able to mark the strand and anchor locations on the slab. With the tendons marked, the contractors could easily adjust their drill location to miss the existing reinforcing. Ground penetrating radar (GPR) can also be used for thicker foundations which will have a larger cover than their ribbed counterparts.

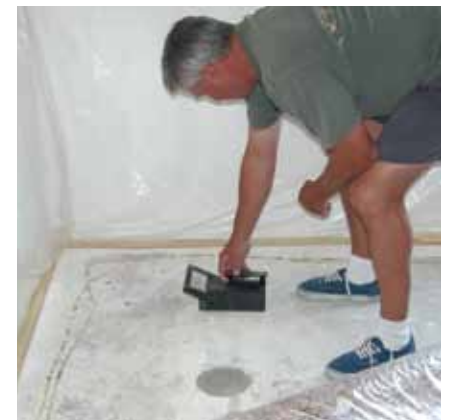
Figure 3: Pacometer (Metal Detector) used to Locate Existing Strands.

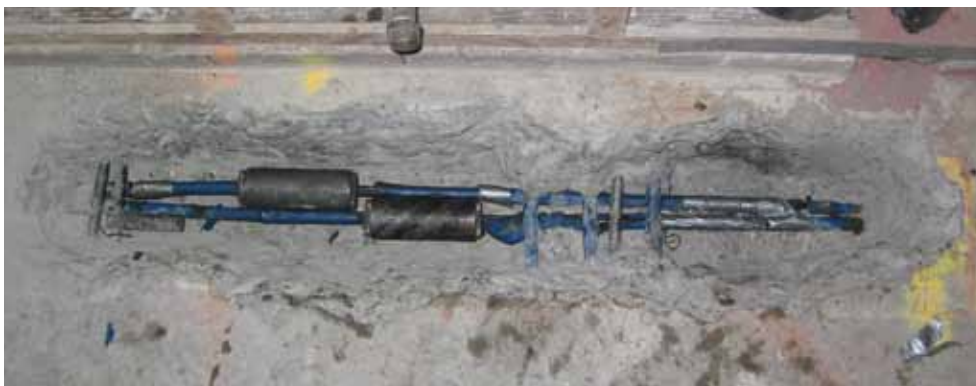
Figure 4: Coupler Used to Re-Connect Broken Strands.

If a strand is broken, there are several repair methods available. The strand can be coupled using a mechanical splicer as shown in *Figure 4*. The couplers are significantly larger than the tendons, so the area around the broken tendon will need to be chipped out to create enough workable room. Care should be taken during this procedure so as not to damage additional strands. Depending on the size of the opening, overlapping epoxy dowels may be required to re-connect the concrete patch to the existing foundation. Prior to placing concrete, the vapor retarder should be repaired (if required) to maintain the effectiveness of the moisture intrusion system. With current technology, it is possible to re-thread a new, greased strand into the existing sheathing. The jack is used in reverse to push the new strand through the slab. This application does not require any additional drilling or verification by an engineer, since the full strength of the system has been replaced. Re-threading a strand

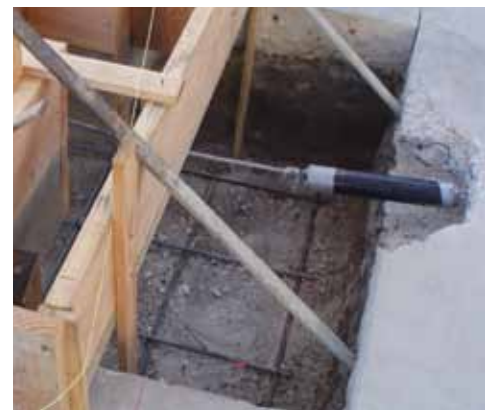
*Figure 5: New Pad Footing in an Existing Post-Tensioned Foundation.*

When a remodel occurs, the foundation system needs to be re-analyzed with the revised loading. In general, a higher perimeter load will increase the stresses for the center lift condition while having minimal impact on edge lift. If the loading is large enough that the foundation does not satisfy the code requirements, a typical retrofit is to add a new perimeter footing that extends further into the soil than the existing foundation. Per section 3.7 of the Post-Tensioning Institute (PTI) manual, a deeper footing will act as a pseudo water barrier, reducing the amount of moisture migration in and out of the foundation. Essentially, if the barrier can prevent any substantial change in water content, the effects of expansive soils are reduced. The new footing is placed on the exterior of the perimeter footing and connected with epoxy dowels. To minimize any affect on usable space, the top of the new footing typically begins several inches below the grade level to

allow for hardscaping or planting. In addition, the new footing can be used in resisting large post load or hold down forces.
